# San Leandro Creek Tree Assessment

February 24, 2015

County of Alameda  
Flood Control and Water Conservation District  
399 Elmhurst Street  
Hayward, CA 94544-1395

URS Corporation  
1333 Broadway, Suite 800  
Oakland, CA 94612

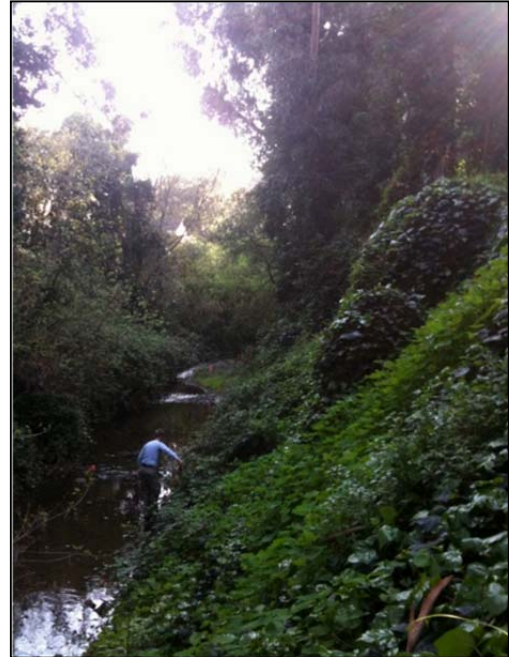
**Photo 1: The creek channel was formed by steep slopes covered with a dense mat of vines that often grew into tree canopies.**

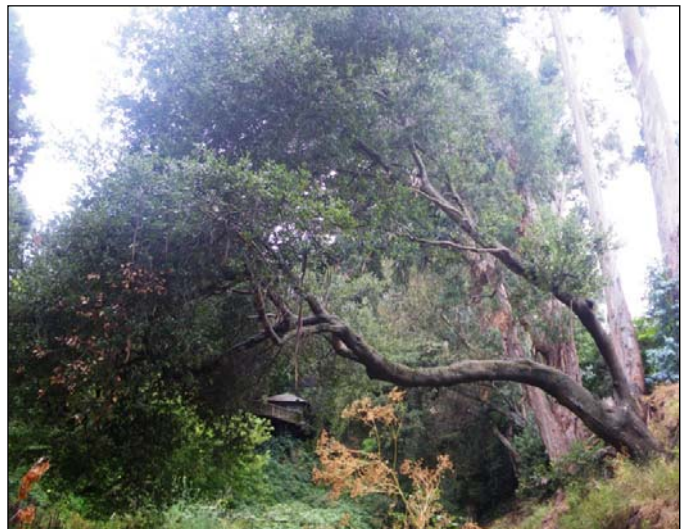
**Photo 2:** Coast live oak #243 had a form typical for the species growing in San Leandro Creek. Growing on the lower bank and suppressed beneath the canopies of the large-growing blue gums, the tree leaned sharply to the south.

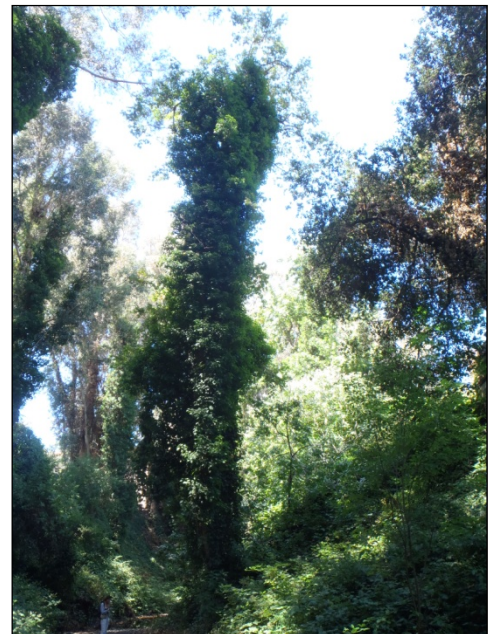
Most of the trees had vines growing up the trunk and into the canopy (Photo 3). The vines compete with the tree for resources, including sunlight, and can cause branches to die within the canopy. It is recommended that the vines at the base of the high priority trees be cut and removed during the course of management activities to prevent them from compromising surrounding trees.

**Photo 3: Tree #228 was typical of trees in San Leandro creek, with a dense matt of vines engulfing the canopy.**

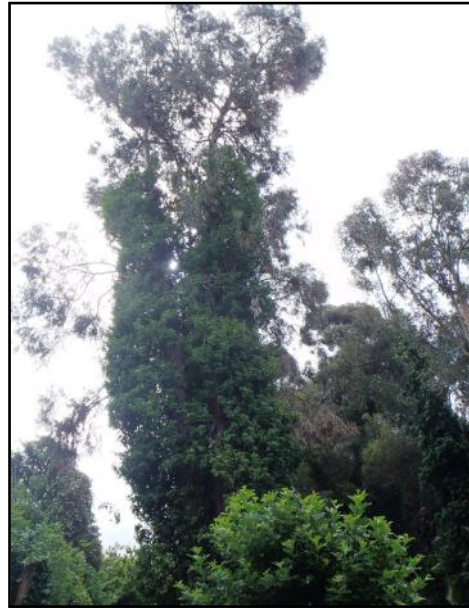
| <b>Comments</b> | Codominant trunks at 8'; N. stem up-right; S. stem bowed S. in upper crown; engulfed in ivy. |

Above: Tree #214 was a large-diameter blue gum in good condition.

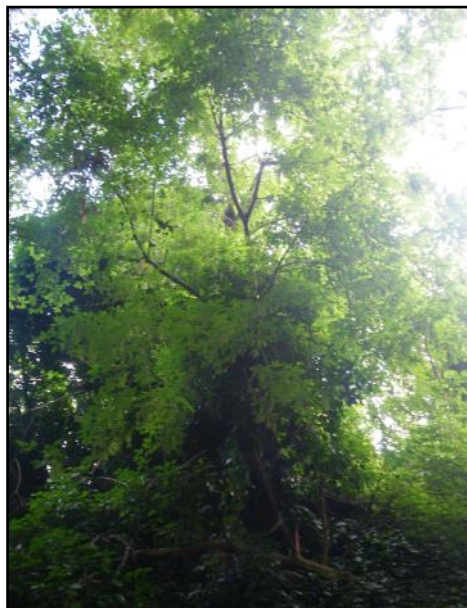
| Comments | Multiple attachments at 7'; W. stem decayed & failed; engulfed in ivy. |

Above: Boxelder #218 had experienced a stem failure.

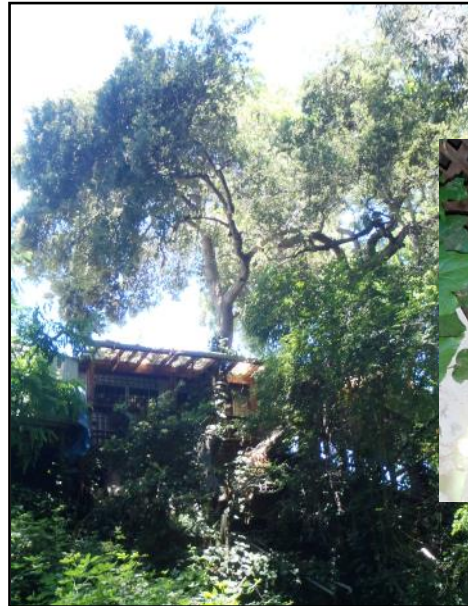
| Comments | Codominant trunks at 2'; trunk wound with decay; deck built around base & canopy; cavities with concrete. |

Inset shows the basal wound and decay.

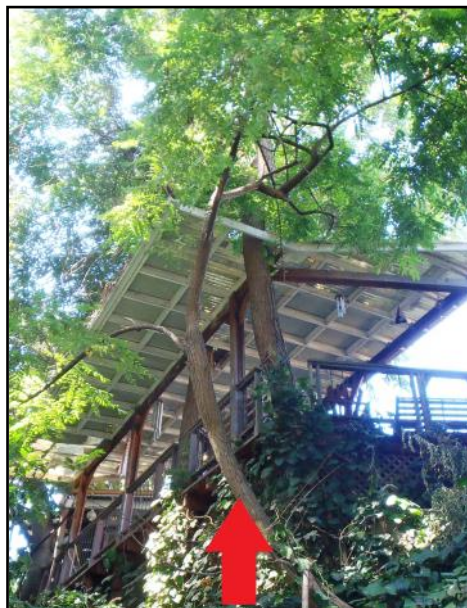
| Comments | Failed at base; suppressed; leans S.; trunk wounds. |

Above: Tree #234, a small-diameter black locust, had failed at the base.

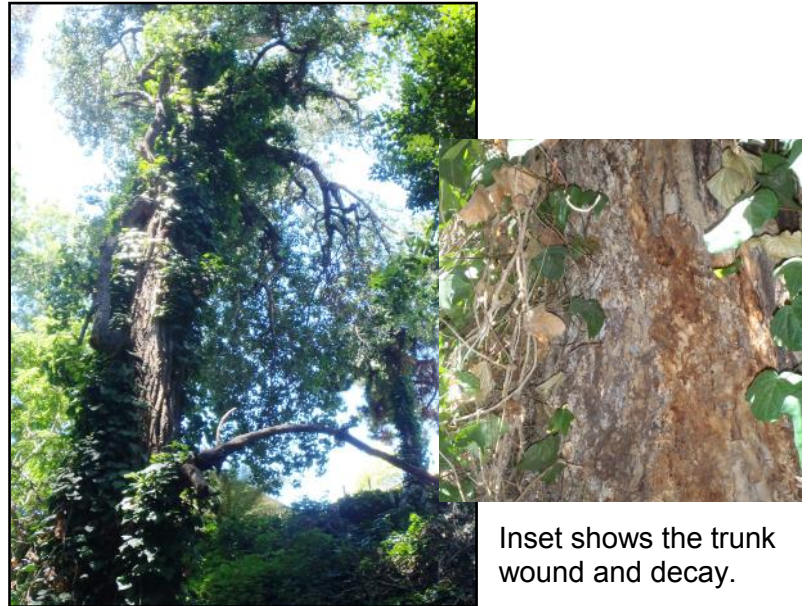
| Comments | Codominant trunks in upper crown; one sided N.; history of branch failures; large trunk wound and decayed area S.; engulfed in ivy. |

Inset shows the trunk wound and decay.

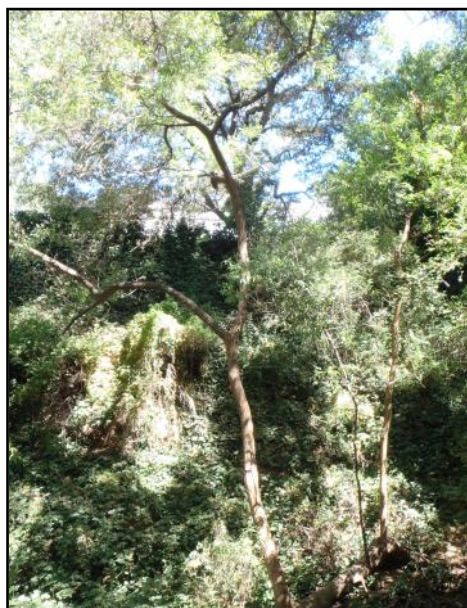
| Comments | Failed at base & laying on ground; 2-8" sprouts turned vertical. |

Above: Arroyo willow #283 had failed at the base and what were branches had become the crown.

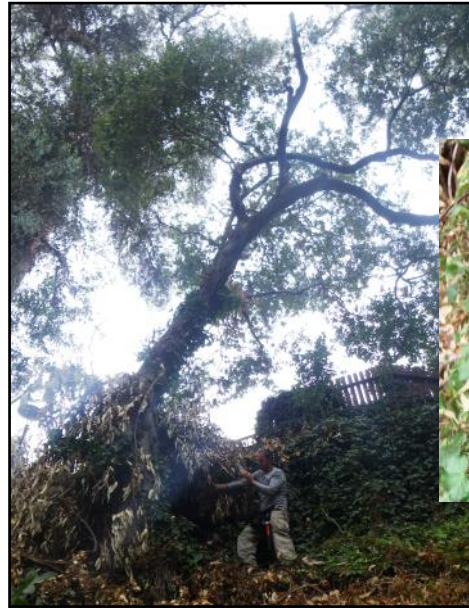
| Comments | Extensive trunk decay; one 14" stem remains; sup-pressed & leaning E. |

Inset shows a cavity and decay at the base.

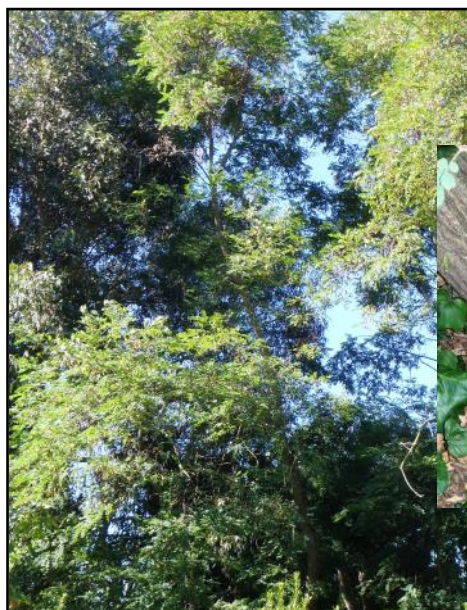
| Comments | Codominant trunks at base; S. stem failing at base but hung up in neighbor. |

Inset shows the base of the tree (S. stem is on Left).

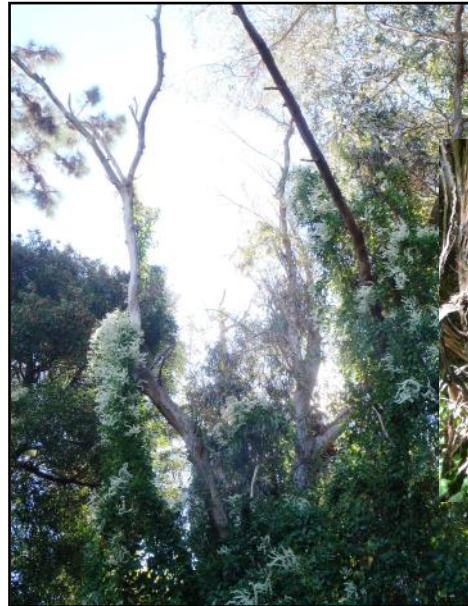
| Comments | Stump sprout; multiple attachments at 3'; base decayed & hollow N.; very thin crown; engulfed in vines. |

Inset shows the basal decay.

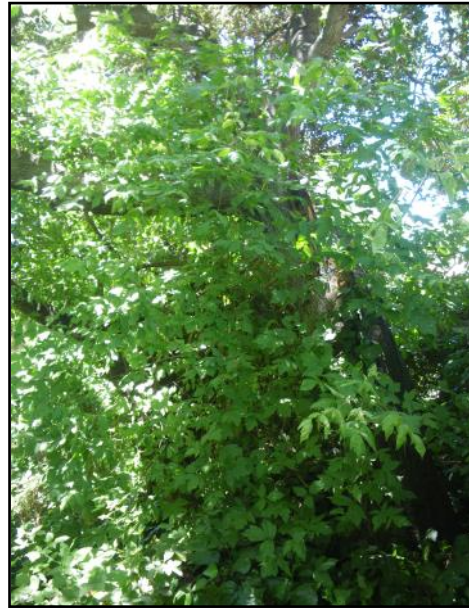
| Comments | Multiple attachments at base; heavy lean S.; basal cavity with decay. |

Above: Boxelder #446 was mature and leaned sharply S.

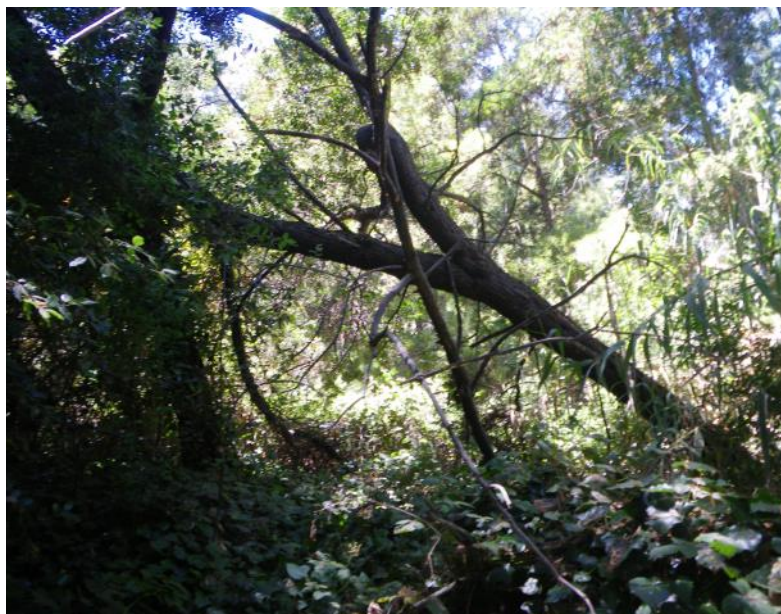
| Comments | Failed at base & hung up in neighbor. |

Above: Blackwood acacia #452 had failed at the base.

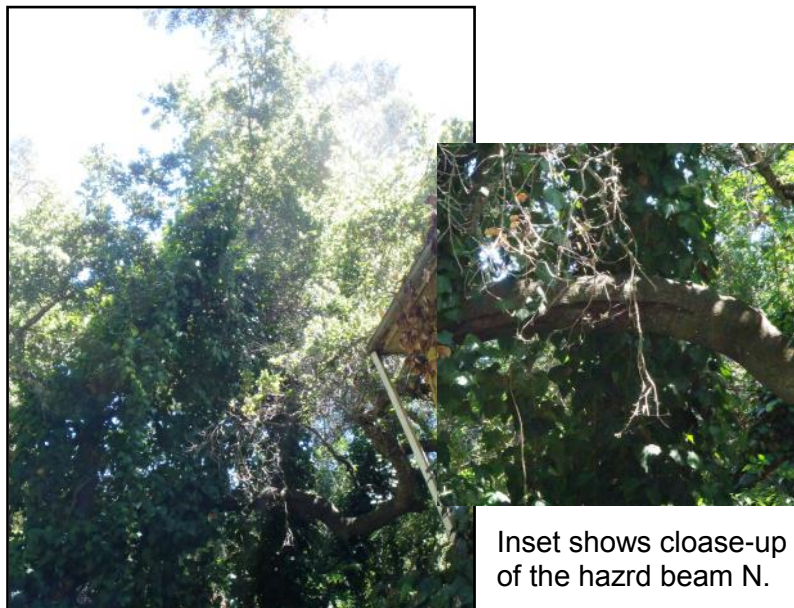
| Comments | Codominant trunks at 20'; leans W.; hazard beam NW. over private prop.; engulfed in ivy & poison oak. |

Inset shows close-up of the hazard beam N.

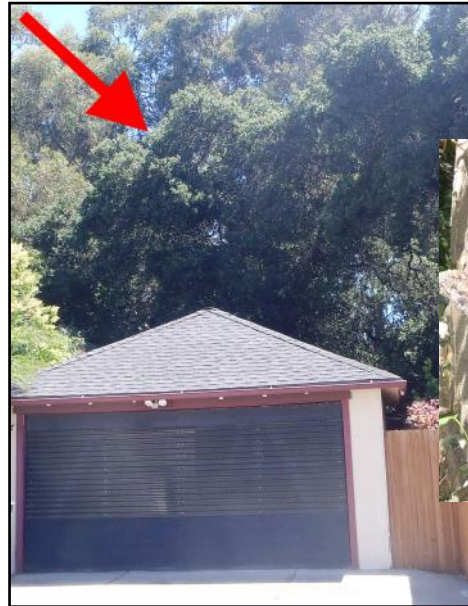
| Comments | Slight lean W. over private prop.; large basal cavity with extensive decay on S. side. |

Inset shows trunk decay and decay fungus.

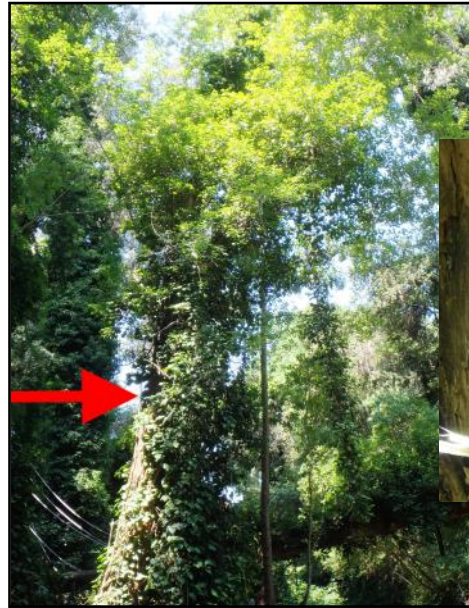
| Comments | Topped at 25'; leaning N.; extensive trunk decay; engulfed in ivy. |

Inset shows extent of trunk decay.

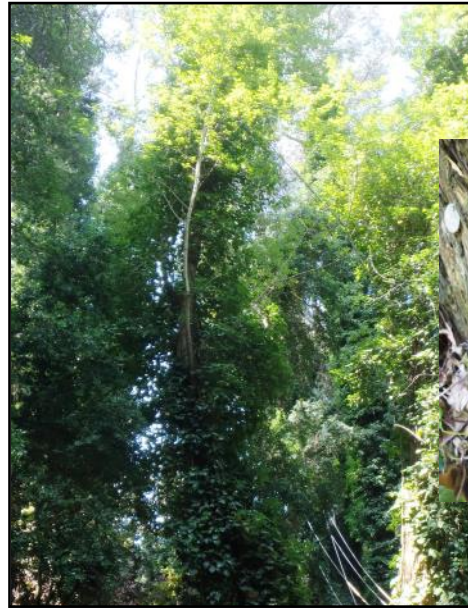
| Comments | Topped at 20'; corrected lean S.; extensive trunk decay; engulfed in ivy. |

Inset shows trunk cavity and decay.

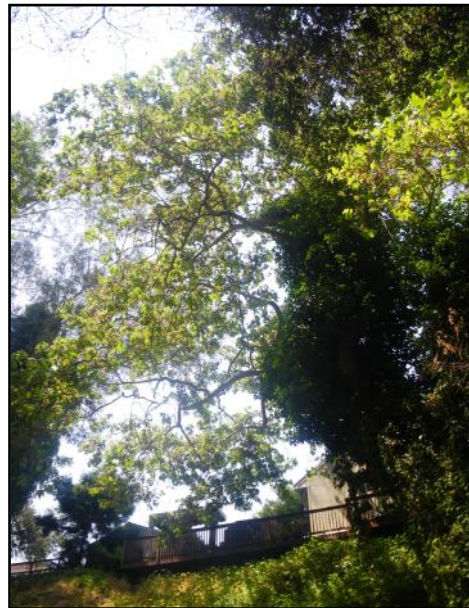
| Comments | Leans NW.; basal cavity & decay; engulfed in ivy. |

Above: This mature Calif. sycamore was in good health but had basal decay.

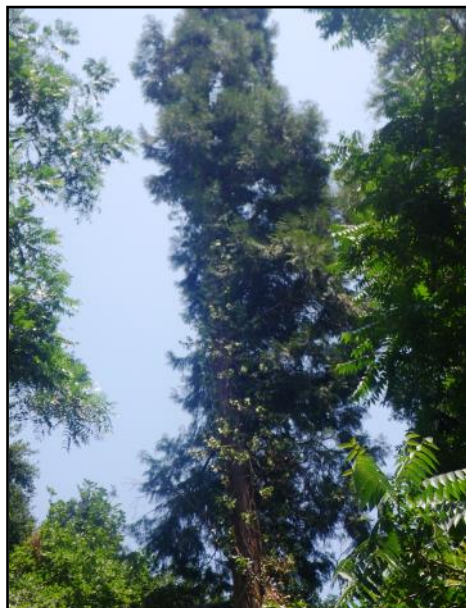
| Comments | Was 3-stemmed;<br>two stems failed at<br>base; bank failure. |

Above: Western red cedar #503 was in an area of whole tree failures.

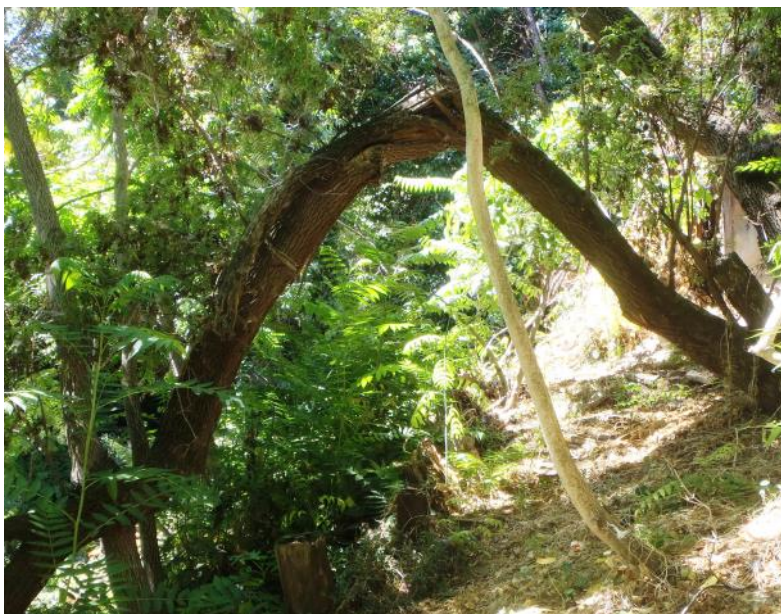
| Comments | Leans SE.; trunk failed at 8' but still alive. |

Above: The trunk of elderberry #505 had broken.

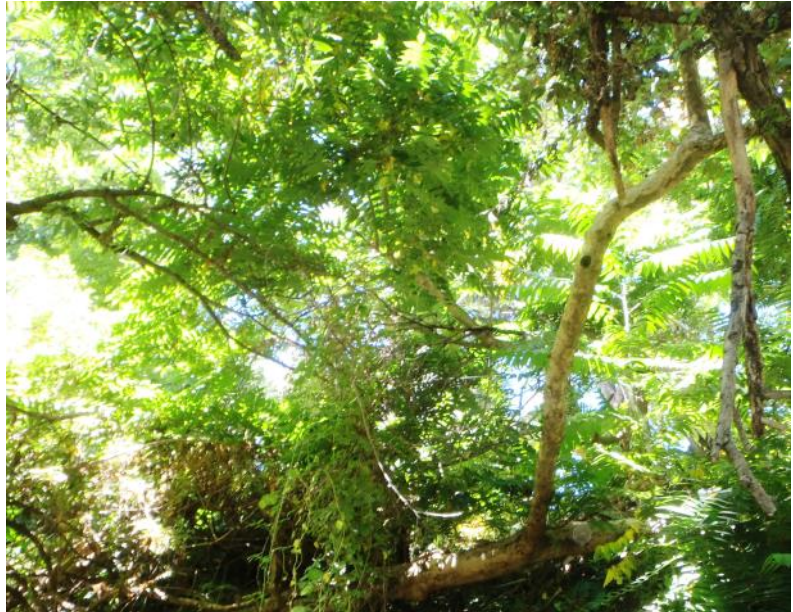
| Comments | Failed at base; laying on ground but still alive. |

Above: Ailanthus #508 had failed at the base.

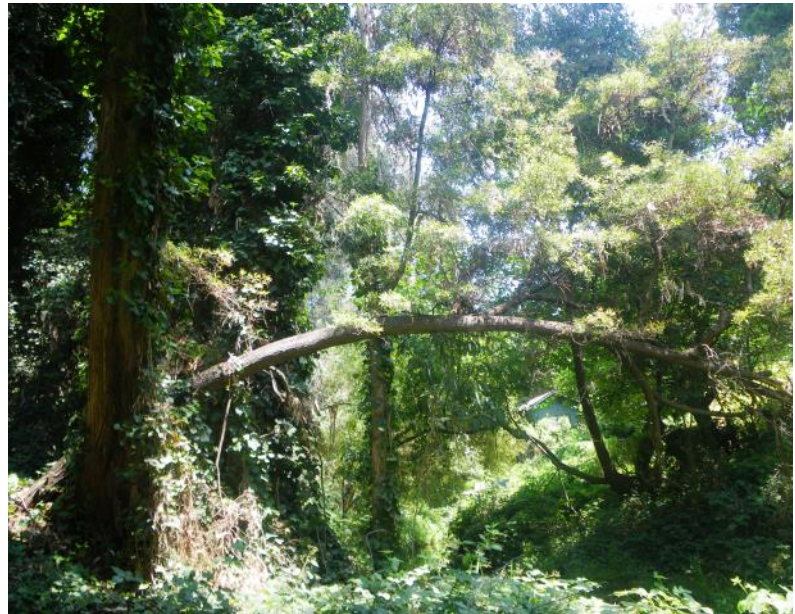
| Comments | Failing at base & hung up in #517; leans S. to horizontal; basal wounds. |

Above: Blackwood acacia #516 had failed at the base.

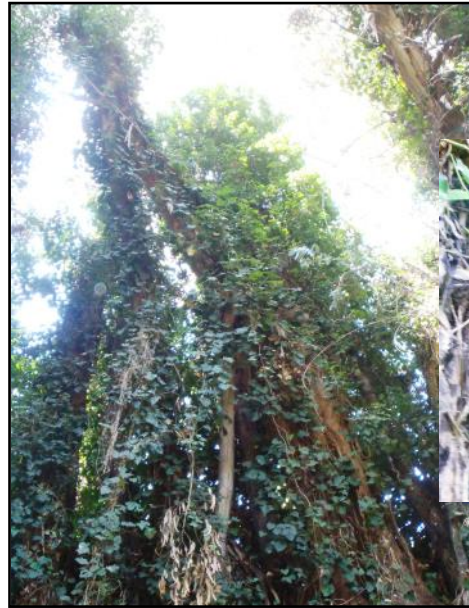
| Comments | Basal decay; leans SW.; engulfed in ivy. |

Inset shows basal decay.

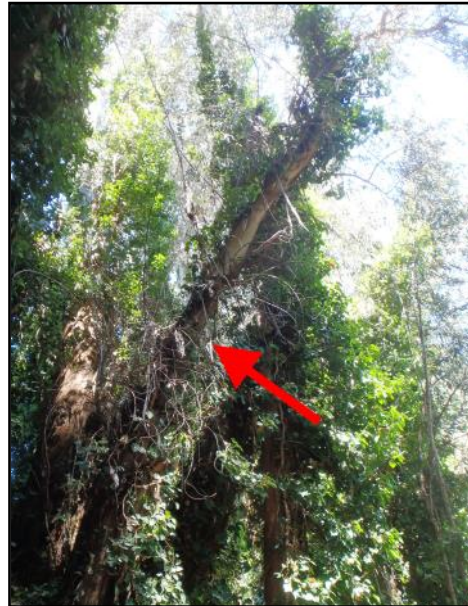
| Comments | Codominant trunks at base; topped at 20'; leans SW. over creek; engulfed in ivy. |

Above: Blue gum #531 was in poor condition and leaned over the creek channel.

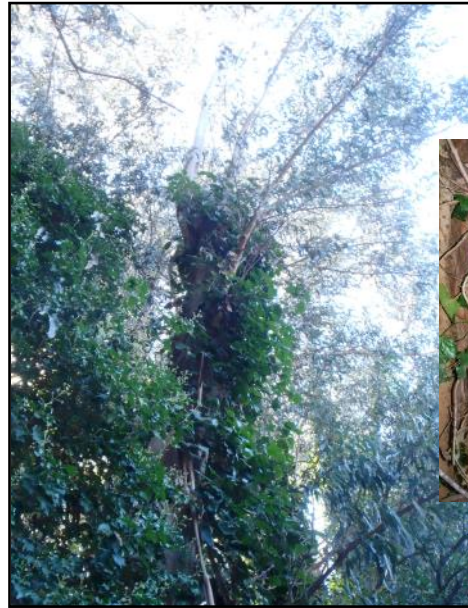
| Comments | Codominant trunks at 3'; basal wounds & decay N.; topped at 20'; 2-6" re-growth; engulfed in ivy. |

Inset shows basal cavity and decay.

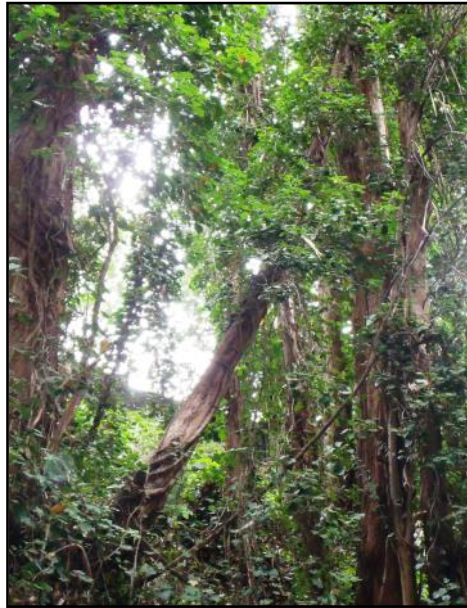
| Comments | Failed at base and hung up in neighbor E. |

Above: This small blue gum had failed at the base and was caught in the crown of its neighbor.

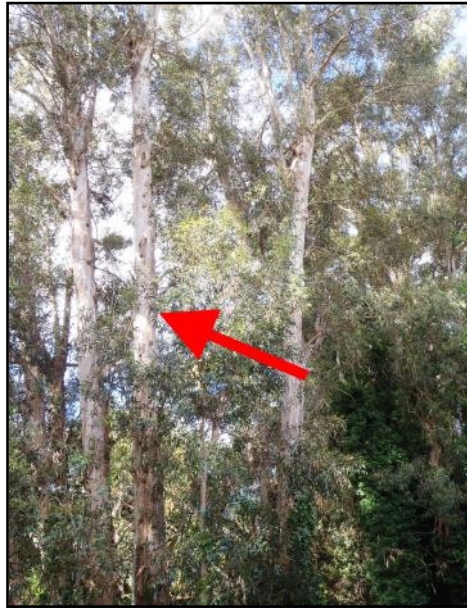
| Comments | Multiple attachments at 10'; old topping points at 50'; decay in topping points; laterals S. & W. in upper crown; engulfed in ivy. |

Above: Arrow points to topping points in the canopy of blue gum #595.

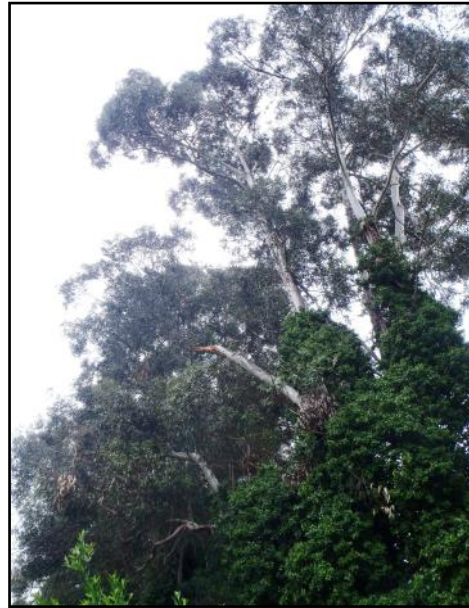
| Comments | Multiple attachment at 8'; upright form; lateral NE.; recent branch failure took out fence N.; engulfed in ivy. |

Above: Looking E. at the canopy of blue gum #603, showing a recent branch failure.

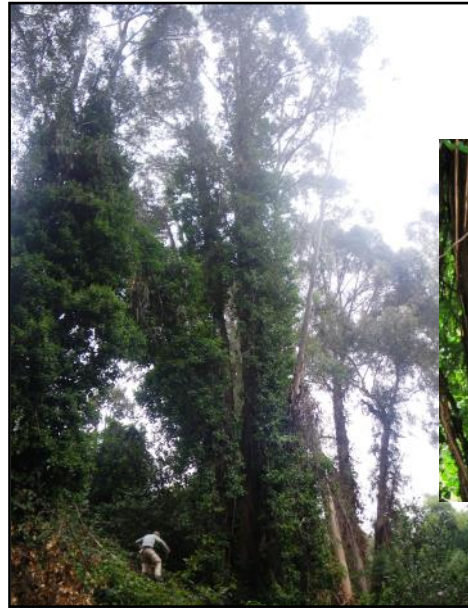
| Comments | Multiple attachment at 10'; section of log embedded in attachment; several stems topped at 20'; decay at topping points; engulfed in ivy; debris piled on uphill |

Inset shows the section of log wedged between the stems.

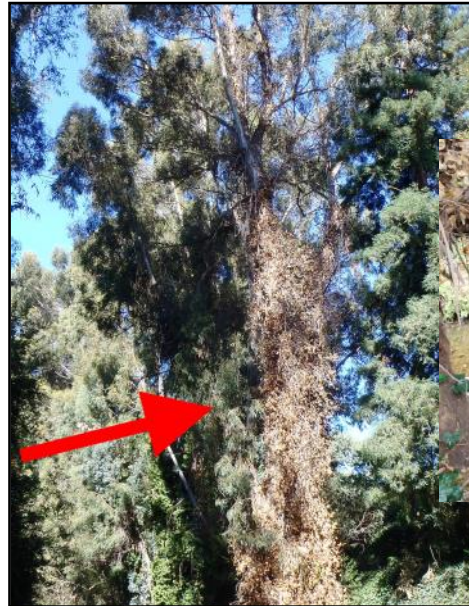
| Comments | Stump sprout; N. half of base decayed; lateral N.; corrected lean N.; ivy. |

Inset shows basal decay.

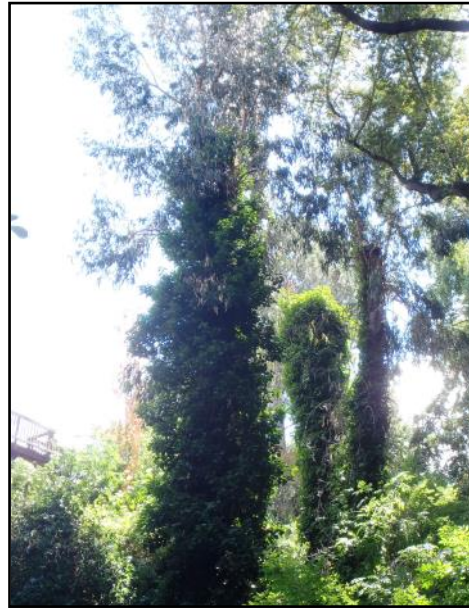
| Comments | Topped at 30'; 2-8" regrowth weakly attached; engulfed in ivy. |

Above: Blue gum #621 (foreground) had been topped and was in poor condition.

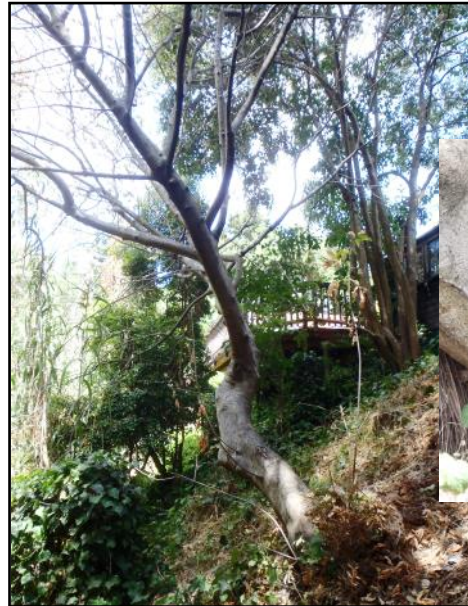
| Comments | Suppressed and leaning W.; basal wound & decay. |

Inset shows basal wound.

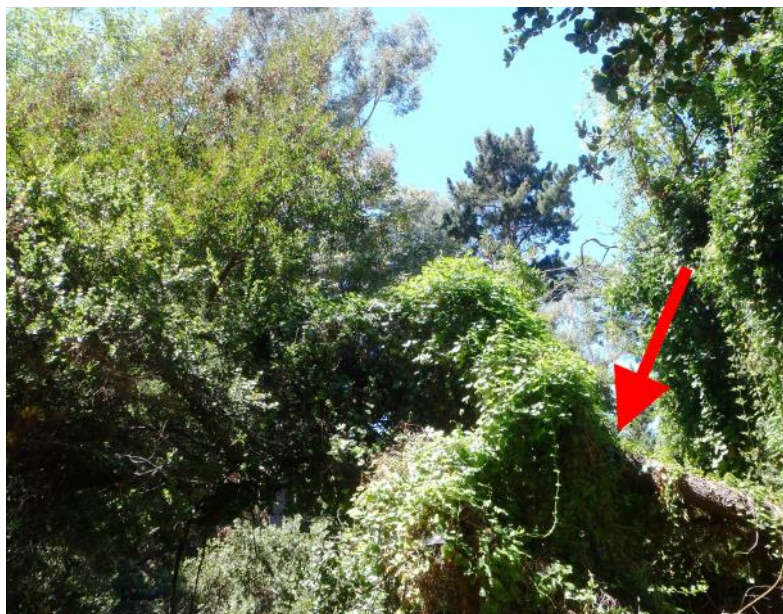
| Comments | Failed at base S.;<br>hung up in #634;<br>engulfed in ivy. |

Above: Arrow points to blackwood acacia #635, which had failed at the base.

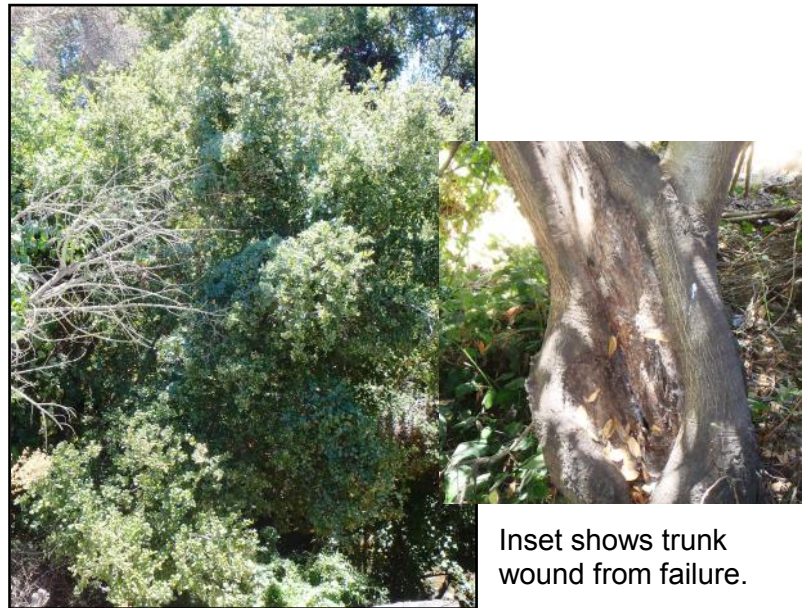
| Comments | Half of tree failed;<br>multiple attachments<br>at 4'; leans S.; trunk<br>decay; ivy. |

Inset shows trunk wound from failure.

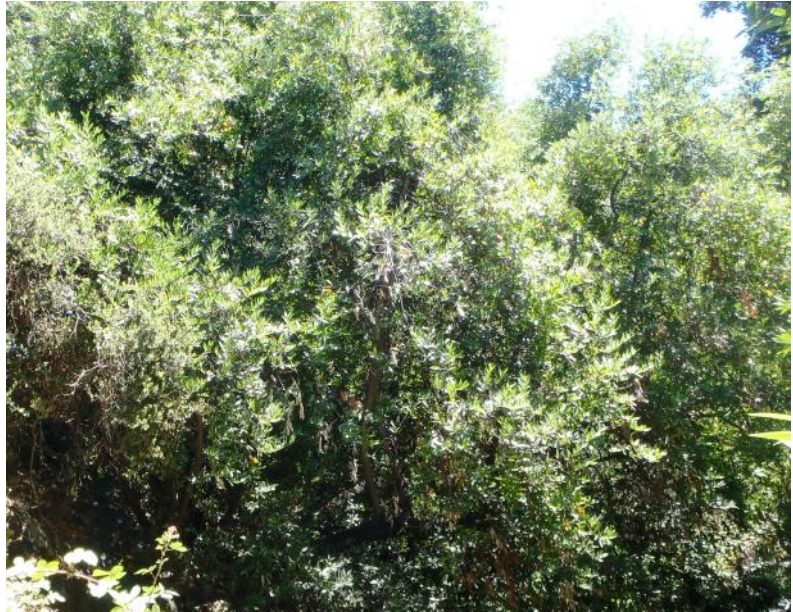
| Comments | Failed at base S.; stems turned up. |

Above: Although difficult to distinguish in this photo, Calif. bay #645 had failed at the base.

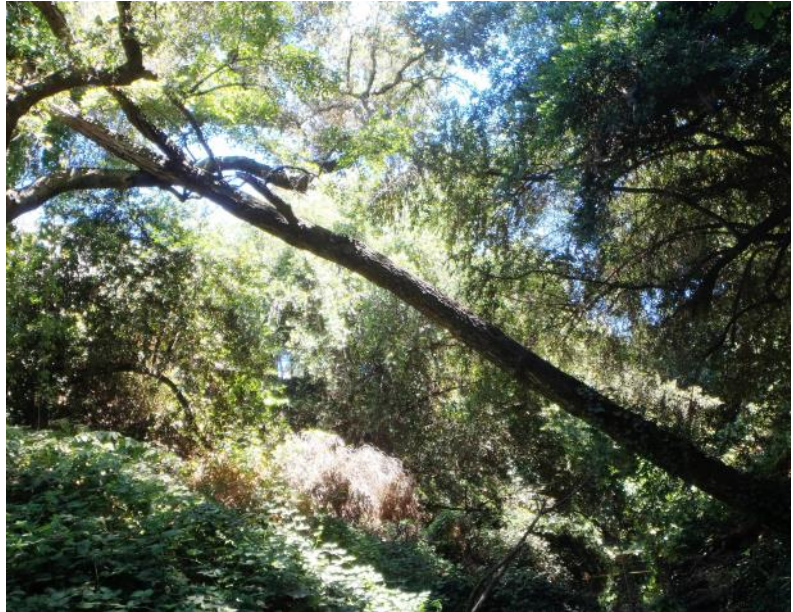
| Comments | Failed at base N. across creek; hung up in canopy of #642. |

Above: Coast live oak #646 had failed across the creek and was hung-up in tree #642.
