# San Leandro Creek Tree Assessment

February 24, 2015

County of Alameda  
Flood Control and Water Conservation District  
399 Elmhurst Street  
Hayward, CA 94544-1395

URS Corporation  
1333 Broadway, Suite 800  
Oakland, CA 94612

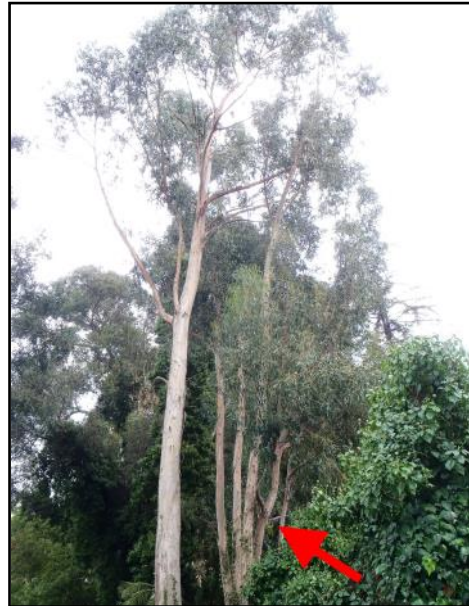
| Comments | Topped at 6'; 6-15" regrowth; one sided S. |

Above: Arrow points to tree #202. It had been topped and was one-sided to the S.

| Risk reduction options | To reduce risk, prune to shorten or remove regrowth from topping points; to eliminate risk, remove tree. |

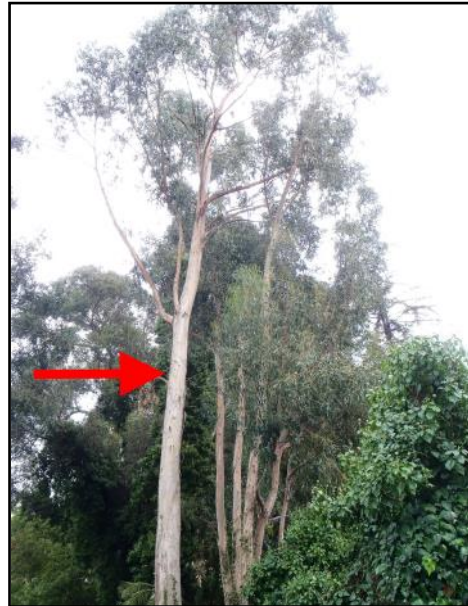
| Comments | Upright form; recently released with removal of other trees. |

Above: Looking east at tree #203 (arrow).

| Risk reduction options | To reduce risk, prune to reduce branch weight & extension N.; to eliminate risk, remove tree. |

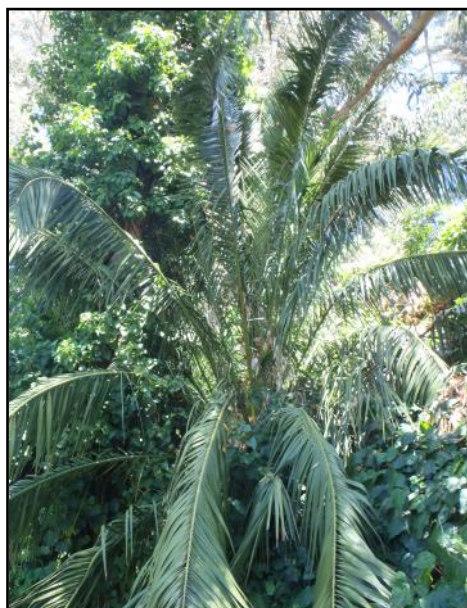
| Comments | Good form and structure; 4' of clear trunk. |

Above: Tree #204 was a young Canary Island palm.

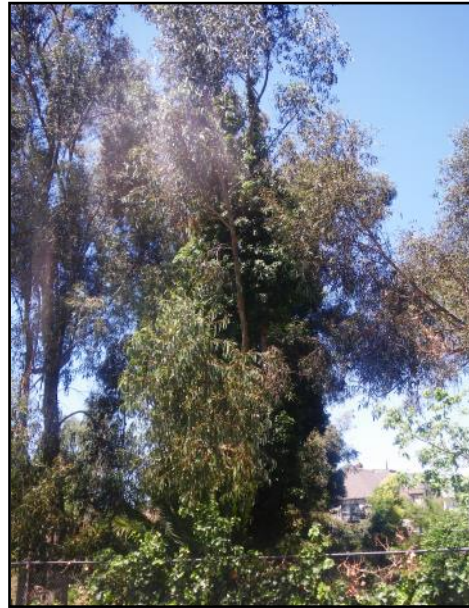
| Comments | Codominant trunks at 3'; laterals S.; engulfed in ivy. |

Above: Tree #205 looking north. The trunk was engulfed in ivy.

| Risk reduction options | To reduce risk, prune to reduce branch weight & extension S.; to eliminate risk, remove tree. |

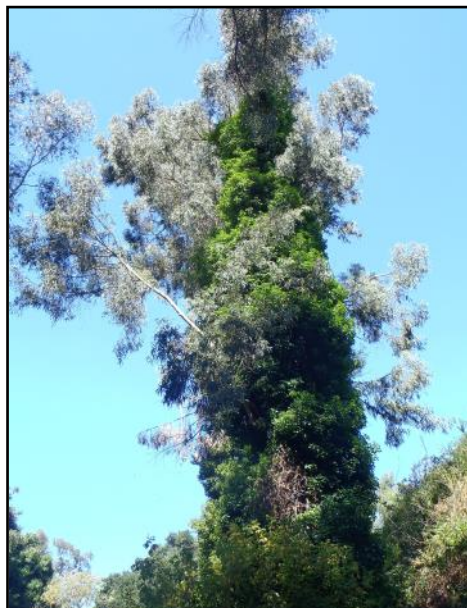
| Comments | Upright form; lateral S.; completely engulfed in ivy. |

Above: Tree #215 was engulfed in ivy.

| Risk reduction options | To reduce risk, prune to reduce branch weight & extension S.; to eliminate risk, remove tree. |

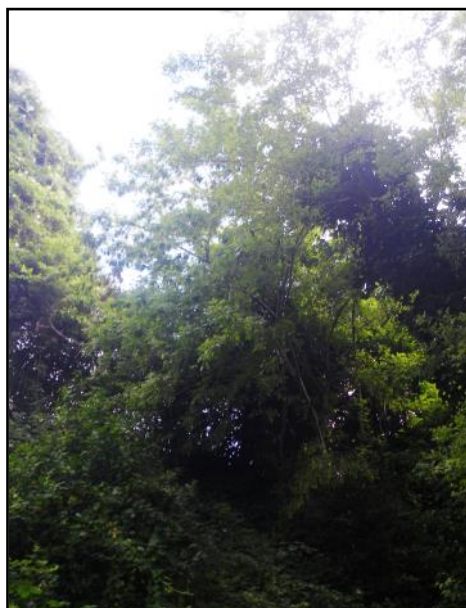
| Comments | Multiple attachments at base; suppressed; crown bowed W. |

Above: Tree #216 (background), was a multi-stemmed boxelder.

| Risk reduction options | To eliminate risk, remove tree. |

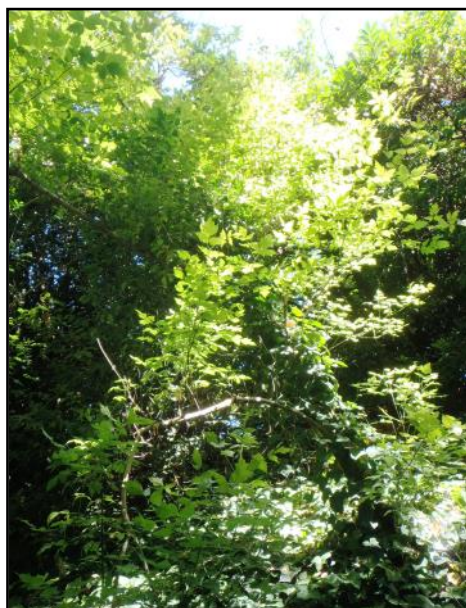
| Comments | Suppressed; engulfed in ivy. |

Above: Tree #217 is hard to distinguish amid the dense vegetation.

| Risk reduction options | To reduce risk, prune to reduce branch weight & extension; to eliminate risk, remove tree. |

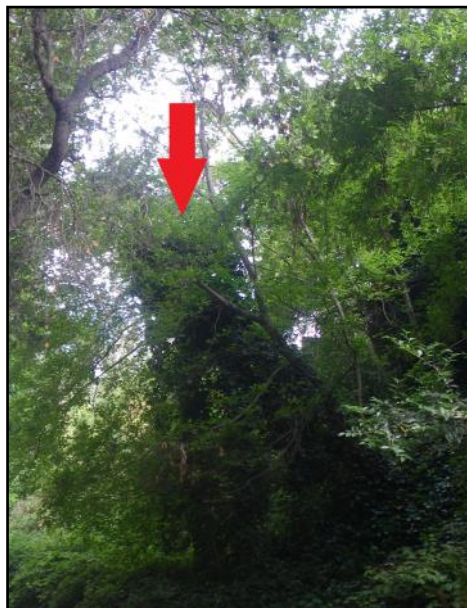
| Comments | Multiple attachments at 2'; leans S.; engulfed in ivy. |

Above: Boxelder #219 looking west (arrow).

| Risk reduction options | To reduce risk, prune to shorten or remove stems; remove tree to eliminate risk. |

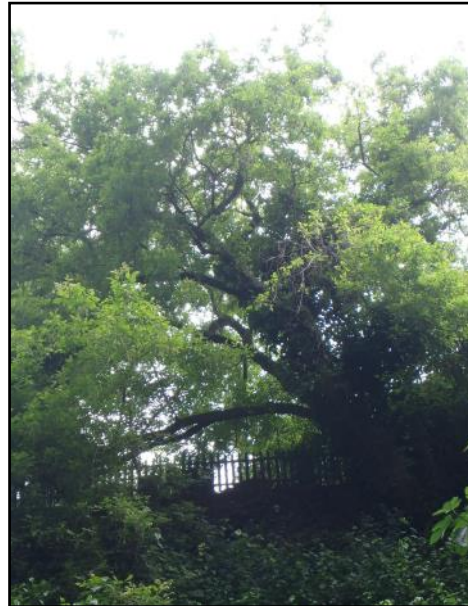
| Comments | Codominant trunks at 7'; crown bowed W.; long laterals W.; engulfed in ivy. |

Above: Boxelder #220 was large in diameter for the species.

| Risk reduction options | To reduce risk, prune to reduce branch weight & extension N.; to eliminate risk, remove tree. |

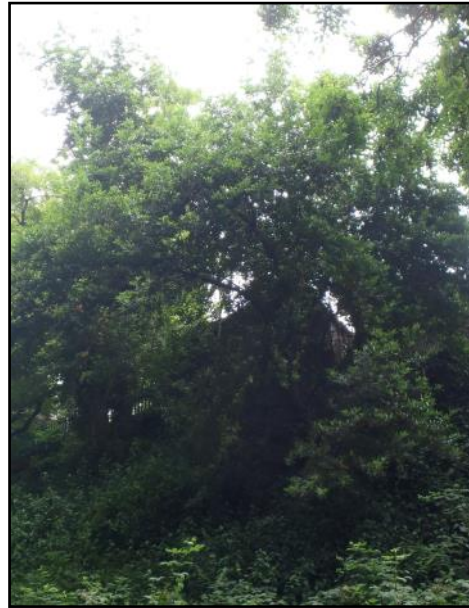
| Comments | Multiple attachments at base; stems bowed N. & S. |

Above: Calif. bay #221 was a healthy specimen.

| Risk reduction options | To reduce risk, prune to reduce branch weight & extension S.; to eliminate risk, remove tree. |

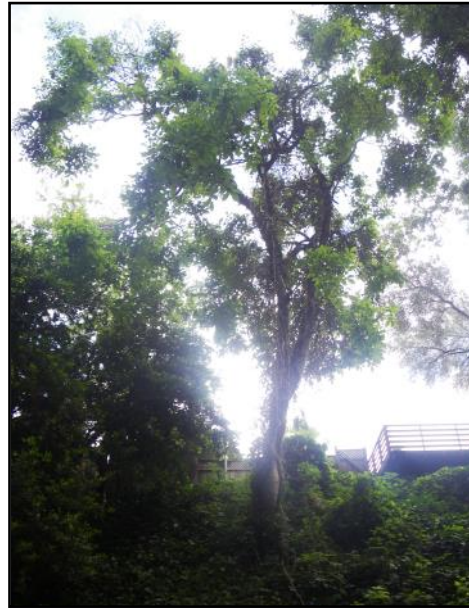
| Comments | Codominant trunks at 10'; narrow crown; dieback to 2"; engulfed in ivy. |

Above: Looking north at tree #222

| Risk reduction options | To reduce risk, prune to reduce branch weight & extension S.; to eliminate risk, remove tree. |

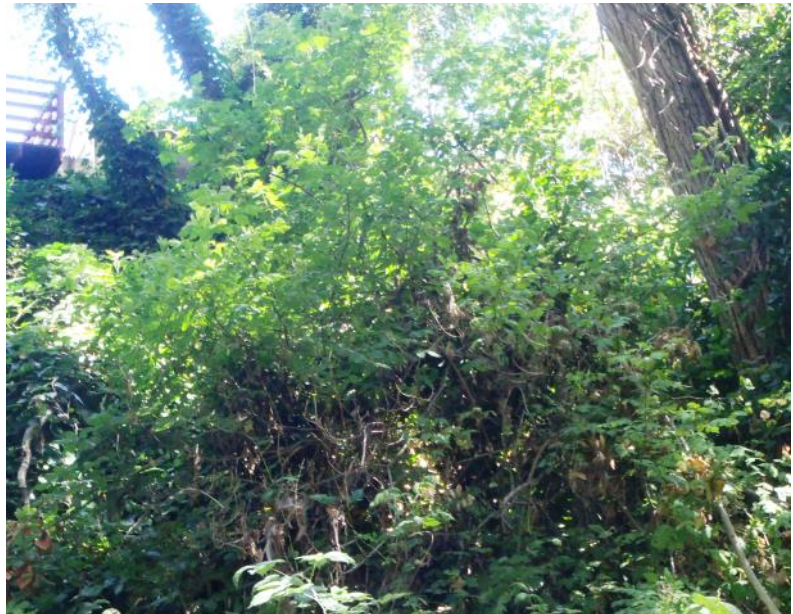
| Comments | Lost top; leans S.; engulfed in ivy. |

Above: Tree #223 was low growing and leaned S.

| Risk reduction options | To eliminate risk, remove tree. |

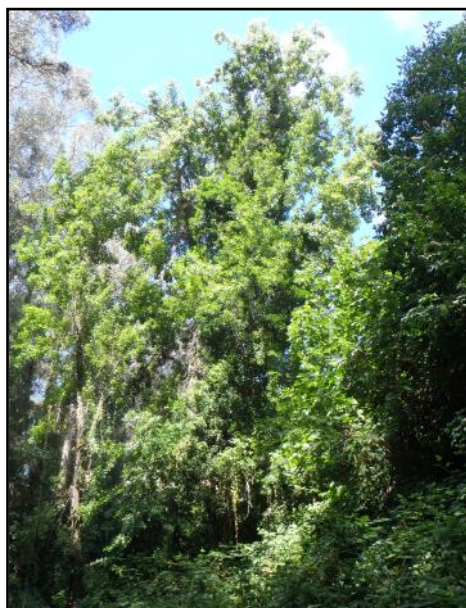
| Comments | Trunk sweeps W. from base and turns upright; deadwood to 4"; engulfed in ivy. |

Above: Fremont cottonwood #224 was large and engulfed in ivy.

| Risk reduction options | To reduce risk, coppice; to eliminate risk, remove tree. |

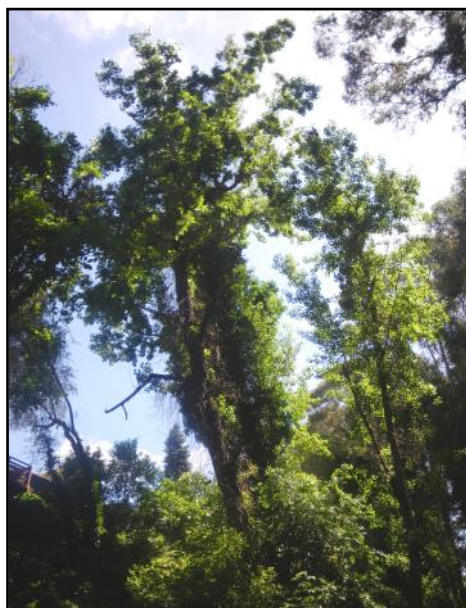
| Comments | Upright form; lateral N. at 35'; engulfed in ivy. |

Above: Fremont cottonwood #225 was upright and engulfed in ivy.

| Risk reduction options | To reduce risk, prune to reduce branch weight & extension N.; to eliminate risk, remove tree. |

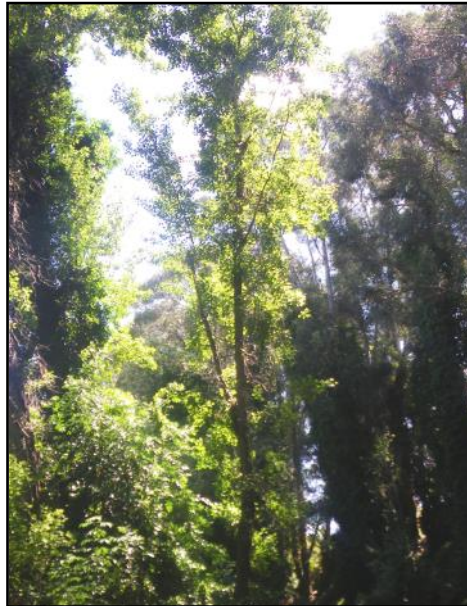
| Comments | Upright form; good young tree; ivy. |

Above: Fremont cottonwood #226 was in good condition.

| Risk reduction options | To eliminate risk, remove tree. |

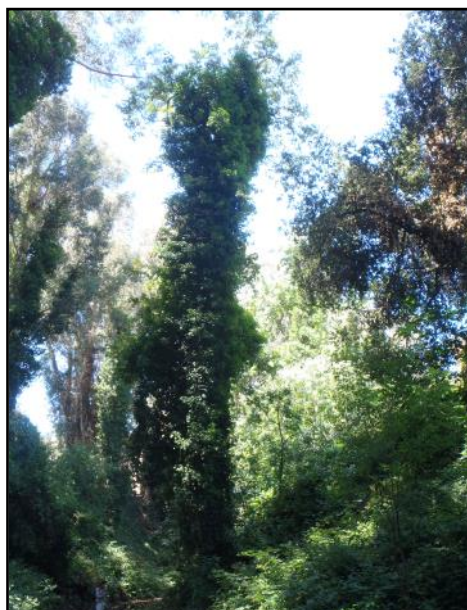
| Comments | Trunk sweeps SE.;<br>minor deadwood;<br>engulfed in ivy. |

Above: Calif. sycamore #228 looking west.

| Risk reduction options | To eliminate risk,<br>remove tree. |

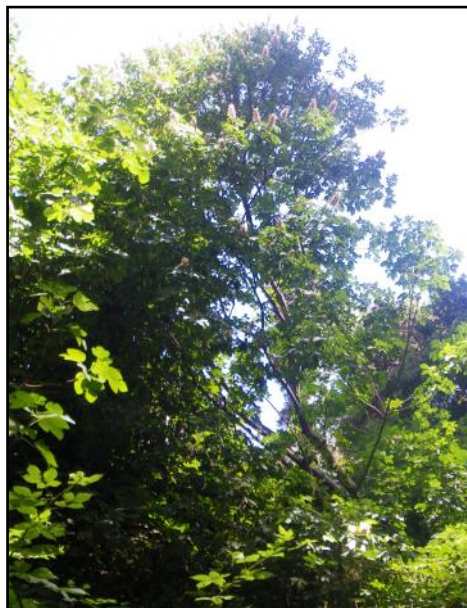
| Comments | Multiple attachments at base; suppressed with stems leaning W.; ivy. |

Above: Buckeye #229 was multi-stemmed and leaning.

| Risk reduction options | To eliminate risk, remove tree. |

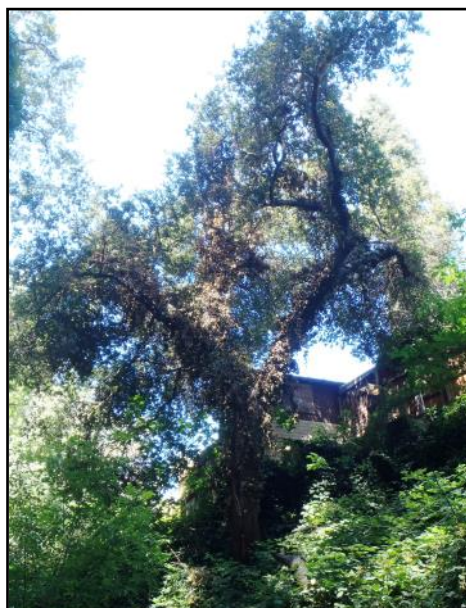
| Comments | Codominant trunks at 10'; one stem to W.; other stem to N.; laterals over fence N. |

Above: Coast live oak #230 had two-trunks. The N. stem extended over the adjacent property.

| Risk reduction options | To reduce risk, prune to reduce branch weight & extension N.; to eliminate risk, remove tree. |

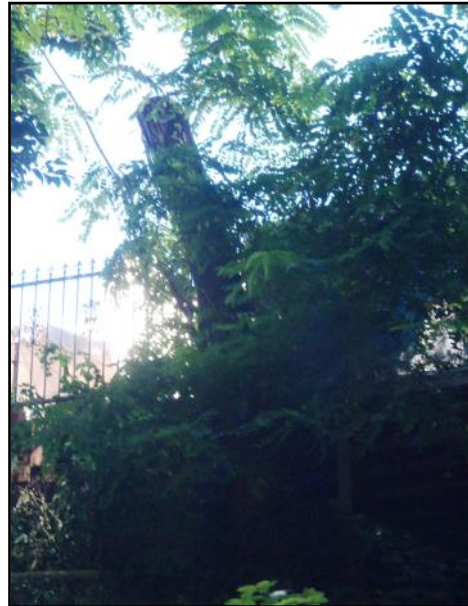
| Comments | Topped at 8'; deck built around base. |

Above: Black locust #232 had been topped at 8'.

| Risk reduction options | To eliminate risk, remove tree. |

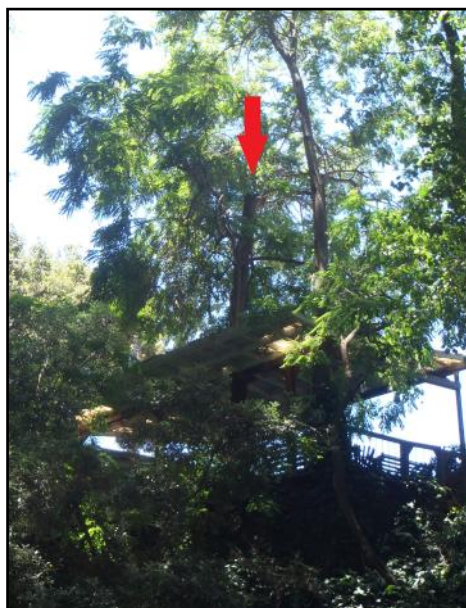
| Comments | Topped at 18'; 8" regrowth from top-ping point; deck built around base & crown. |

Above: Arrow points to tree #233. A deck had been built around the tree.

| Risk reduction options | To eliminate risk, remove tree. |

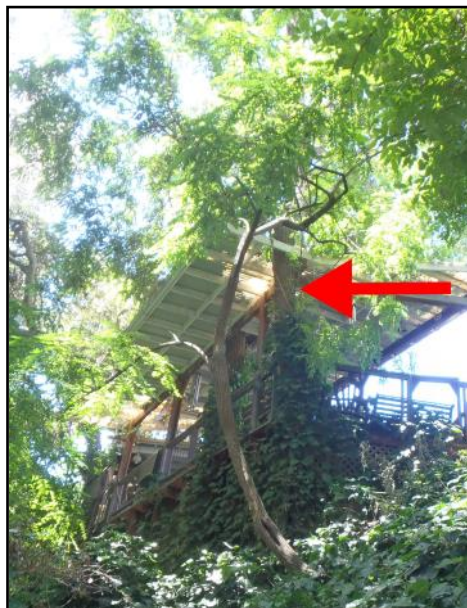
| Comments | Topped at 25'; weakly attached re-growth to 4"; deck built around base. |

Above: Arrow points to tree #235. A deck had been built around the tree.

| Risk reduction options | To reduce risk, prune to reduce branch weight & extension N.; to eliminate risk, remove tree. |

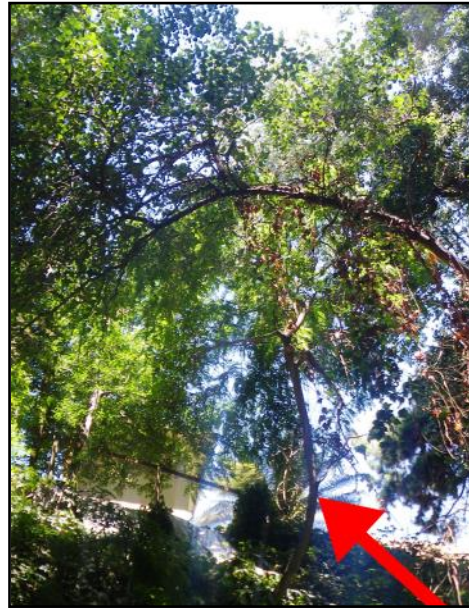
| Comments | Suppressed; debris at base N.; poor structure. |

Above: Looking N. at tree #236 (arrow).

| Risk reduction options | To eliminate risk, remove tree. |

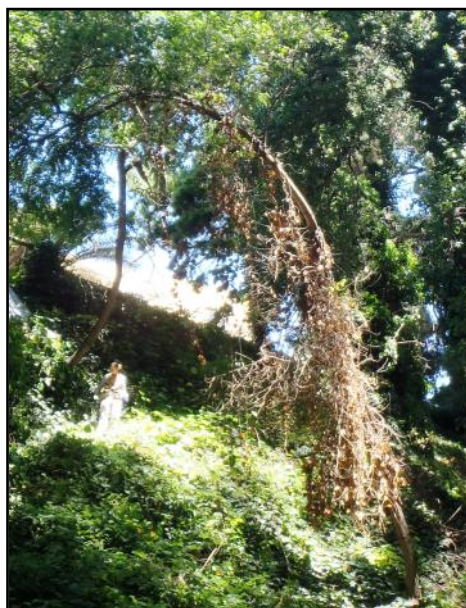
| Comments | Suppressed; crown bowed W.; trunk wound at 20'. |

Above: This small-diameter Fremont cottonwood was suppressed.

| Risk reduction options | To eliminate risk, remove tree. |

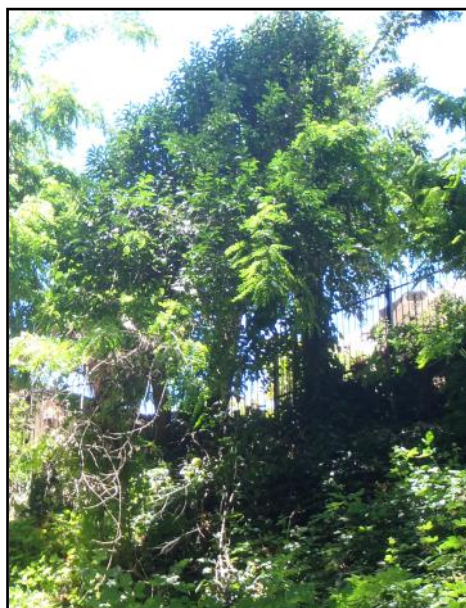
| Comments | Suppressed but up-right. |

Above: Tree #239, looking northwest

| Risk reduction options | To reduce risk, prune to shorten or remove stems; to eliminate risk, remove tree. |

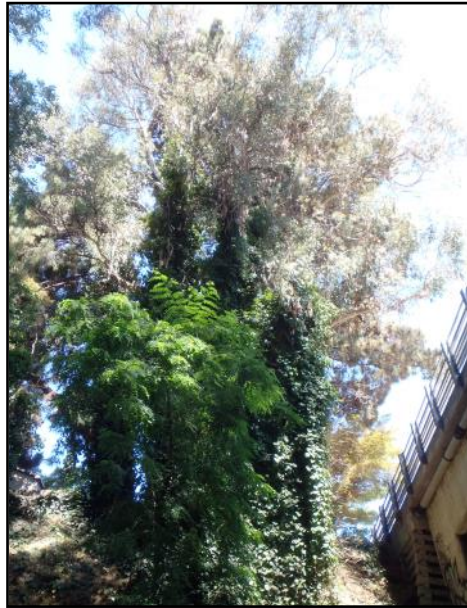
| Comments | Codominant trunks at 20'; one sided SE.; thin crown/ dieback; lateral N. Pruned at PL; engulfed in ivy. |

Above: Blue gum #240 was large and one-sided to the SE. over Bancroft Ave.

| Risk reduction options | To reduce risk, prune to reduce branch weight & extension E.; to eliminate risk, remove tree. |

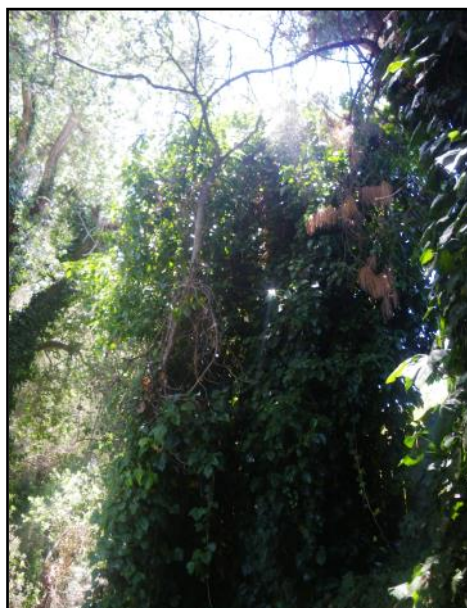
| Comments | Codominant trunks at base; leans N. over private property; engulfed in ivy. |

Above: English walnut #241 was dead and engulfed in ivy.

| Risk reduction options | To eliminate risk, remove tree. |

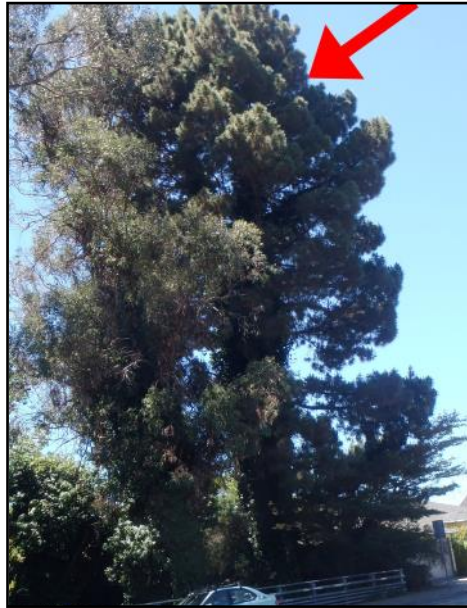
| Comments | Codominant trunks at 25'; one sided NE.; laterals over sidewalk; engulfed in ivy. |

Above: Canary Island pine #242 was one-sided to the NE. over Bancroft Ave.

| Risk reduction options | To reduce risk, prune to reduce branch weight & extension E.; to eliminate risk, remove tree. |

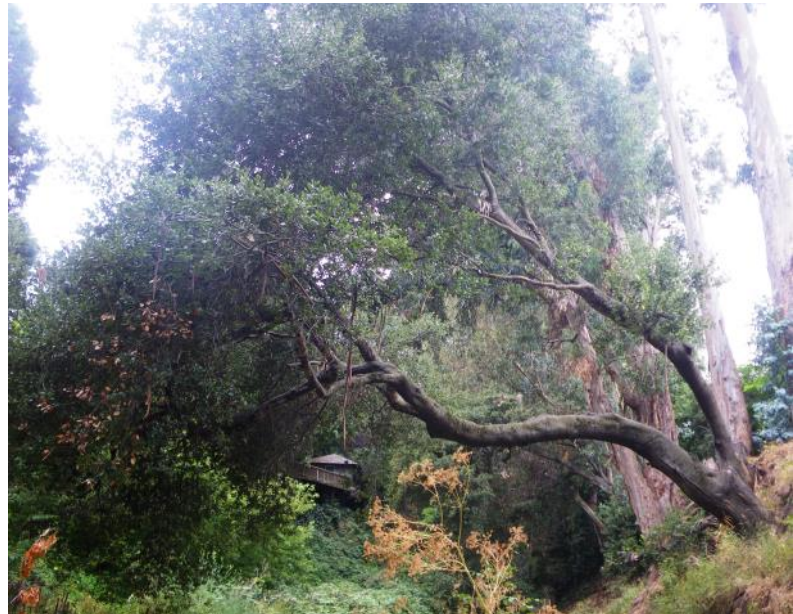
| Comments | Codominant trunks at 3'; suppressed; trunk bowed S. to horizontal; trunk wounds. |

Above: Growing beneath large blue gums, Coast live oak #243 leaned sharply to the south.

| Risk reduction options | To reduce risk, prune to reduce canopy weight & extension S.; to eliminate risk, remove tree. |

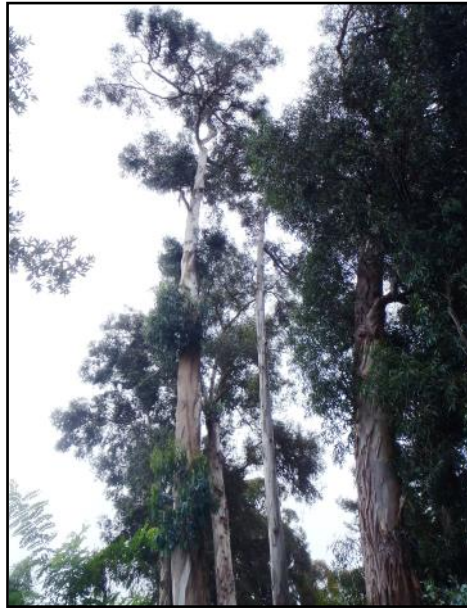
| Comments | Upright form; minor deadwood & laterals in upper crown. |

Above: Blue gum #244 was in good condition, with a high crown.

| Risk reduction options | To reduce risk, prune to reduce branch weight & extension; to eliminate risk, remove tree. |

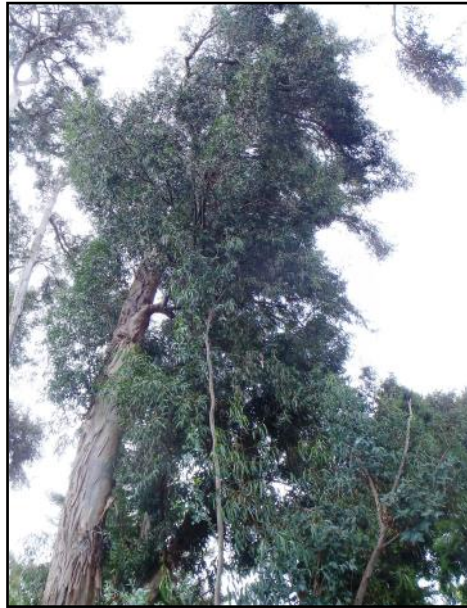
| Comments | Codominant trunks at 8'; crown bowed S.; laterals S. |

Above: Looking east at blue gum #246.

| Risk reduction options | To reduce risk, prune to reduce branch weight & extension S.; to eliminate risk, remove tree. |

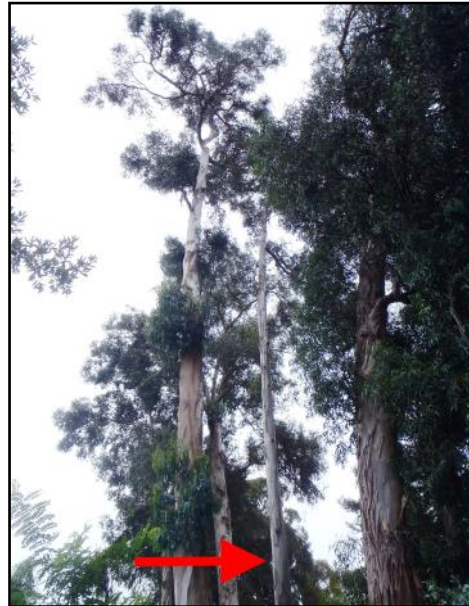
| Comments | One sided & bowed S.; laterals SE. |

Above: Arrow points to tree #247.

| Risk reduction options | To reduce risk, prune to reduce branch weight & extension SE.; to eliminate risk, remove tree. |

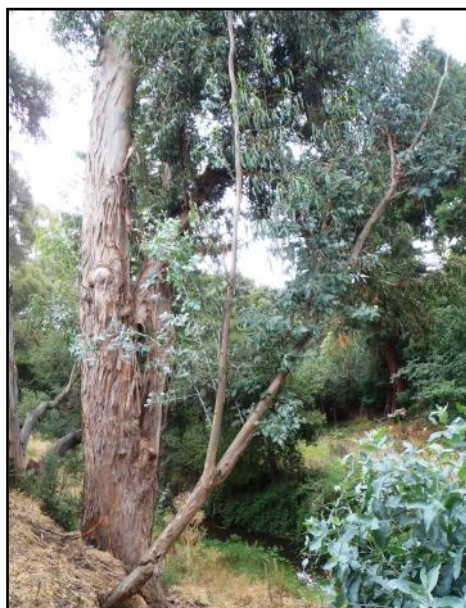
| Comments | Suppressed and leaning S.; large trunk wound at base. |

Above: Blue gum #248 was suppressed and leaning S.

| Risk reduction options | To eliminate risk, remove tree. |

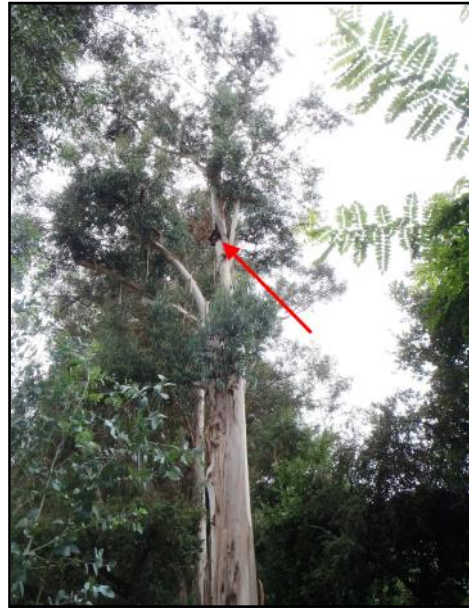
| Comments | Topped at 30'; 15" regrowth upright from topping point; 3'-6" regrowth extends S.; trunk wound at 45'. |

Above: Blue gum #250 had been topped in the past. Arrow points to a trunk wound at ~45'.

| Risk reduction options | To reduce risk, prune to shorten or remove regrowth from topping points; to eliminate risk, remove tree. |

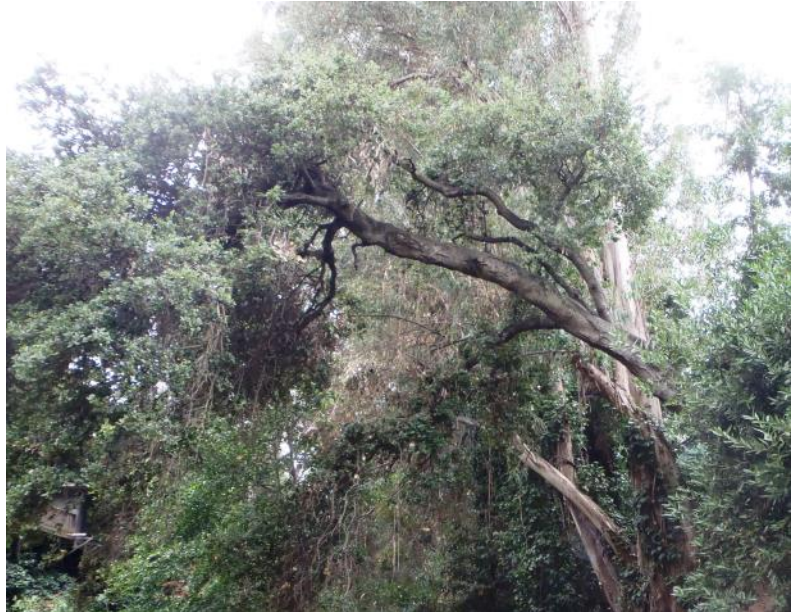
| Comments | Codominant trunks at 15'; suppressed; trunk leans S. to horizontal; possible basal cavity N. |

Above: Coast live oak #252 leaned S. to horizontal.

| Risk reduction options | To reduce risk, prune to reduce canopy weight & extension S.; to eliminate risk, remove tree. |

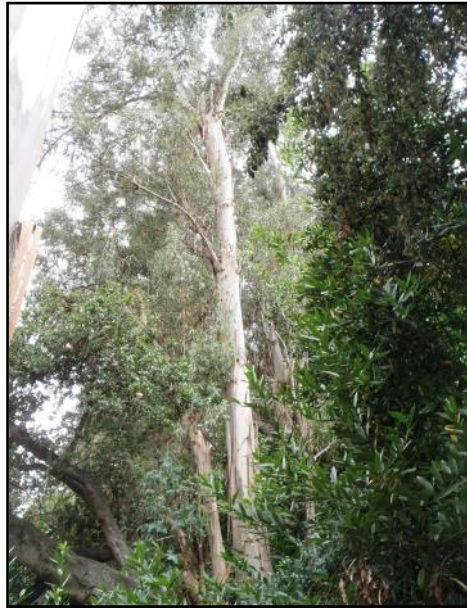
| Comments | Topped at 45'; 2-7" regrowth at topping point; ivy |

Above: Small regrowth emerged from the topping points of tree #254.

| Most likely failure | Branch |
| Failure potential | 3 |

| Risk reduction options | To reduce risk, prune to shorten or remove regrowth from topping points; to eliminate risk, remove tree. |

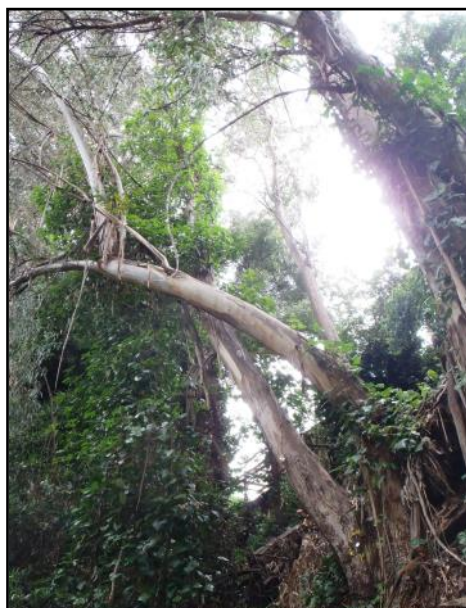
| Comments | Multiple attachments at base; sup-pressed; two stems bowed SW.; one stem upright; ivy |

Above: Blue gum #255 was multi-stemmed at the base.

| Most likely failure | Stem |
| Failure potential | 3 |

| Risk reduction options | To reduce risk, prune to shorten or remove stems SW.; to eliminate risk, remove tree. |

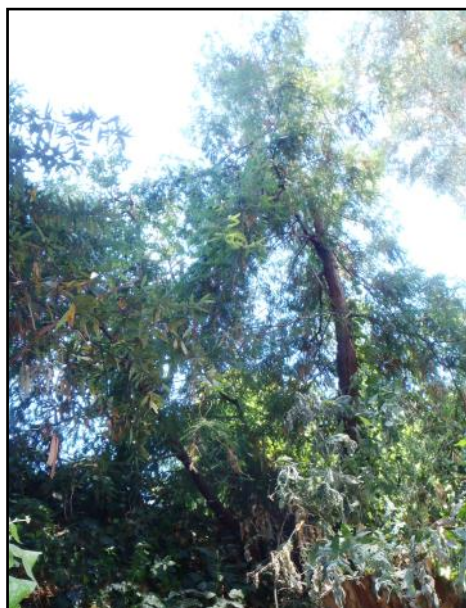
| Comments | Stump sprout; trunk sweeps at base; good young tree. |

Above: Coast redwood #257 was a stump sprout, with multiple trunks.

| Most likely failure | Stem |
| Failure potential | 2 |

| Risk reduction options | To eliminate risk, remove tree. |

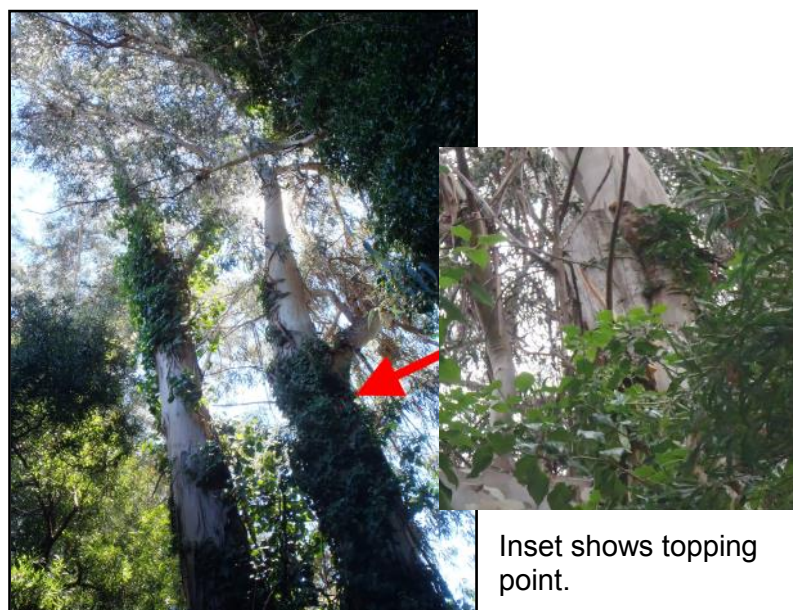
| Comments | Topped at 35'; multiple attachments at topping point; one stem extends N.; ivy |

Inset shows topping point.

Above: Arrow points to blue gum #259. Topping point is obscured.

| Most likely failure | Stem |
| Failure potential | 3 |

| Risk reduction options | To reduce risk, prune to shorten or remove regrowth from topping points; to eliminate risk, remove tree. |

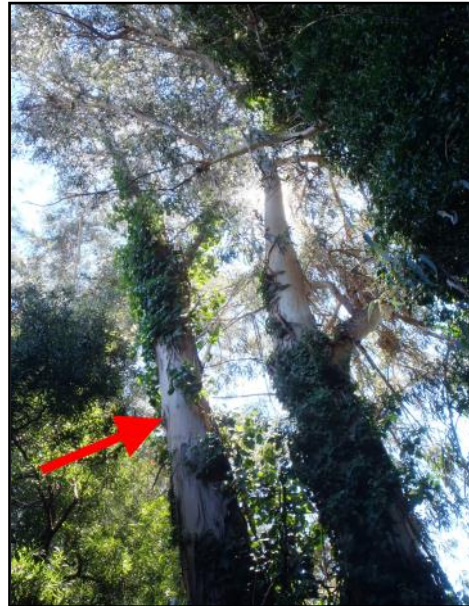
| Comments | Topped at 30'; one sided S.; heavy lateral limbs; ivy |

Above: Arrow points to blue gum #260. Topping point is obscured by ivy.

| Most likely failure | Branch |
| Failure potential | 3 |

| Risk reduction options | To reduce risk, prune to shorten or remove regrowth from topping points; to eliminate risk, remove tree. |

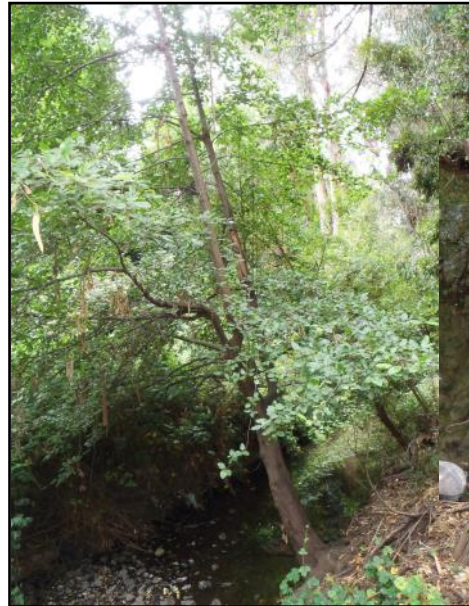
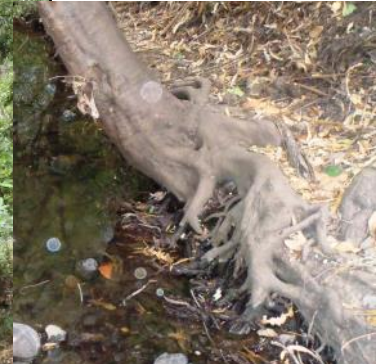
| Comments | No tag; trunk sweeps S. from base; trunk & branch wounds. |

Inset shows roots exposed in the channel.

Above: White alder #261 was growing in the active channel.

| Most likely failure | Whole tree |
| Failure potential | 3 |

| Risk reduction options | To eliminate risk, remove tree. |

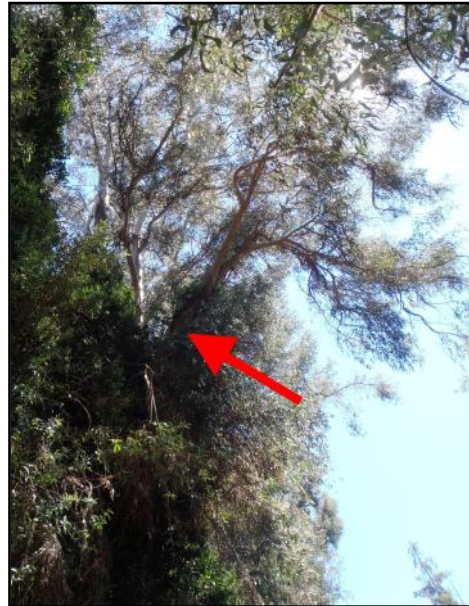
| Comments | Multiple attachments at 3'; S. stem bowed S. w/ heavy lateral limb; N. stems suppressed & bowed N.; engulfed in ivy. |

Above: Looking east at the canopy of blue gum #263.

| Most likely failure | Branch |
| Failure potential | 2 |

| Risk reduction options | To reduce risk, prune to shorten branches S. & N.; to eliminate risk, remove tree. |

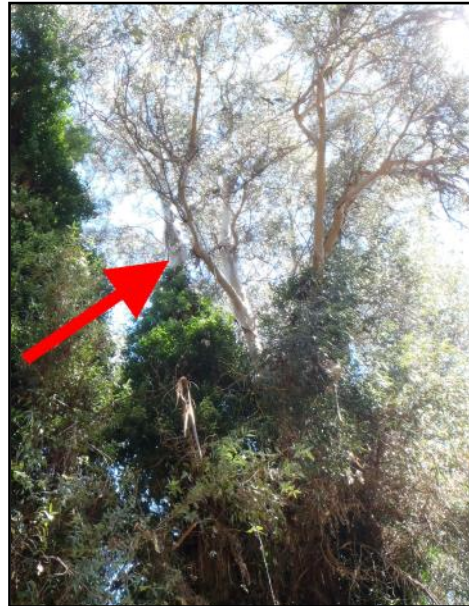
| Comments | Upright form; laterals E. & W.; engulfed in ivy. |

Above: Blue gum #264 was a large tree with an upright form.

| Most likely failure | Branch |
| Failure potential | 2 |

| Risk reduction options | To eliminate risk, remove tree. |

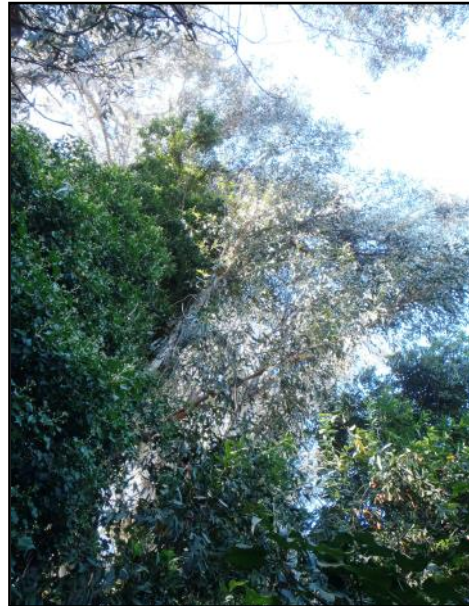
| Comments | Slight lean NW.; laterals N. & W.; engulfed in ivy. |

Above: Looking up into the canopy of blue gum #265.

| Most likely failure | Branch |
| Failure potential | 2 |

| Risk reduction options | To reduce risk, reduce branch weight & extension N. & W.; to eliminate risk, remove tree. |

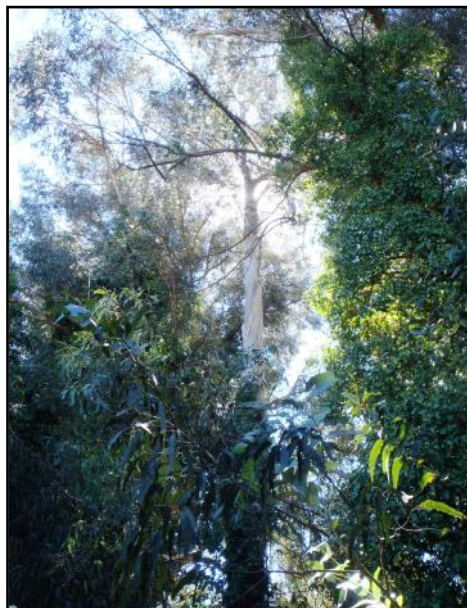
| Comments | Upright form; laterals S.; engulfed in ivy |

Above: Blue gum #266 had an upright form.

| Most likely failure | Branch |
| Failure potential | 2 |

| Risk reduction options | To reduce risk, reduce branch weight & extension S.; to eliminate risk, remove tree. |

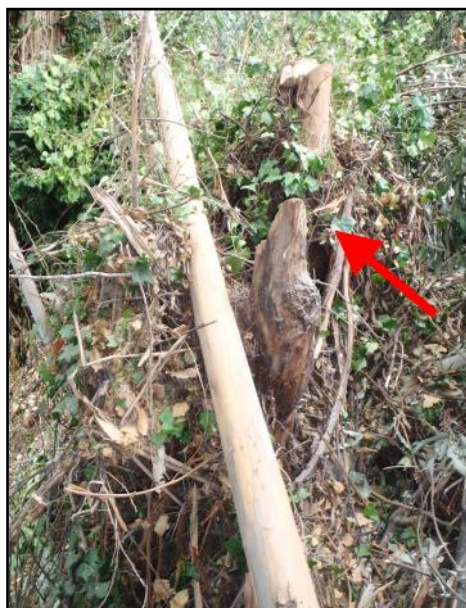
| Comments | Stump sprout; suppressed; leans N.; epicormics; ivy. |

Above: Looking east at blue gum #267. The tree was suppressed and leaned N.

| Most likely failure | Stem |
| Failure potential | 2 |

| Risk reduction options | To eliminate risk, remove tree. |

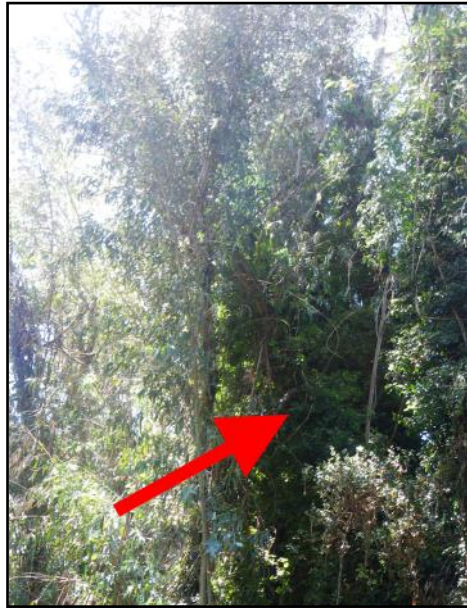
| Comments | Codominant trunks at 3'; leans S.; poor form & structure; engulfed in ivy. |

Above: Looking W. at tree #268.

| Most likely failure | Whole tree |
| Failure potential | 2 |

| Risk reduction options | To eliminate risk, remove tree. |

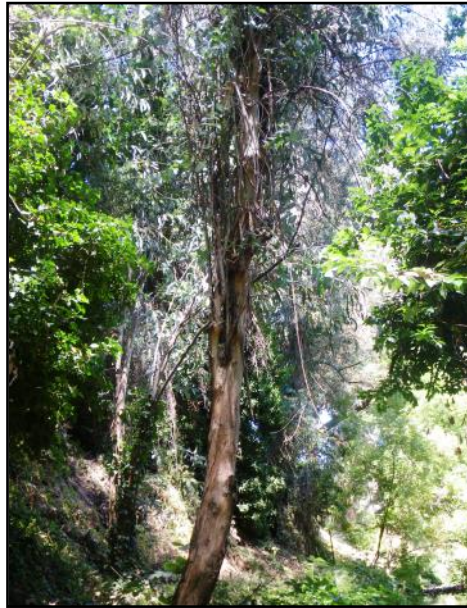
| Comments | Suppressed; dead wood; leans S.; epi-cormics. |

Above: This small-diameter blue gum was growing at the edge of the creek channel.

| Most likely failure | Whole tree |
| Failure potential | 2 |

| Risk reduction options | To eliminate risk, remove tree. |

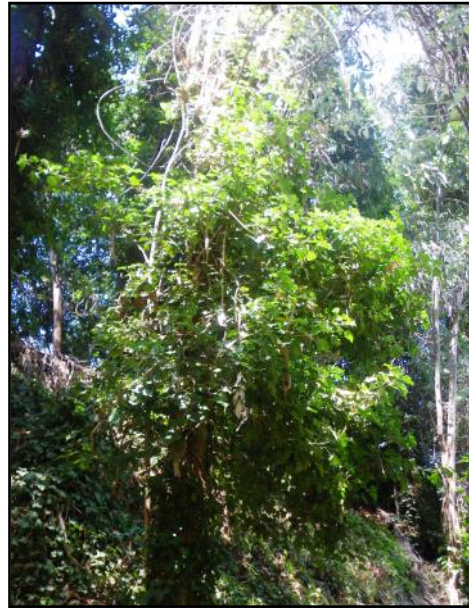
| Comments | Suppressed; lost top; epicormics; ivy. |

Above: Tree #270 is mostly obscured by the ivy growing on its trunk.

| Most likely failure | Branch |
| Failure potential | 3 |

| Risk reduction options | To eliminate risk, remove tree. |

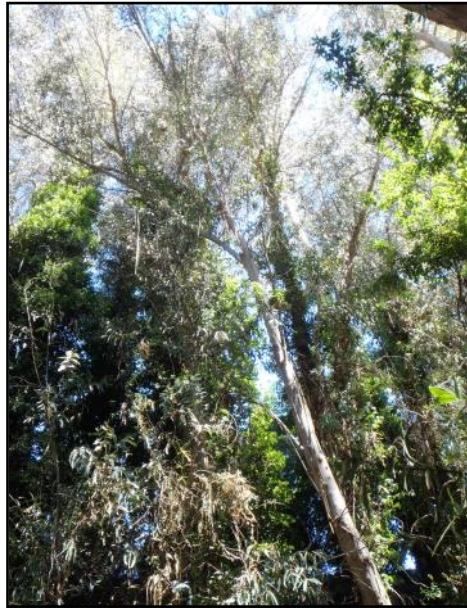
| Comments | Suppressed; upper crown bowed SW.; bank eroded S. |

Above: Blue gum #271 is shown in the foreground.

| Most likely failure | Whole tree |
| Failure potential | 2 |

| Risk reduction options | To eliminate risk, remove tree. |

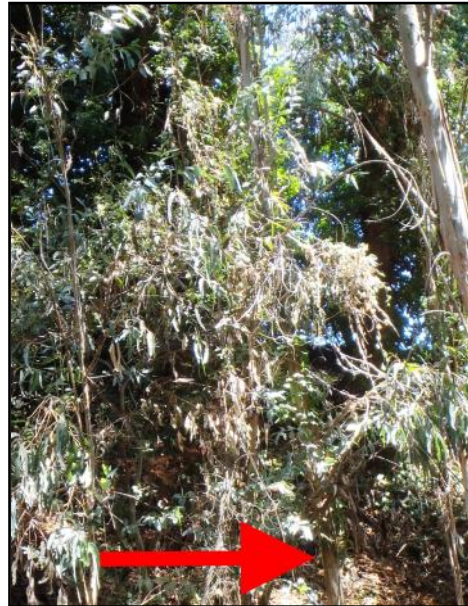
| Comments | Suppressed but up-right; epicormics. |

Above: Arrow points to blue gum #272.

| Most likely failure | Branch |
| Failure potential | 1 |

| Risk reduction options | To eliminate risk, remove tree. |

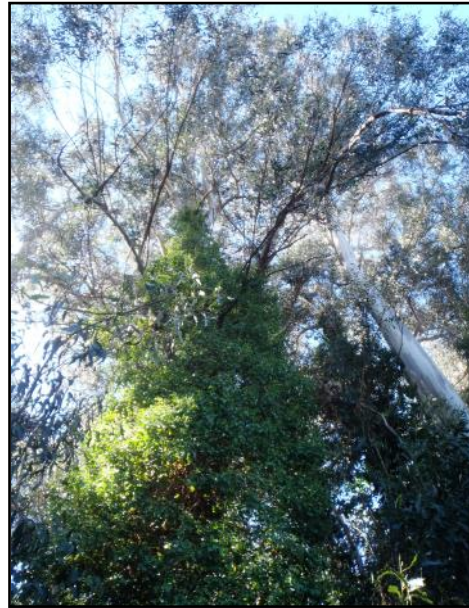
| Comments | Multiple attachments at base; 24" stem leans S.; weight & laterals S.; engulfed in ivy |

Above: Looking up into the canopy of blue gum #273. Ivy engulfed the trunk.

| Most likely failure | Branch |
| Failure potential | 2 |

| Risk reduction options | To reduce risk, prune to reduce branch weight & extension S.; to eliminate risk, remove tree. |

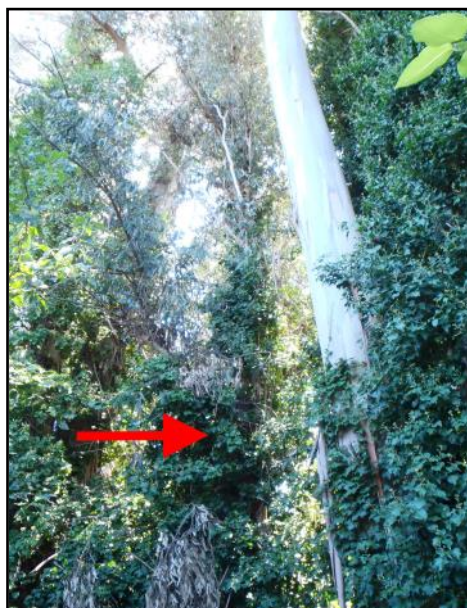
| Comments | Large Yellow Jacket nest just downhill; multiple attachments at 5'; some bank erosion S.; engulfed in ivy |

Above: Arrow points to blue gum #274, which was difficult to get a good photo of.

| Most likely failure | Branch |
| Failure potential | 2 |

| Risk reduction options | To reduce risk, prune to reduce branch weight & extension N.; to eliminate risk, remove tree. |

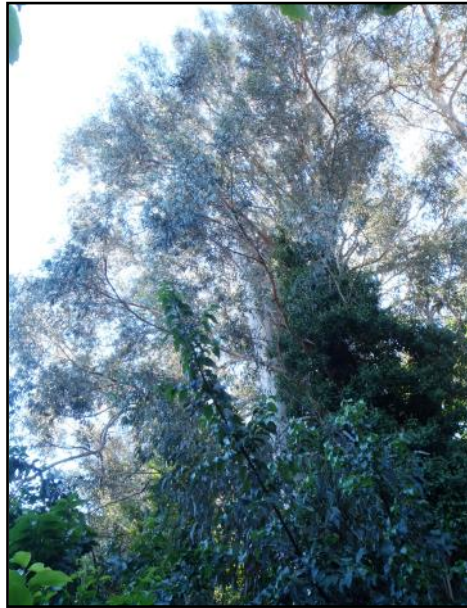
| Comments | Upright form; some bank erosion S.; engulfed in ivy |

Above: Blue gum #275 was a large-diameter, codominant tree.

| Most likely failure | Branch |
| Failure potential | 2 |

| Risk reduction options | To reduce risk, prune to reduce branch weight & extension N.; to eliminate risk, remove tree. |

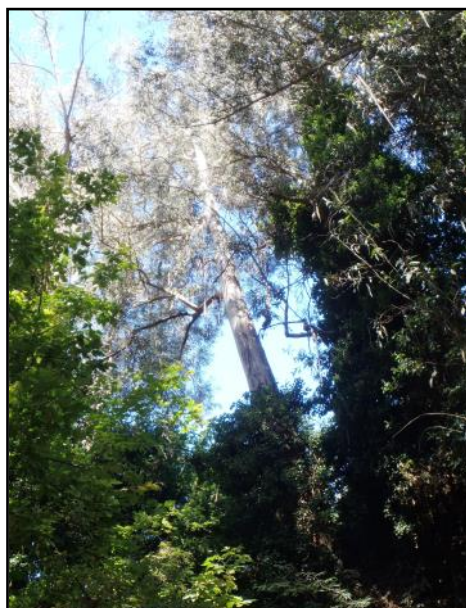
| Comments | Slight lean & one sided W.; bank eroded S.; ivy. |

Above: Looking N. at blue gum #276.

| Most likely failure | Branch |
| Failure potential | 2 |

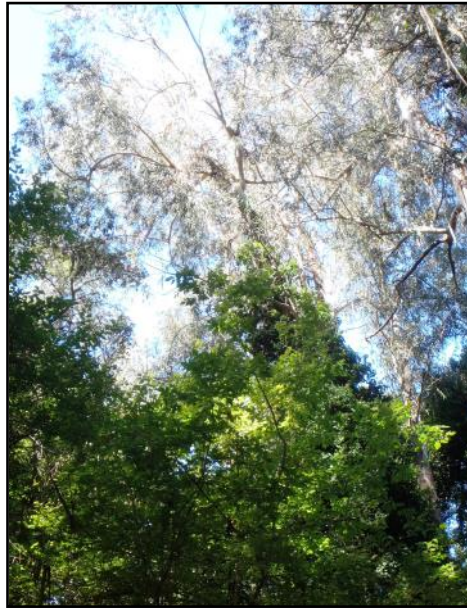
| Comments | Codominant trunks at base; 22" stem upright; 15" stem leans heavily SW.; engulfed in ivy. |

Above: Looking SE. at blue gum #277. Upper crown is washed-out in photo.

| Most likely failure | Stem |
| Failure potential | 3 |

| Risk reduction options | To reduce risk, remove 15" stem SW.; to eliminate risk, remove tree. |

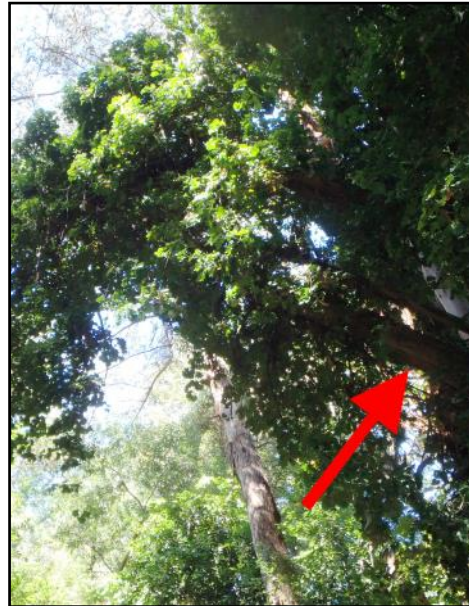
| Comments | Heavy lean SW.; trunk wound at 35'; engulfed in ivy. |

Above: Arrow points to blue gum #278, which leaned SW.

| Most likely failure | Whole tree |
| Failure potential | 3 |

| Risk reduction options | To eliminate risk, remove tree. |

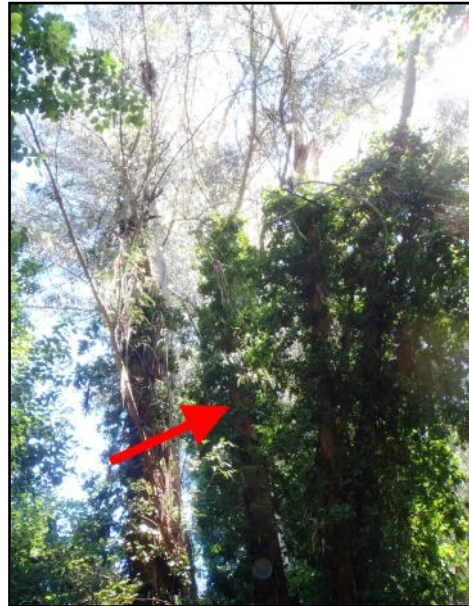
Above: Arrow points to blue gum #279.

| Comments | One sided S.; laterals & dead wood S.; engulfed in ivy. |

| Most likely failure | Branch |
| Failure potential | 2 |

| Risk reduction options | To reduce risk, prune to clean crown & reduce branch extension S.; to eliminate risk, remove tree. |

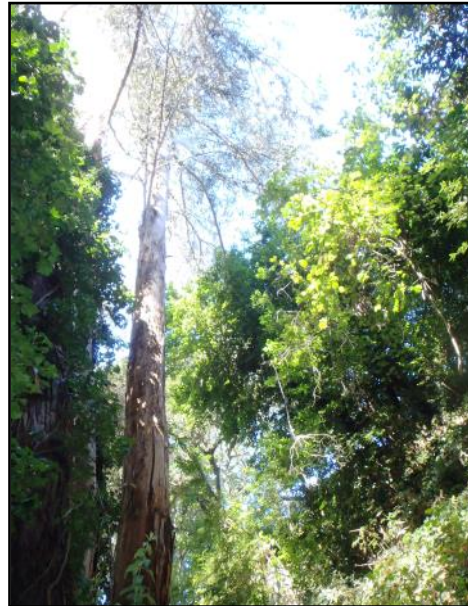
| Comments | Slight lean N.; upper crown bowed N.; long lateral NW. |

Above: Looking west at the lower trunk and crown of blue gum #280.

| Most likely failure | Branch |
| Failure potential | 3 |

| Risk reduction options | To reduce risk, prune to reduce branch weight & extension NW.; to eliminate risk, remove tree. |

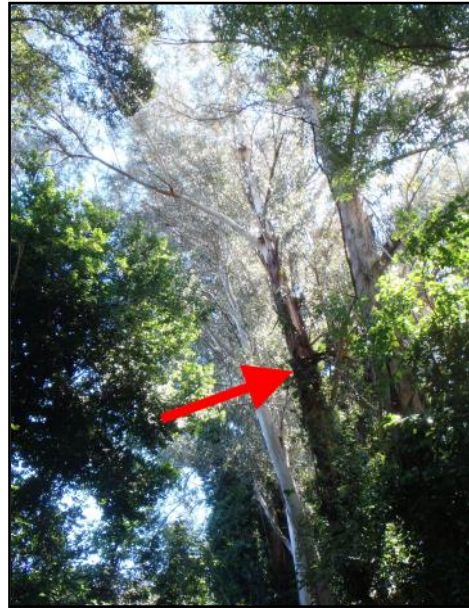
Above: Arrow points to blue gum #281.

| Comments | Codominant trunks at base; upper crown bowed W.; lateral NW.; ivy. |

| Most likely failure | Branch |
| Failure potential | 2 |

| Risk reduction options | To reduce risk, prune to reduce branch weight & extension NW.; to eliminate risk, remove tree. |

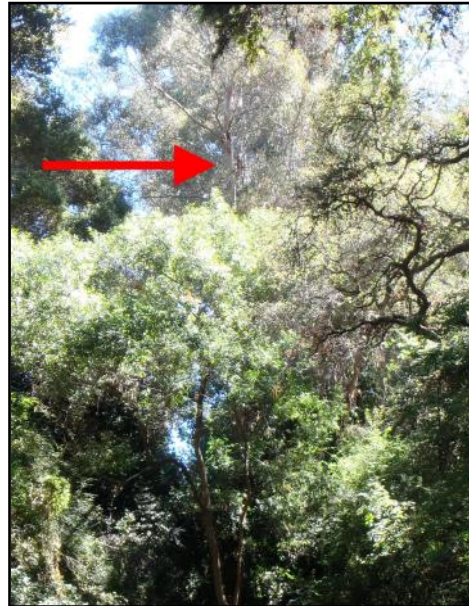
| Comments | Slight lean & one sided W.; laterals W. |

Above: Arrow points to blue gum #282, located at the west end long row of blue gums.

| Most likely failure | Branch |
| Failure potential | 2 |

| Risk reduction options | To reduce risk, prune to reduce branch weight & extension W.; to eliminate risk, remove tree. |
