# San Leandro Creek Tree Assessment

February 24, 2015

County of Alameda  
Flood Control and Water Conservation District  
399 Elmhurst Street  
Hayward, CA 94544-1395

URS Corporation  
1333 Broadway, Suite 800  
Oakland, CA 94612

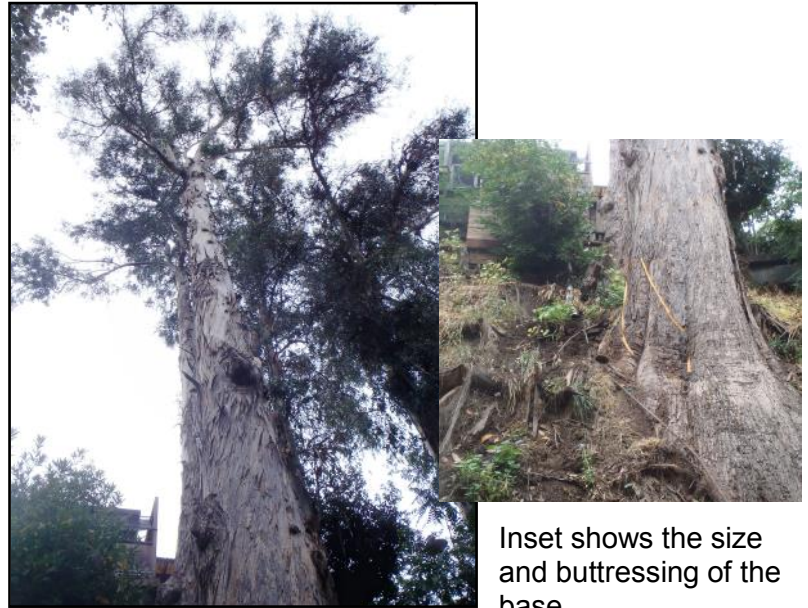
| Comments | Upright form.; well buttressed; laterals in upper crown. |

Inset shows the size and buttressing of the base.

Above: Tree #284 was one of the largest blue gums assessed.

| Most likely failure | Branch |
| Failure potential | 2 |

| Risk reduction options | To reduce risk, prune to reduce branch weight & extension NW.; to eliminate risk, remove tree. |

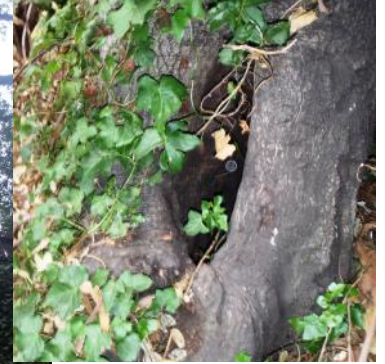
| Comments | Extensive trunk decay; one 14" stem remains; sup-pressed & leaning E. |

Inset shows a cavity and decay at the base.

Above: Looking north at coast live oak #289.

| Most likely failure | Whole tree |
| Failure potential | 3 |

| Risk reduction options | To eliminate risk, remove tree. |

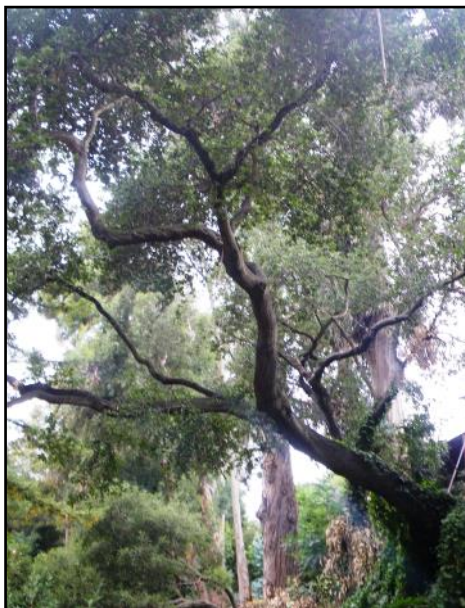
| Comments | Suppressed; leans S. to horizontal; growing over failing retaining wall; engulfed in ivy |

Above: Coast live oak #290 leaned sharply to the south.

| Most likely failure | Whole tree |
| Failure potential | 3 |

| Risk reduction options | To reduce risk, prune to reduce crown weight & extension S.; to eliminate risk, remove tree. |

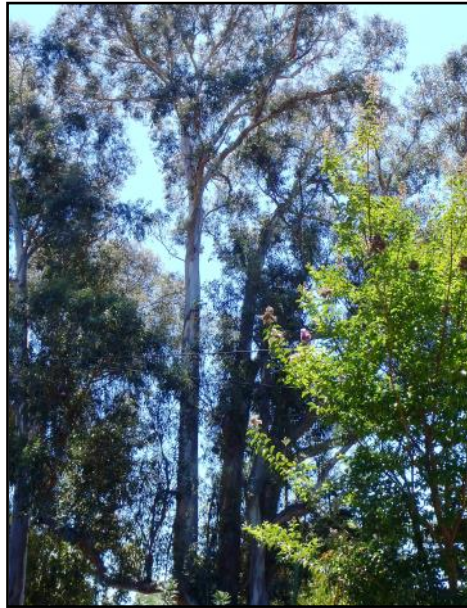
| Comments | Multiple attachments at 7'; one stem up-right; others suppressed and bowed w/ weight S. & W.; laterals reduced. |

Above: Blue gum #291 was a large-diameter, dominant tree.

| Most likely failure | Branch |
| Failure potential | 2 |

| Risk reduction options | To eliminate risk, remove tree. |

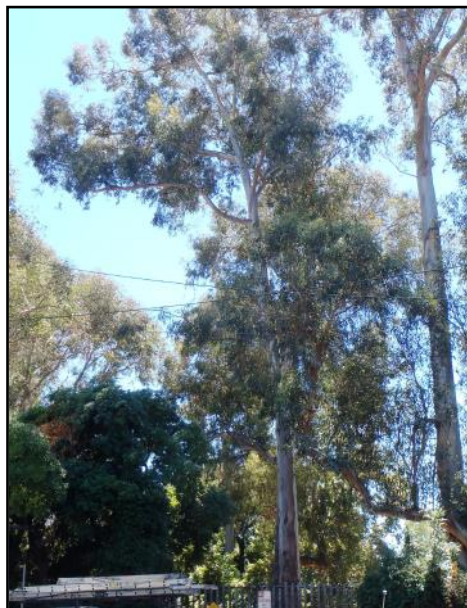
| Comments | Codominant trunks at 2'; one stem up-right; one stem leans S.; twig die-back & bleeding along trunk; laterals reduced. |

Above: Looking S. at blue gum #292 from St. Mary's Ave.

| Most likely failure | Branch |
| Failure potential | 2 |

| Risk reduction options | To eliminate risk, remove tree. |

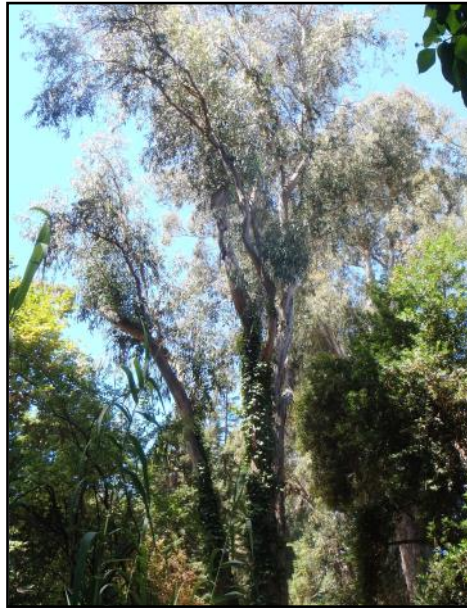
Above: Looking W. at blue gum #293.

| Comments | No tag; multiple attachments at 3'; fair structure; twig die-back; trunk wounds; laterals reduced. |

| Most likely failure | Branch |
| Failure potential | 2 |

| Risk reduction options | To eliminate risk, remove tree. |

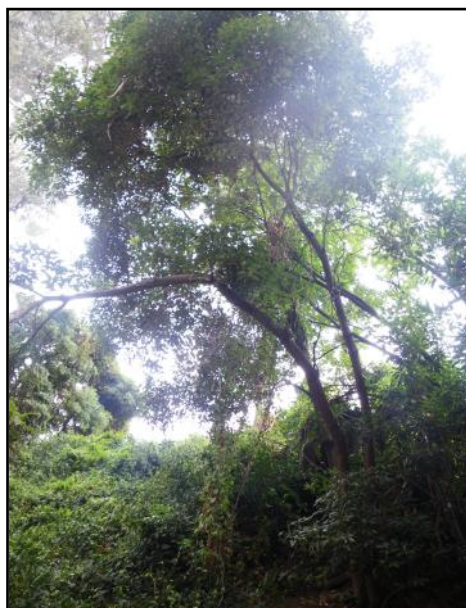
Above: Victorian box #294.

| Comments | Multiple attachments at base; two stems upright; one stem leans S.; trunk wounds. |

| Most likely failure | Stem |
| Failure potential | 2 |

| Risk reduction options | To reduce risk, remove S. stem; to eliminate risk, remove tree. |

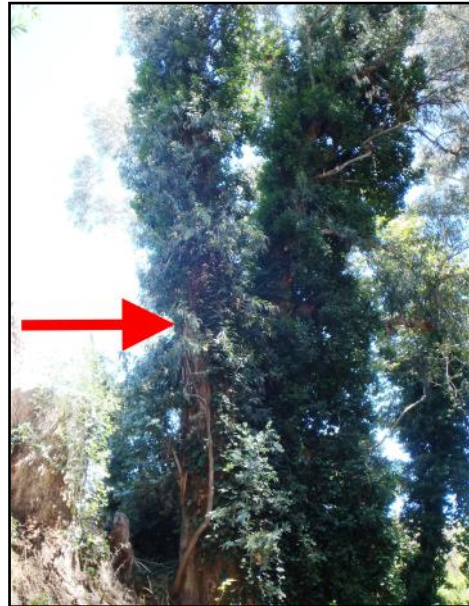
| Comments | Topped at 40'; 6" regrowth; engulfed in ivy. |

Above: Arrow points to blue gum #297, which had been topped..

| Most likely failure | Branch |
| Failure potential | 3 |

| Risk reduction options | To eliminate risk, remove tree. |

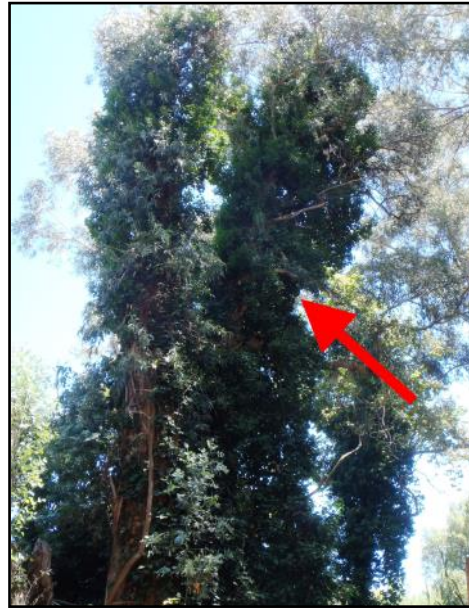
| Comments | Leans S.; 15" lateral extends NE.; 8" lateral S.; engulfed in ivy. |

Above: Arrow points to blue gum #298, which had been topped.

| Most likely failure | Branch |
| Failure potential | 2 |

| Risk reduction options | To reduce risk, prune to shorten or remove regrowth from topping points; to eliminate risk, remove tree. |

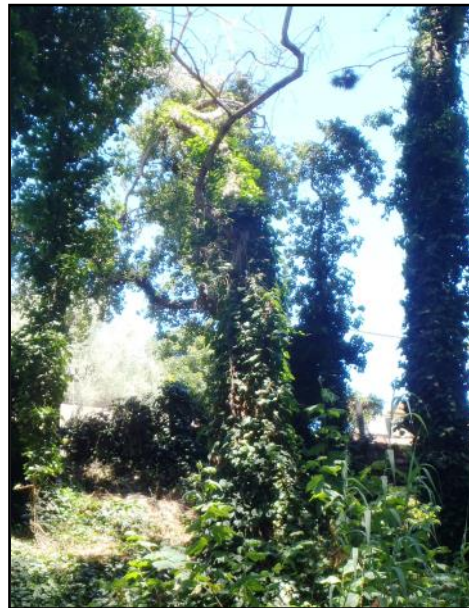
| Comments | Dead top; only basal sprouts remain; leans N.; engulfed in ivy. |

Above: Looking N. at Calif. sycamore #299. Lean is obscured.

| Most likely failure | Whole tree |
| Failure potential | 4 |

| Risk reduction options | To reduce risk, coppice; to eliminate risk, remove tree. |

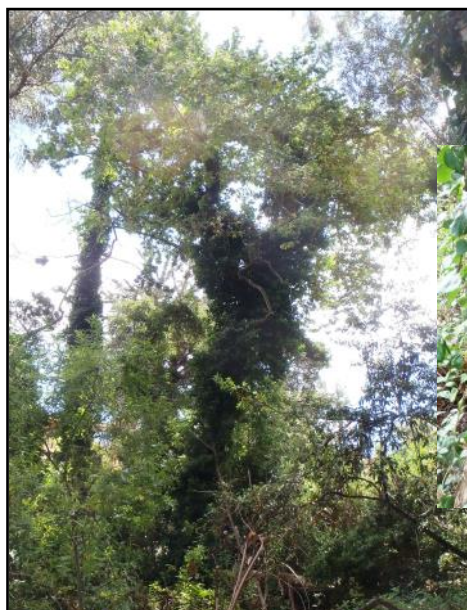
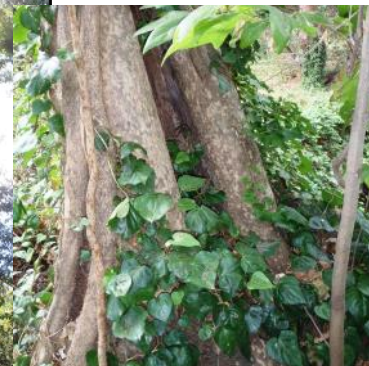
| Comments | Corrected lean S.; trunk wounds and cavities N.; engulfed in ivy. |

Inset shows the large trunk wound on the N. side.

Above: Looking E. at Calif. sycamore #300.

| Most likely failure | Whole tree |
| Failure potential | 2 |

| Risk reduction options | To reduce risk, coppice; to eliminate risk, remove tree. |

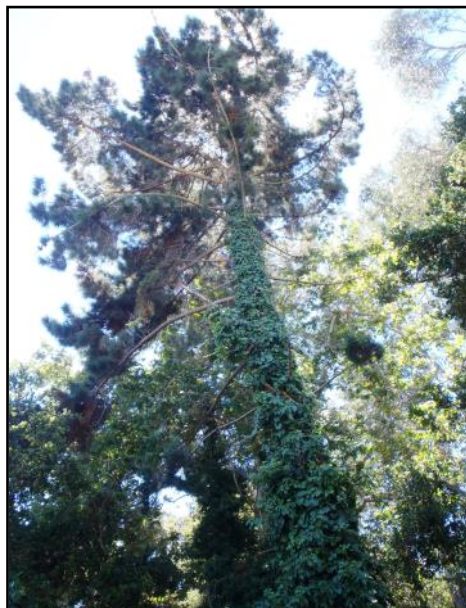
| Comments | High crown; slight lean E.; engulfed in ivy. |

Above: Monterey pine #301, looking S.

| Most likely failure | Branch |
| Failure potential | 2 |

| Risk reduction options | To eliminate risk, remove tree. |

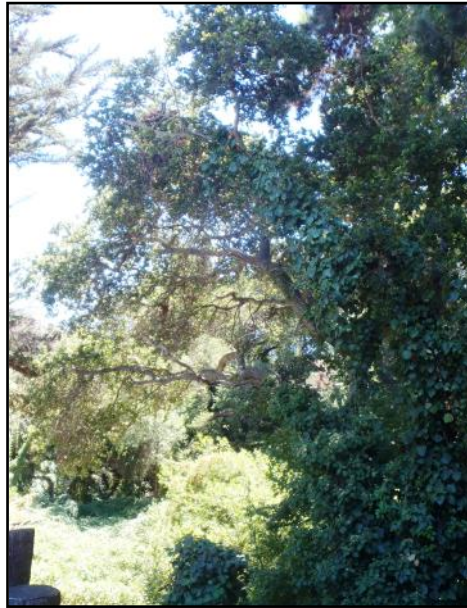
| Comments | Suppressed; crown bowed E. to horizontal; engulfed in ivy. |

Above: The crown of coast live oak #303 was bowed to the E.

| Most likely failure | Branch |
| Failure potential | 2 |

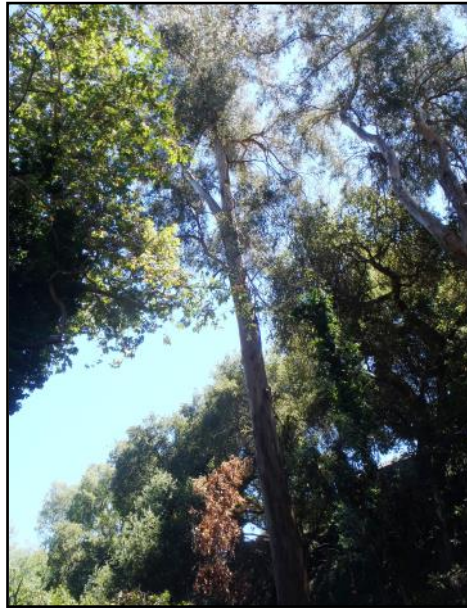
| Comments | Upright form; lateral NE. |

Above: Looking up at the crown of blue gum #306.

| Most likely failure | Branch |
| Failure potential | 2 |

| Risk reduction options | To reduce risk, prune to reduce branch weight & extension NE.; to eliminate risk, remove tree. |

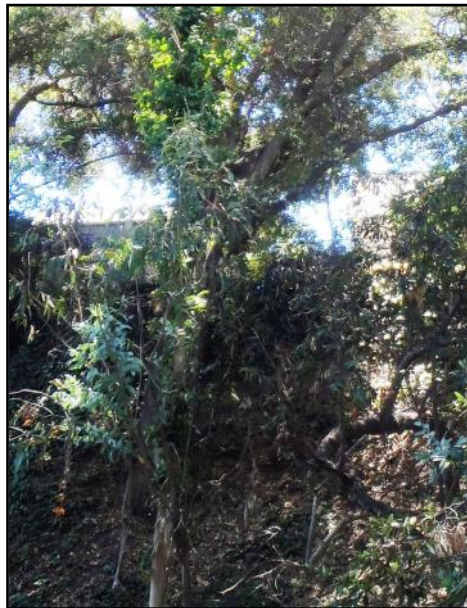
| Comments | Corrected lean from base; small crown; ivy. |

Above: Blue gum #314 was suppressed beneath its dominant neighbors.

| Risk reduction options | To eliminate risk, remove tree. |

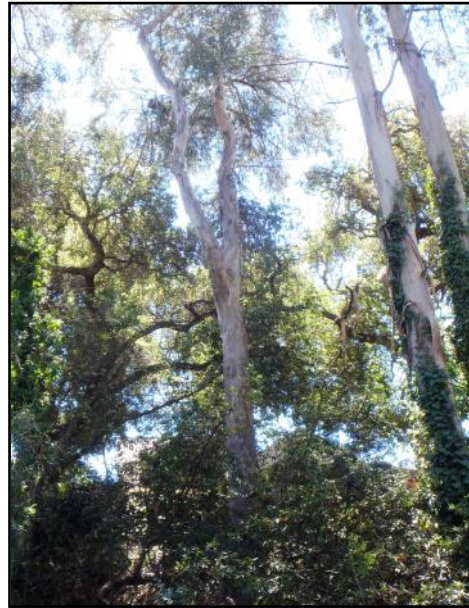
| <b>Comments</b> | Codominant trunks at 30'; one sided S.; upper crown bowed S. |

Above: Looking S. at blue gum #315.

| <b>Risk reduction options</b> | To reduce risk,<br>prune to reduce<br>branch weight & ex-<br>tension S.; to elimi-<br>nate risk, remove<br>tree. |

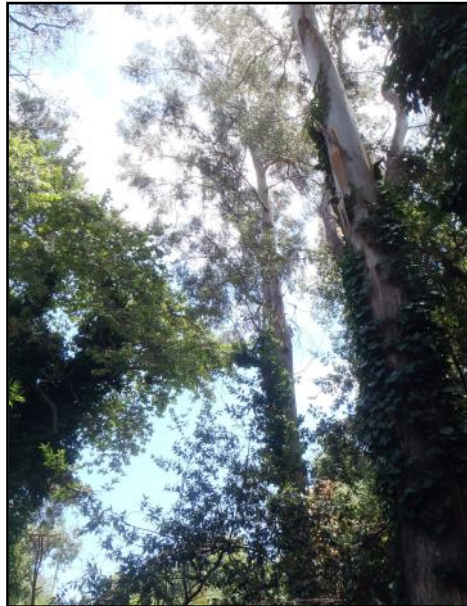
| Comments | High crown; lateral E.; dead wood; ivy. |

Above: Blue gum #316 was part of a small cluster of blue gums on the S. bank of San Leandro creek.

| Risk reduction options | To eliminate risk, remove tree. |

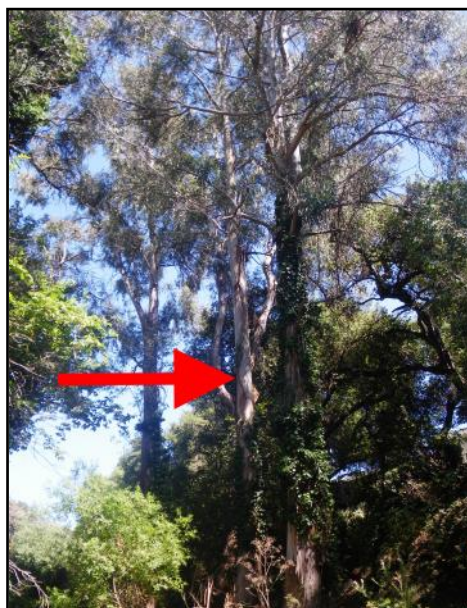
| Comments | High crown; slight lean S.; dead wood; ivy. |

Above: Looking E., arrow points to blue gum #317.

| Risk reduction options | To eliminate risk, remove tree. |

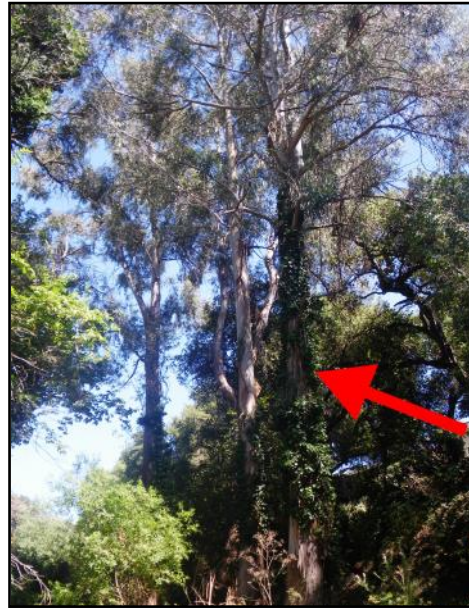
| Comments | One sided W.; dead wood; ivy. |

Above: Looking E., arrow points to blue gum #318.

| Risk reduction options | To eliminate risk, remove tree. |

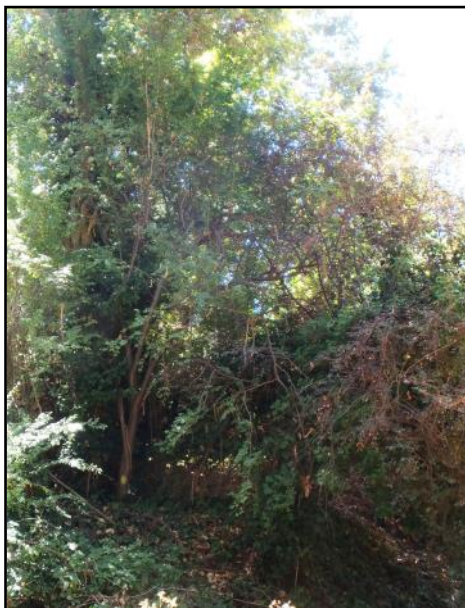
| Comments | Codominant trunks at 3'; stems twisted around one another; weight N.; ivy. |

Above: Plum #328 was growing along the S. edge of the creek.

| Risk reduction options | To eliminate risk, remove tree. |

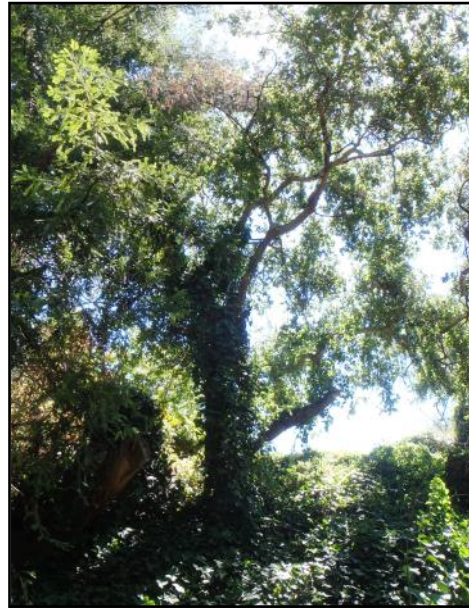
| Comments | Codominant trunks at 2'; one stem up-right; smaller stem lateral SW.; engulfed in ivy. |

Above: Coast live oak #344 was growing on ACFCD property adjacent to the Haas Ave. footbridge.

| Risk reduction options | To reduce risk, prune to reduce or remove stem SW.; to eliminate risk, remove tree. |

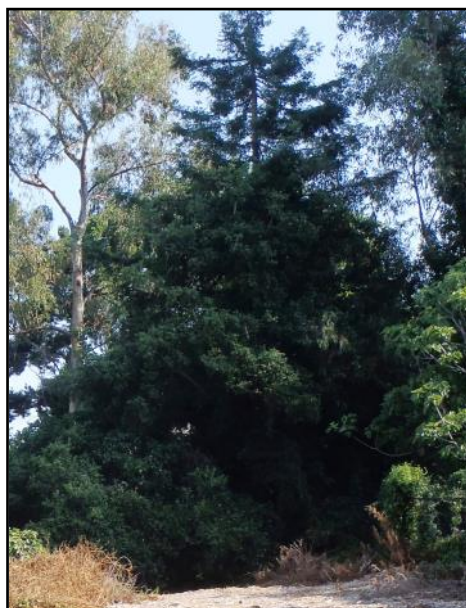
| Comments | Good form and structure; thin canopy; ivy on lower trunk. |

Above: Coast redwood #345 was in good condition, with good form and structure.

| Risk reduction options | To eliminate risk, remove tree. |

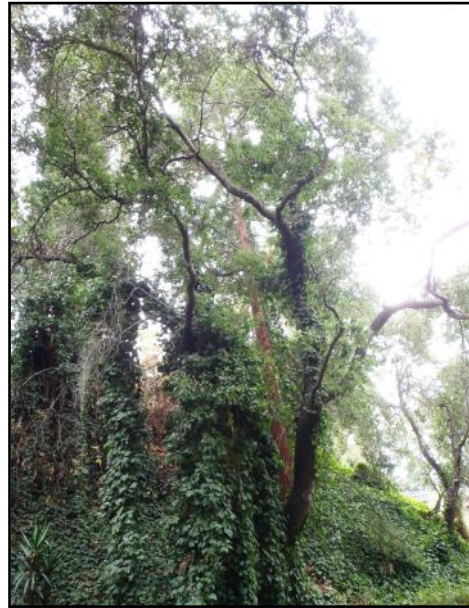
| Comments | Codominant trunks at 5'; slight lean N.; one stem upright; smaller stem suppressed E.; lateral W. with wounds; engulfed in ivy. |

Above: Looking S. at tree #346.

| Risk reduction options | To reduce risk, prune to reduce branch weight & extension W.; to eliminate risk, remove tree. |

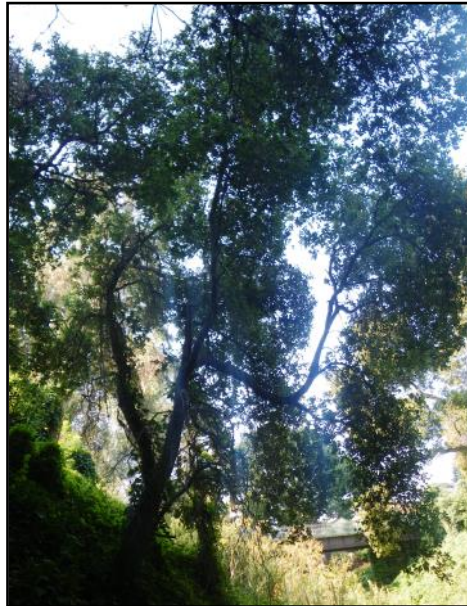
| Comments | Codominant trunks at 5'; one sided SW.; lateral; branch wound; ivy. |

Above: Coast live oak #347 was growing down-slope from the Haas Ave. footbridge.

| Risk reduction options | To reduce risk, prune to reduce branch weight & extension NW.; to eliminate risk, remove tree. |

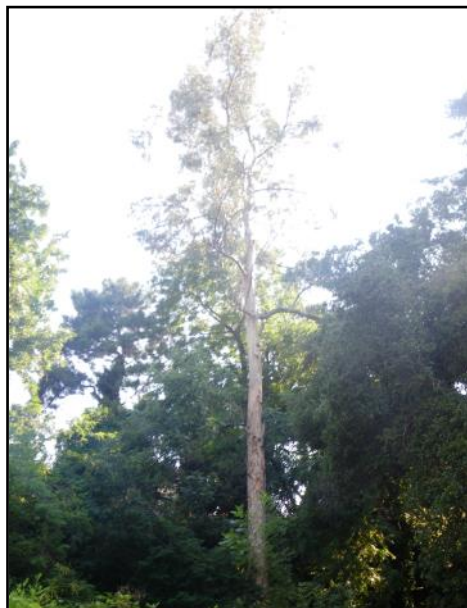
| Comments | Upright form; lateral E. over creek; die-back. |

Above: Blue gum #348 was in good condition and upright.

| Risk reduction options | To eliminate risk, remove tree. |

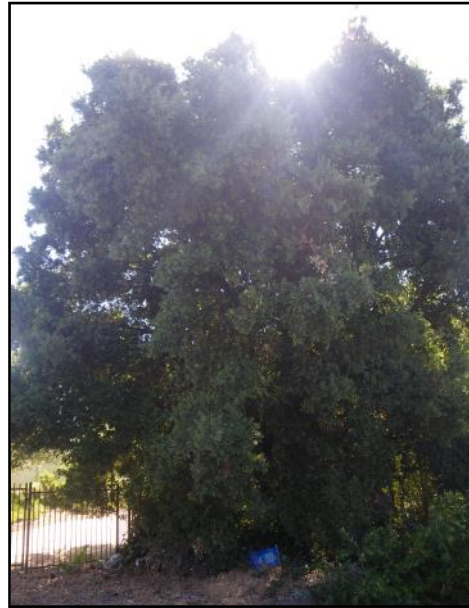
| Comments | Multiple attachments at 5'; leans heavily NW.; full crown; ivy. |

Above: Coast live oak #401 leaned W.

| Risk reduction options | To eliminate risk, remove tree. |

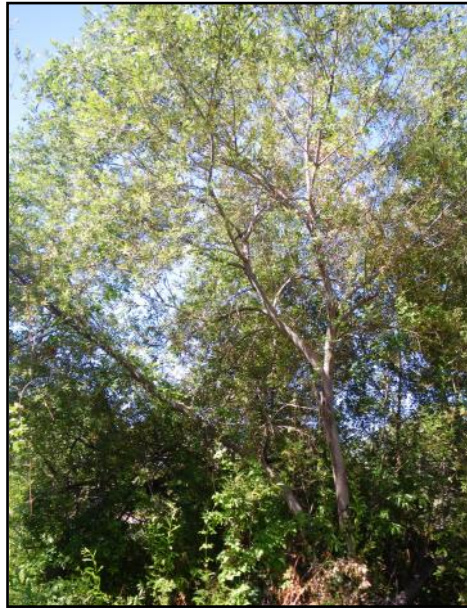
| Comments | Multiple attachments at base; history of stem failures. |

Above: Arroyo willow #402 had several stems emerging from the base.

| Risk reduction options | To reduce risk, prune to reduce or remove stems; to eliminate risk, remove tree. |

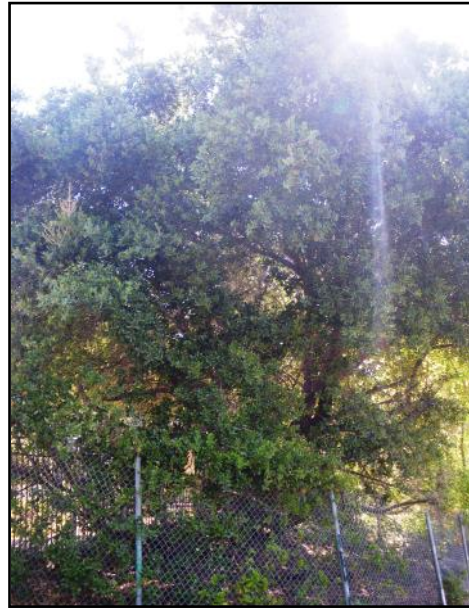
| Comments | Multiple attachments at 2'; low laterals; good form. |

Above: Coast live oak #403 was low branching.

| Risk reduction options | To eliminate risk, remove tree. |

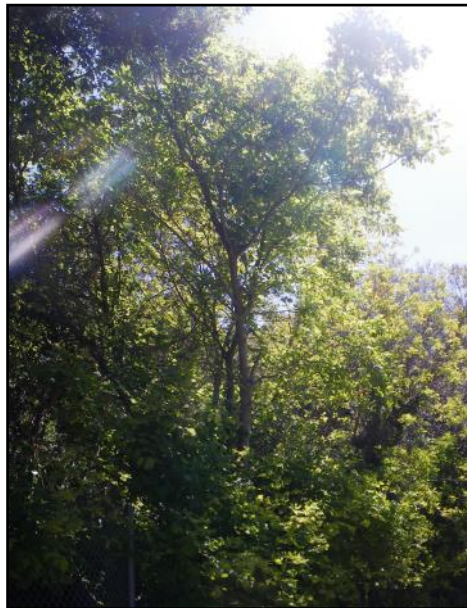
| Comments | Multiple attachments at 4'; twig dieback. |

Above: Looking N. at the multi-stemmed boxelder.

| Risk reduction options | To eliminate risk, remove tree. |

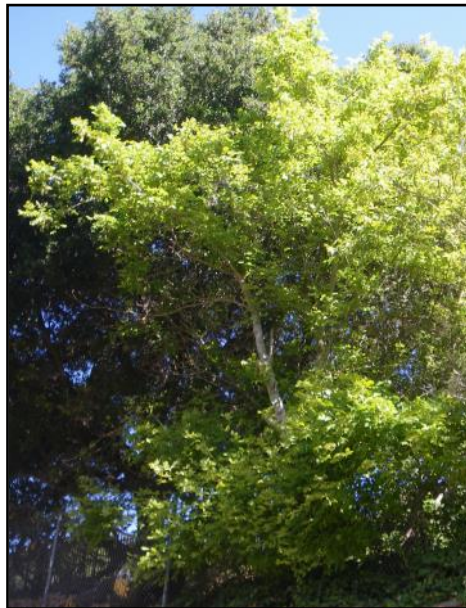
| Comments | Multiple attachments at 3'; dieback; engulfed in ivy. |

Above: Boxelders #404 and 405 were clustered together.

| Risk reduction options | To eliminate risk, remove tree. |

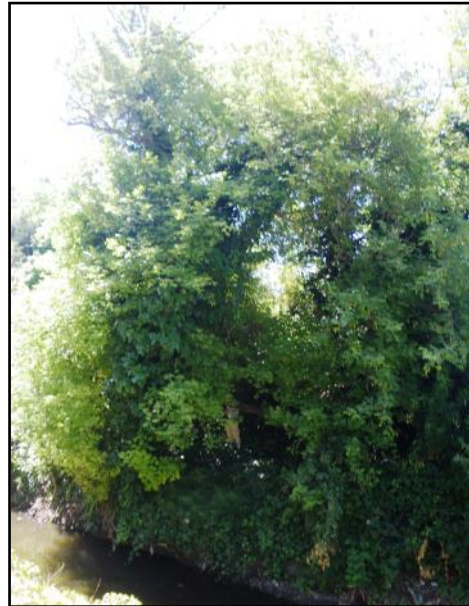
| Comments | Multiple attachments at 2'; lateral SW. has rooted; dieback in upper crown; engulfed in ivy. |

Above: Looking S. at this mature specimen.

| Risk reduction options | To reduce risk, prune to reduce branch weight & extension W.; to eliminate risk, remove tree. |

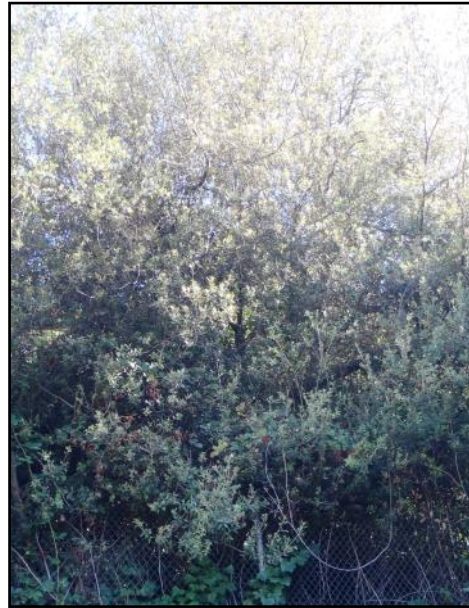
| Comments | Multiple attachments at 2'; spreading form; thin crown; engulfed in ivy. |

Above: Holly oak #407 was a thicket of stems.

| Risk reduction options | To eliminate risk, remove tree. |

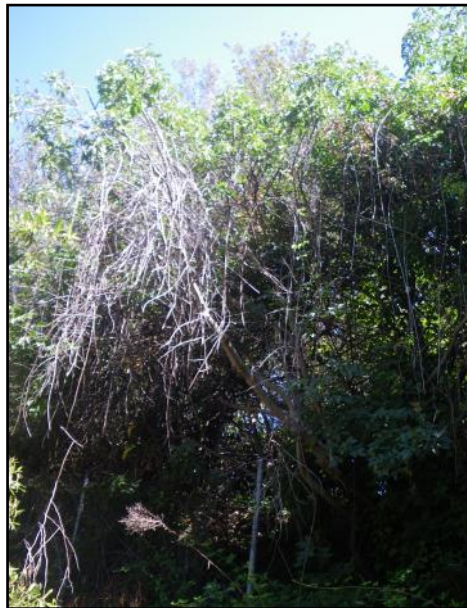
| Comments | Multiple attachments at base; one sided E; vines. |

Above: Buckeye #408 was covered in vines.

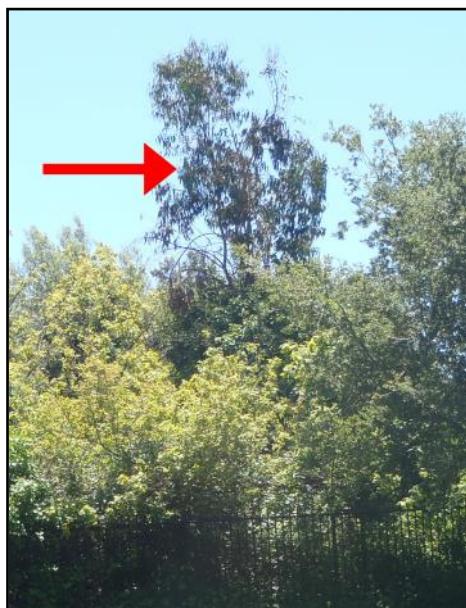
| Comments | Lost top; engulfed in ivy. |

Above: Looking S. at blue gum #409 emerging from the dense vegetation.

| Most likely failure | Branch |
| Failure potential | 2 |

| Risk reduction options | To eliminate risk, remove tree. |

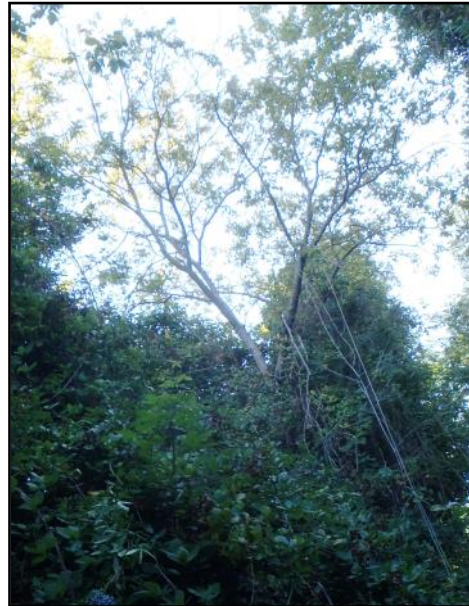
| Comments | Multiple attachments at 2'; low growing N.; dieback; engulfed in vines. |

Above: Just the top of boxelder #410 can be seen.

| Most likely failure | Stem |
| Failure potential | 2 |

| Risk reduction options | To eliminate risk, remove tree. |

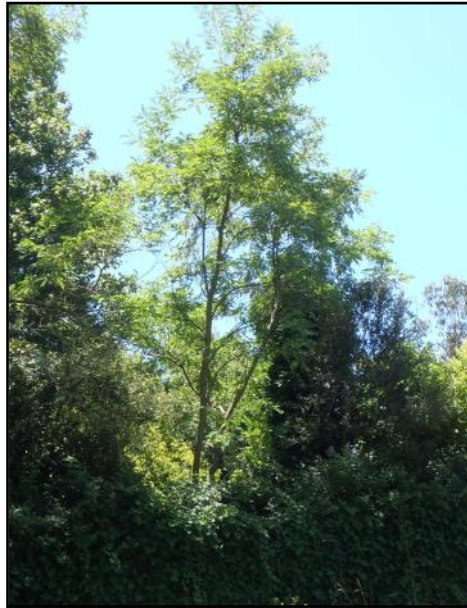
| Comments | No tag; codominant trunks at 4'; good young tree. |

Above: Black locust #411 was inaccessible.

| Risk reduction options | To eliminate risk, remove tree. |

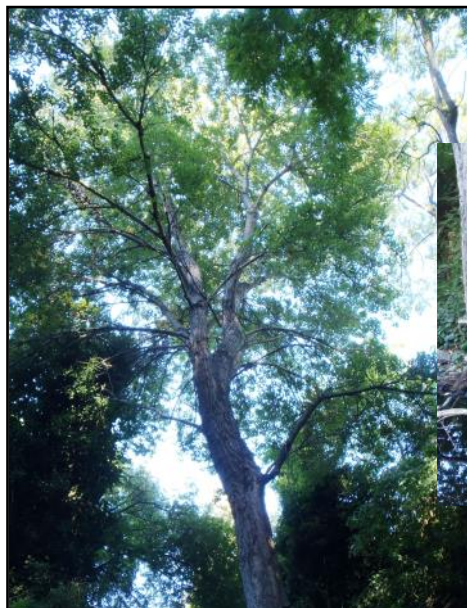
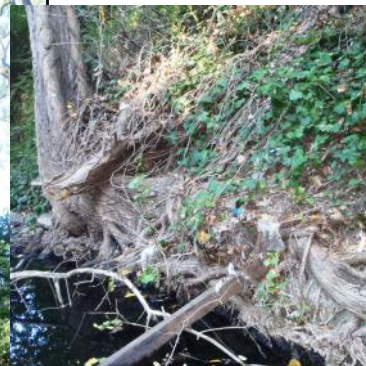
| Comments | Multiple attachments at 25'; upright form; roots exposed along creek bank. |

Inset shows roots exposed by erosion.

Above: Looking up at the canopy of Fremont cottonwood #412.

| Most likely failure | Whole tree |
| Failure potential | 2 |

| Risk reduction options | To reduce risk, coppice; to eliminate risk, remove tree. |

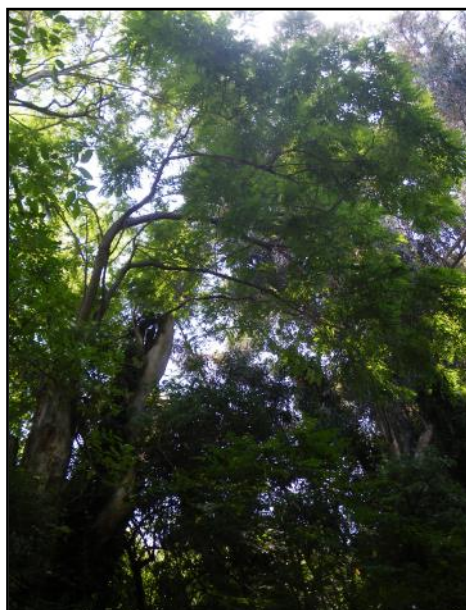
| Comments | Multiple attachments at base; N. stem bowed over off-site park. |

Above: Looking NE. at tree #413.

| Most likely failure | Stem |
| Failure potential | 2 |

| Risk reduction options | To reduce risk, prune to reduce or remove stem N.; to eliminate risk, remove tree. |

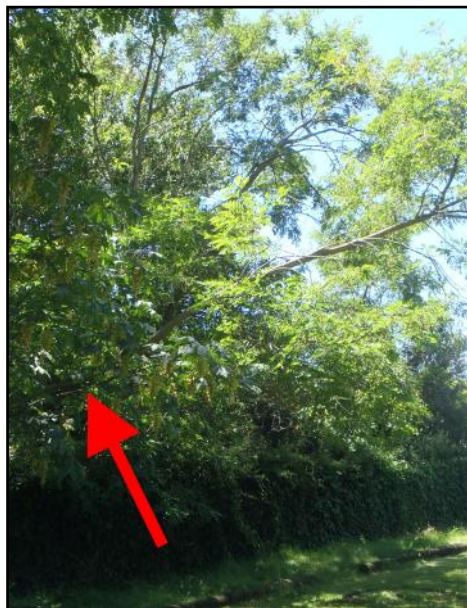
| Comments | Multiple attachments at base; N. stem bowed over off-site park; trunk wound on N. stem. |

Above: N. stem of black locust #414 can be seen reaching over the fence and park.

| Most likely failure | Stem |
| Failure potential | 3 |

| Risk reduction options | To reduce risk, prune to reduce or remove stem N.; to eliminate risk, remove tree. |

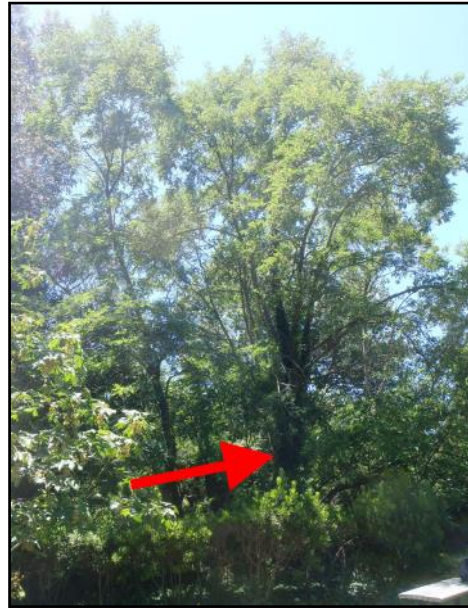
| Comments | Leans N.; trunk in contact with fence; branches over off-site park. |

Above: Looking SW. at black locust #415.

| Most likely failure | Branch |
| Failure potential | 2 |

| Risk reduction options | To eliminate risk, remove tree. |

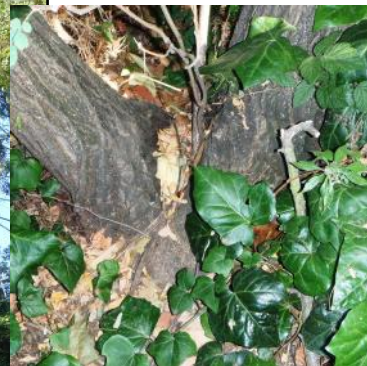
| Comments | Codominant trunks at base; S. stem failing at base but hung up in neighbor. |

Inset shows the base of the tree (S. stem is on Left).

Above: Black locust #416 had two trunks emerging at the base.

| Most likely failure | Stem |
| Failure potential | 4 |

| Risk reduction options | To reduce risk, prune to reduce or remove stem S.; to eliminate risk, remove tree. |

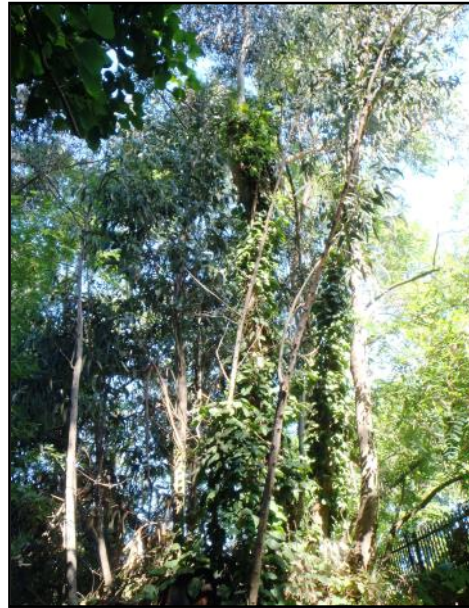
| Comments | Stump sprout; multiple attachments at 4'. |

Above: Blue gum #417 was a stump sprout with several sprouts.

| Most likely failure | Stem |
| Failure potential | 2 |

| Risk reduction options | To reduce risk, prune to reduce or remove stems; to eliminate risk, remove tree. |

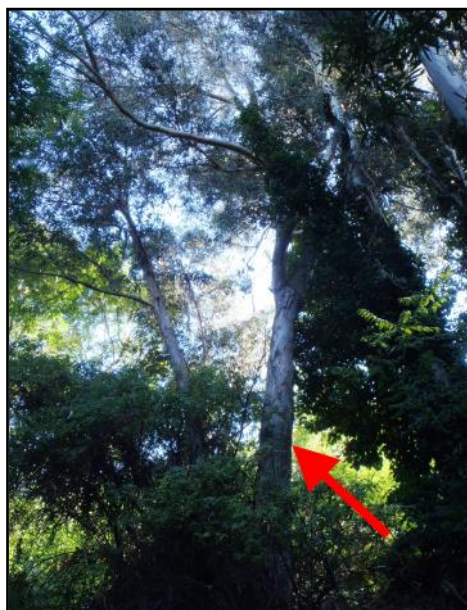
| Comments | Codominant trunks at 3'; 36" stem leans SE. & caught up in neighbor. |

Above: Looking N. at blue gum #418 (arrow).

| Most likely failure | Branch |
| Failure potential | 2 |

| Risk reduction options | To reduce risk, prune to reduce or remove stem S.; to eliminate risk, remove tree. |

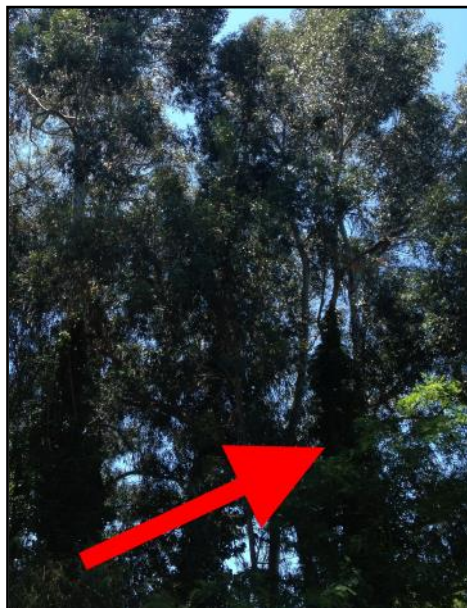
| Comments | Multiple attachments at 7'; 18" stem leans S. over creek; one stem topped at 15'. |

Above: Arrow points to blue gum #419.

| Most likely failure | Stem |
| Failure potential | 2 |

| Risk reduction options | To reduce risk, prune to reduce or remove stem S.; to eliminate risk, remove tree. |

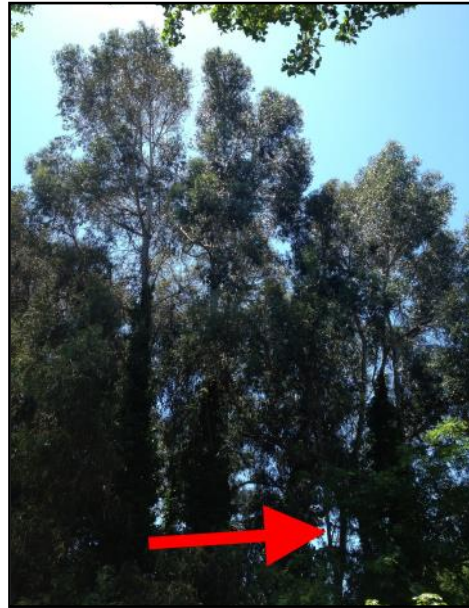
| Comments | Codominant trunks at base; one sided N. over park. |

Above: Arrow points to blue gum #420.

| Most likely failure | Stem |
| Failure potential | 1 |

| Risk reduction options | To eliminate risk, remove tree. |

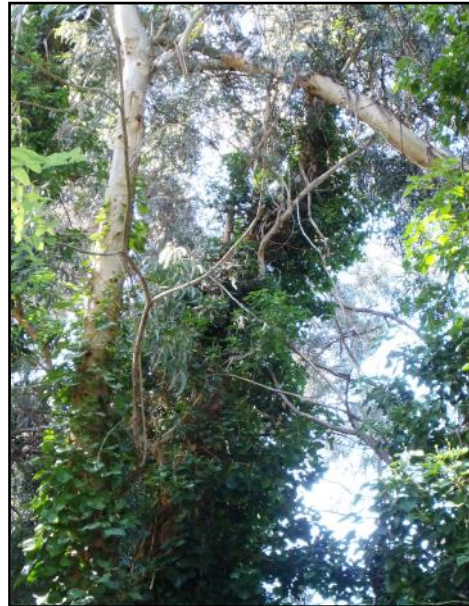
| Comments | Upright form; engulfed in ivy. |

Above: Looking up into the canopy of blue gum #421.

| Most likely failure | Branch |
| Failure potential | 2 |

| Risk reduction options | To eliminate risk, remove tree. |

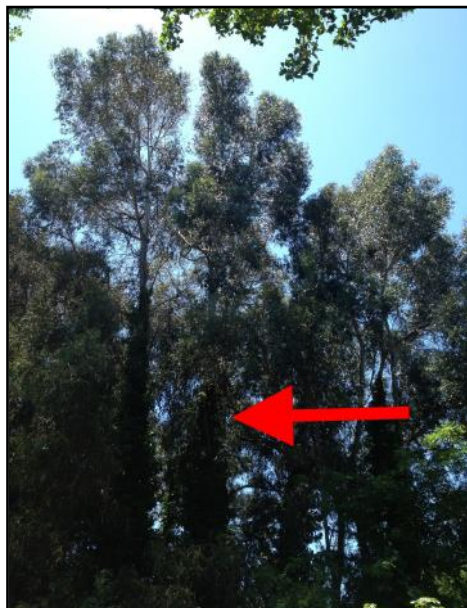
| Comments | Upright form; engulfed in ivy. |

Above: Arrow points to blue gum #422.

| Most likely failure | Branch |
| Failure potential | 1 |

| Risk reduction options | To eliminate risk, remove tree. |

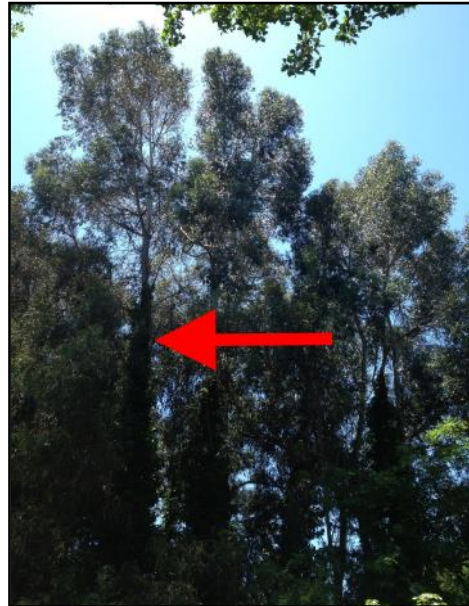
| Comments | Upright form; engulfed in ivy; 15' lateral @ 55' extends NW. over play-ground. |

Above: Arrow points to blue gum #423.

| Most likely failure | Branch |
| Failure potential | 2 |

| Risk reduction options | To reduce risk, prune to remove or reduce branch NW.; to eliminate risk, remove tree. |

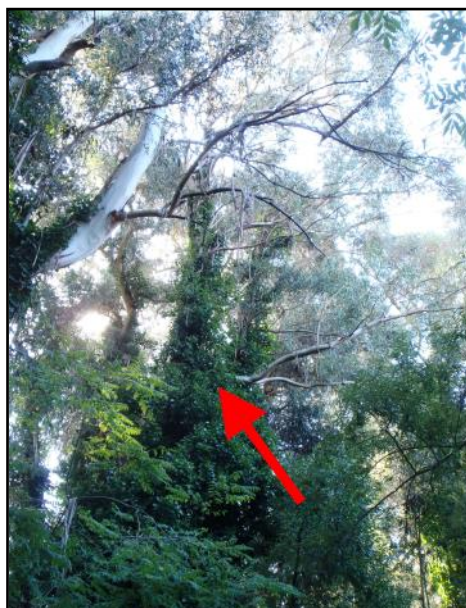
| Comments | One sided SW. over creek; engulfed ivy. |

Above: Blue gum #424 was one-sided S. over the creek.

| Most likely failure | Branch |
| Failure potential | 2 |

| Risk reduction options | To eliminate risk, remove tree. |

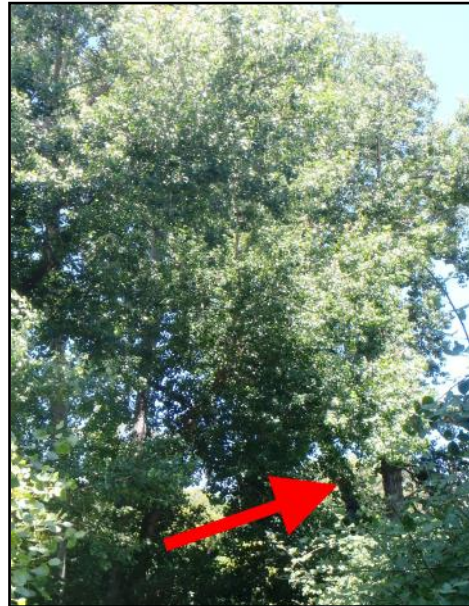
| Comments | Multiple attachments at base; one sided N.; 15" stem bowed N. & pruned @ PL. |

Above: Arrow points to Fremont cottonwood #425.

| Most likely failure | Stem |
| Failure potential | 3 |

| Risk reduction options | To reduce risk, prune to remove or reduce stem N.; to eliminate risk, remove tree. |

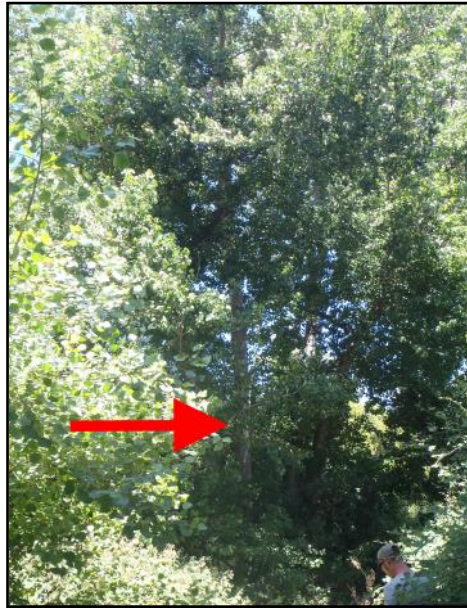
| Comments | Codominant trunks at 2'; one sided W.; one stem upright; 13" stem suppressed. |

Above: Looking east at Fremont cottonwoods #425 (R) and 426 (L).

| Most likely failure | Stem |
| Failure potential | 2 |

| Risk reduction options | To reduce risk, prune to remove or reduce stem W.; to eliminate risk, remove tree. |

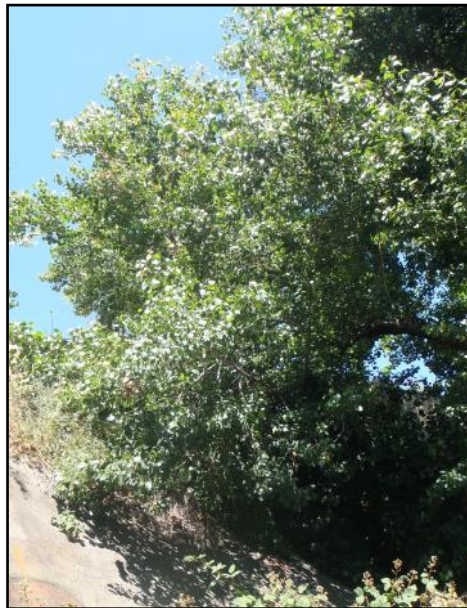
| Comments | Leans N.; topped;<br>one branch remains. |

Above: Fremont cottonwood #427 was uphill and leaning N.

| Most likely failure | Whole tree |
| Failure potential | 3 |

| Risk reduction options | To eliminate risk, remove tree. |

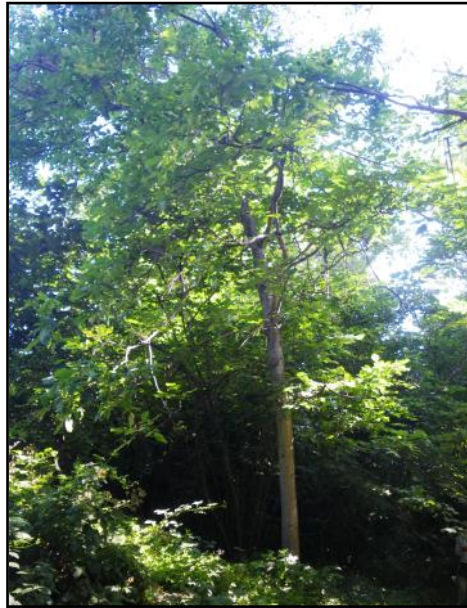
| Comments | Trunk sweeps S. & W.; trunk wounds N.; sapsucker damage. |

Above: English walnut #428 was young.

| Risk reduction options | To eliminate risk, remove tree. |

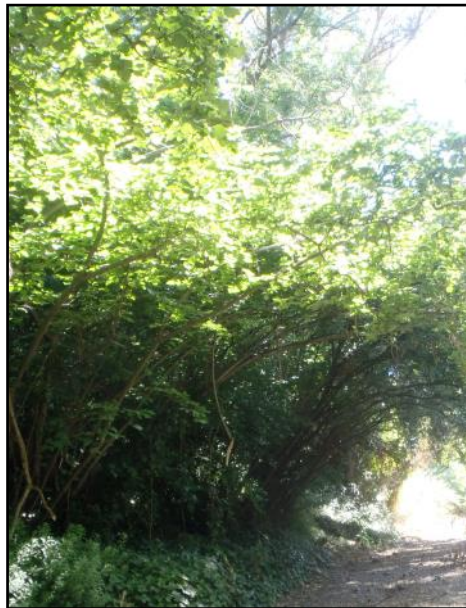
| Comments | Large stand of 75 stems 6" and less. |

Above: Tree #429 was grove of elm sapplings ≤6" in diameter.

| Risk reduction options | To eliminate risk, remove tree. |

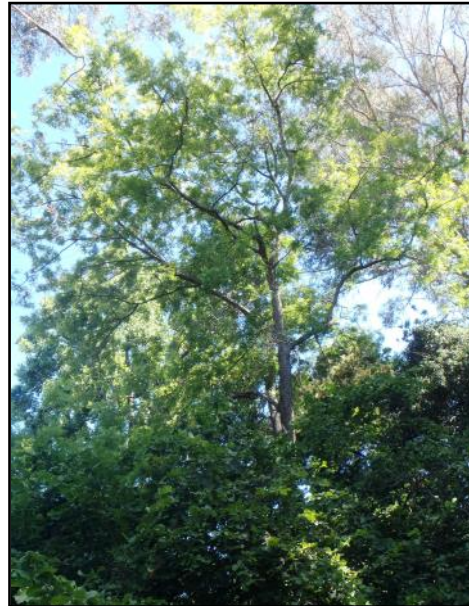
| Comments | Codominant trunks at 20'; one sided W. with long laterals; twig dieback. |

Above: Looking N. at tree #430.

| Risk reduction options | To reduce risk, prune to reduce branch weight & extension W; to eliminate risk, remove tree. |

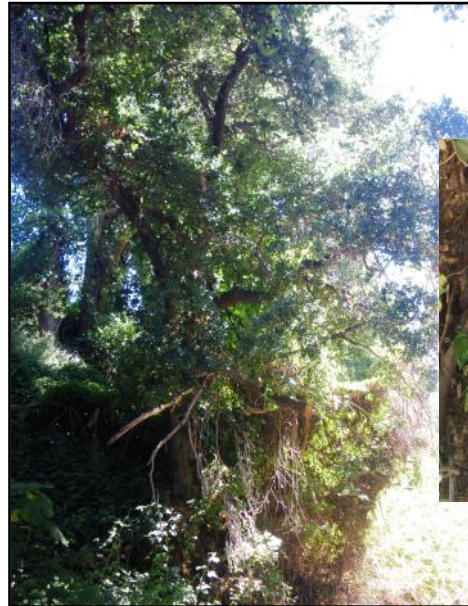
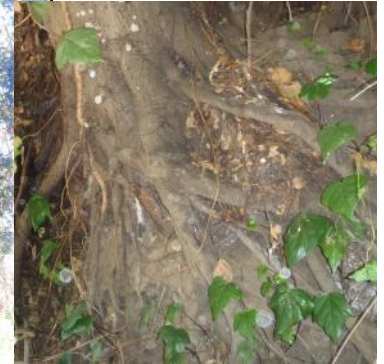
| Comments | Codominant trunks at 8'; one sided S.; roots exposed by erosion S.; debris build up N. |

Inset shows the roots exposed by erosion.

Above: Coast live oak #431 was growing on the lower bank.

| Risk reduction options | To reduce risk, prune to reduce crown weight & extension S.; to eliminate risk, remove tree. |

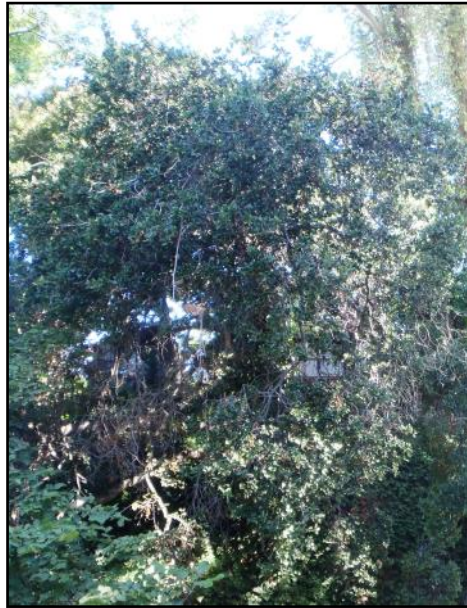
| Comments | Leans W. with low lateral W.; dead wood to 6"; engulfed in ivy; debris build up N. |

Above: Looking N. at tree #432.

| Risk reduction options | To reduce risk, prune to clean crown & reduce branch weight & extension W.; to eliminate risk, remove tree. |

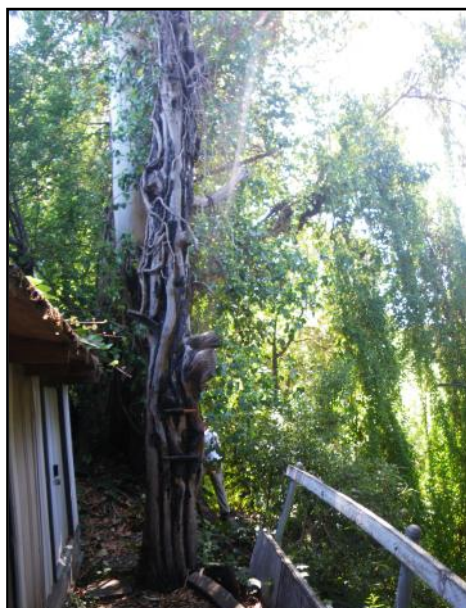
| Comments | Dead stump. |

Above: Blackwood acacia #433 was a dead stump.

| Risk reduction options | To eliminate risk, remove tree. |

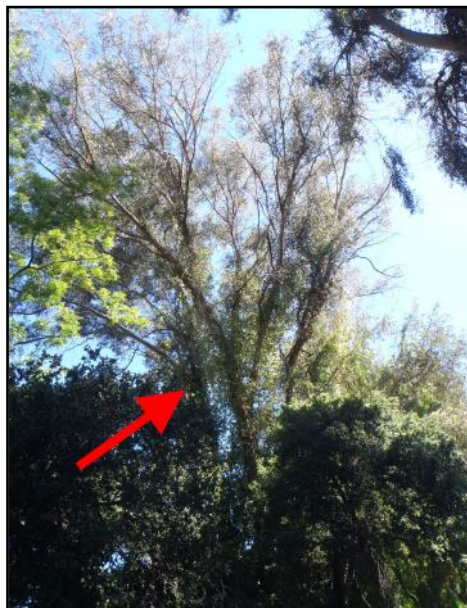
| Comments | One sided W.; long lateral W.; minor dead wood; engulfed in ivy. |

Above: Looking up at the canopy of blue gum #434 (arrow).

| Risk reduction options | To eliminate risk, remove tree. |

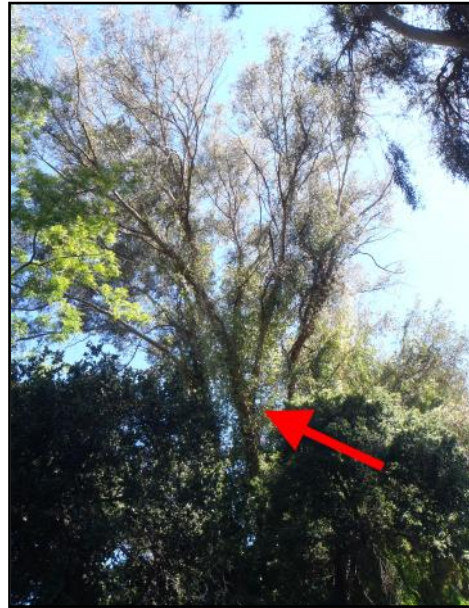
| Comments | Leaning & one sided S.; large laterals S.; trunk wound with minor decay N.; history of branch failure S.; thin crown; dead wood; engulfed in ivy. |

Above: Arrow points to blue gum #435.

| Risk reduction options | To reduce risk, prune to reduce branch weight & extension S.; to eliminate risk, remove tree. |

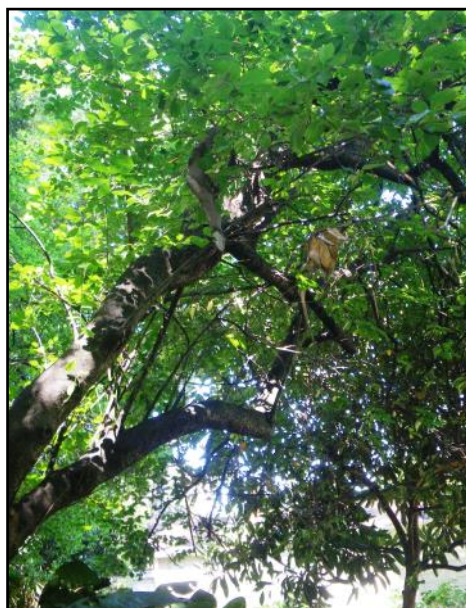
| Comments | Leans N.; debris at base. |

Above: Plum #436 was suppressed and leaned N.

| Risk reduction options | To eliminate risk, remove tree. |

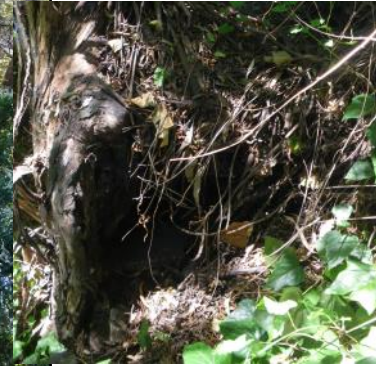
| Comments | Stump sprout; multiple attachments at 3'; base decayed & hollow N.; very thin crown; engulfed in vines. |

Inset shows the basal decay.

Above: Blue gum #437 was mostly dead.

| Risk reduction options | To eliminate risk, remove tree. |

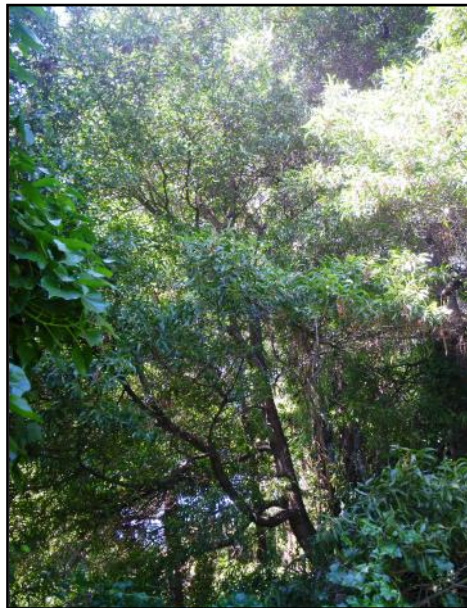
| Comments | Low lateral SE.; deadwood & 6" lateral N.; vines. |

Above: Looking west at tree #438.

| Risk reduction options | To reduce risk, prune to reduce branch weight & extension NW.; to eliminate risk, remove tree. |

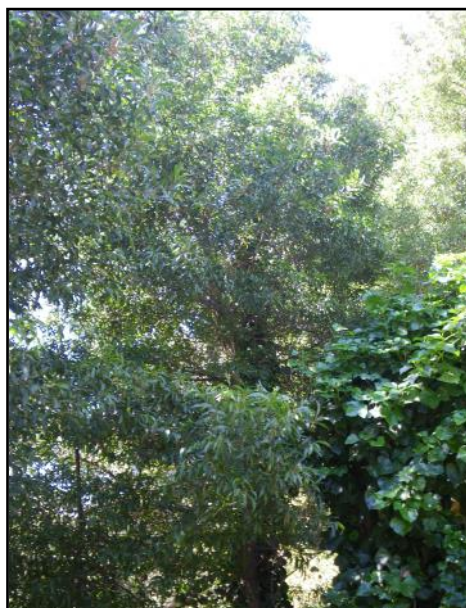
| Comments | Largest in group of several stems in area <6"; vines. |

Above: Tree #439 was the largest in a group of many blackwood acacia stems.

| Risk reduction options | To eliminate risk, remove tree. |
