# San Leandro Creek Tree Assessment

February 24, 2015

County of Alameda  
Flood Control and Water Conservation District  
399 Elmhurst Street  
Hayward, CA 94544-1395

URS Corporation  
1333 Broadway, Suite 800  
Oakland, CA 94612

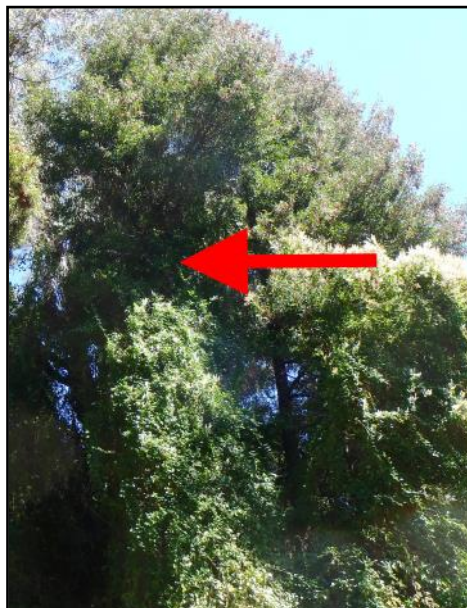
| Comments | One sided S.; erosion at base S. |

Above: Arrow points to blackwood acacia #440.

| Risk reduction options | To eliminate risk, remove tree. |

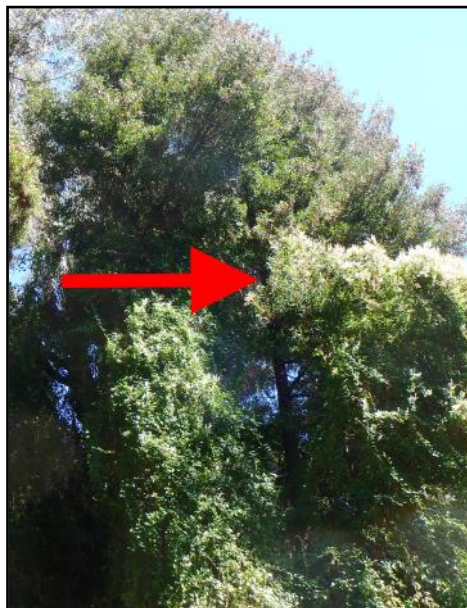
| Comments | One sided S.; erosion at base S.; trunk wound E. |

Above: Arrow points to blackwood acacia #441.

| Risk reduction options | To eliminate risk, remove tree. |

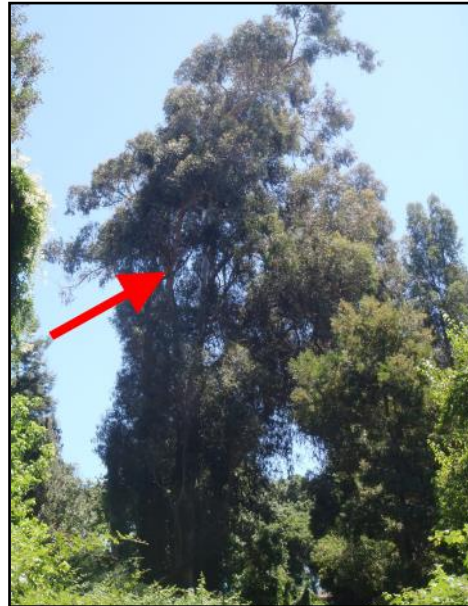
| Comments | Suppressed; upper crown bowed SW.; low laterals S.; engulfed in ivy. |

Above: Arrow points to blue gum #442.

| Risk reduction options | To reduce risk, prune to reduce branch weight & extension S.; to eliminate risk, remove tree. |

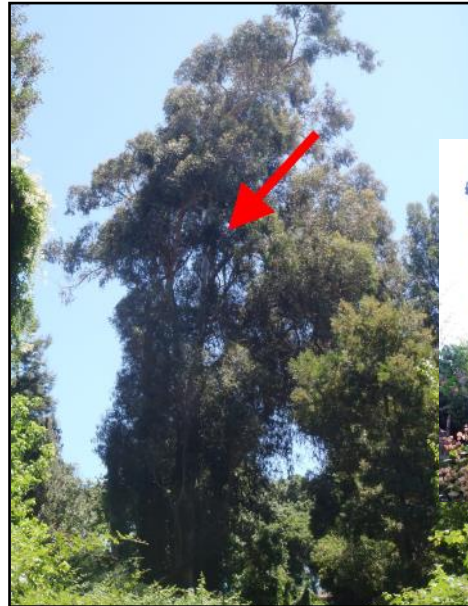
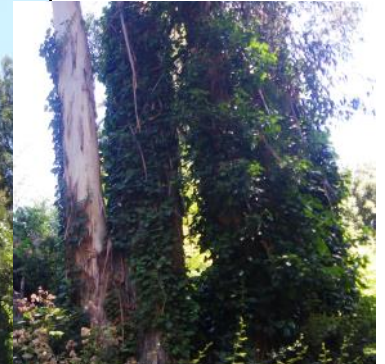
| Comments | Codominant trunks at 7'; one sided S.; laterals S. in upper crown; engulfed in ivy. |

Inset shows trunk engulfed in ivy.

Above: Arrow points to blue gum #443.

| Risk reduction options | To reduce risk, prune to reduce branch weight & extension S.; to eliminate risk, remove tree. |

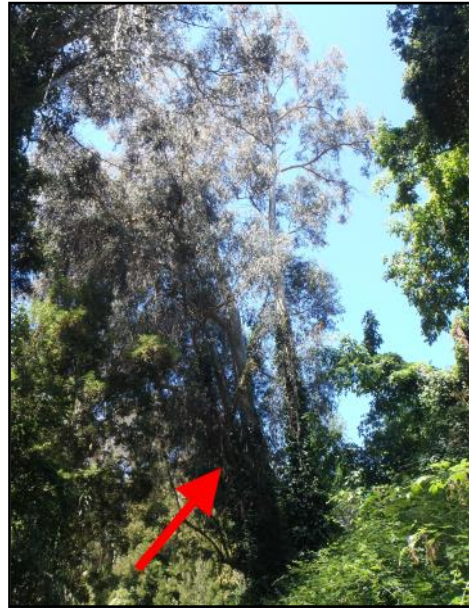
| Comments | Suppressed; lost top; leaning & one sided S.; engulfed in ivy. |

Above: Arrow points to blue gum #444.

| Risk reduction options | To reduce risk, prune to reduce branch weight & extension S.; to eliminate risk, remove tree. |

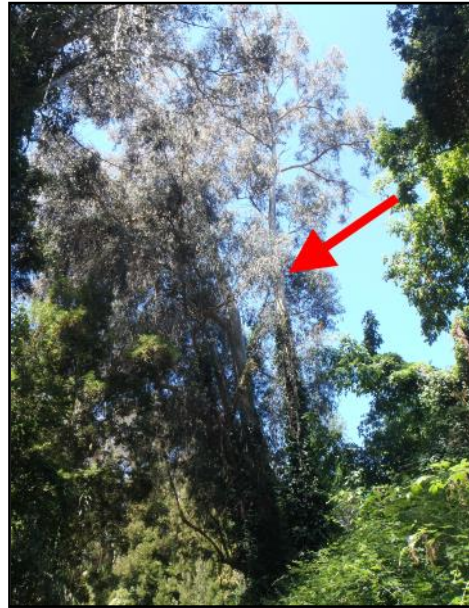
| Comments | Codominant trunks at 5'; one trunk topped & dead; up-right form; laterals N. @ 70'; engulfed in ivy. |

Above: Arrow points to blue gum #445.

| Risk reduction options | To reduce risk, prune to reduce branch weight & extension N.; to eliminate risk, remove tree. |

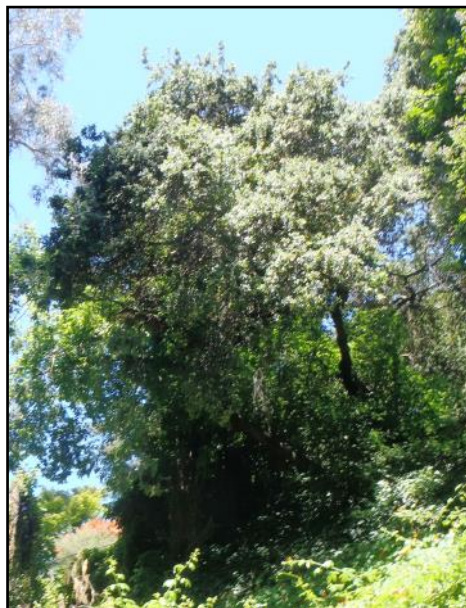
| Comments | Leaning & one sided S.; heavy lateral S.; ribbing/adding wood N. |

Above: Looking NW. at coast live oak #447.

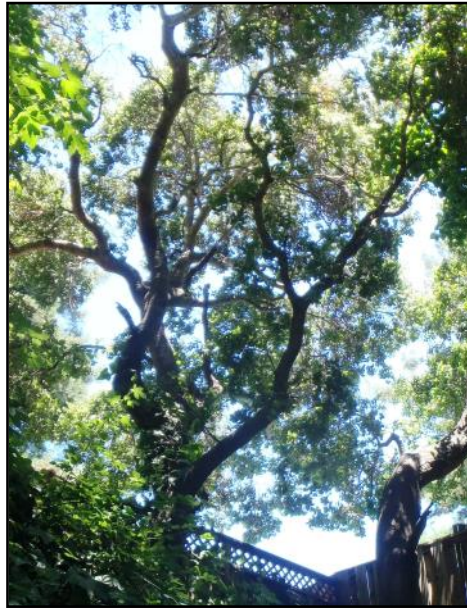
| Comments | Upright form; small crown; twig dieback. |

Above: Coast live oak #448 was one of a group of 3 along the top of the bank.

| Risk reduction options | To reduce risk, prune to reduce branch weight & extension N.; to eliminate risk, remove tree. |

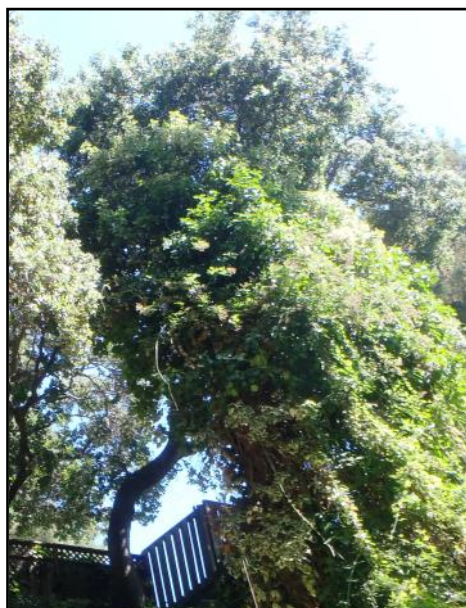
| Comments | Trunk sweeps from base; crown bowed E. |

Above: The crown of coast live oak #449 extended E.

| Risk reduction options | To eliminate risk, remove tree. |

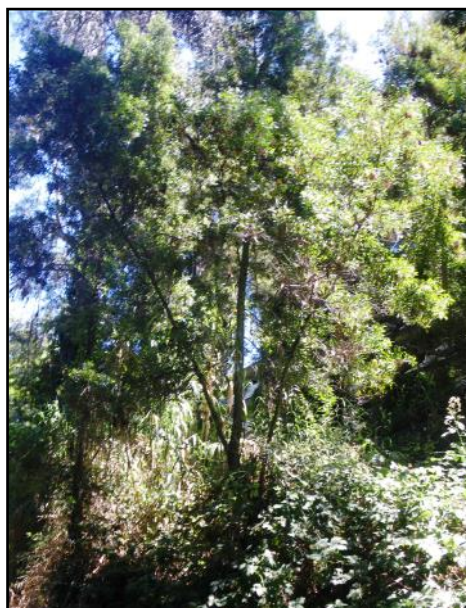
| Comments | Failed at base & turned up. |

Above: Blackwood acacia #450 was one in a group growing on the S. side of the creek.

| Risk reduction options | To eliminate risk, remove tree. |

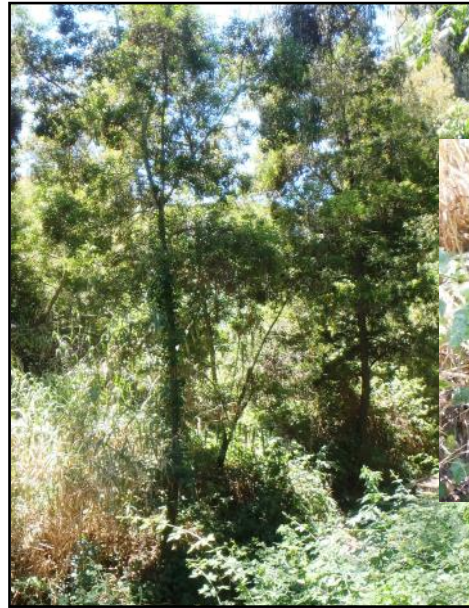
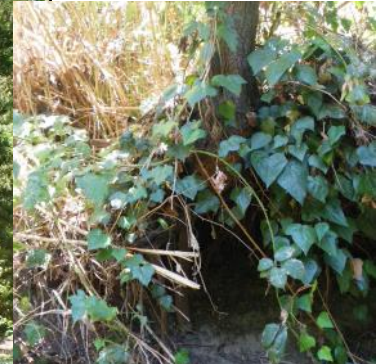
| Comments | Roots below tree completely exposed. |

Inset shows the bank has been undercut, exposing the roots.

Above: Looking S. at blackwood acacia #451.

| Risk reduction options | To eliminate risk, remove tree. |

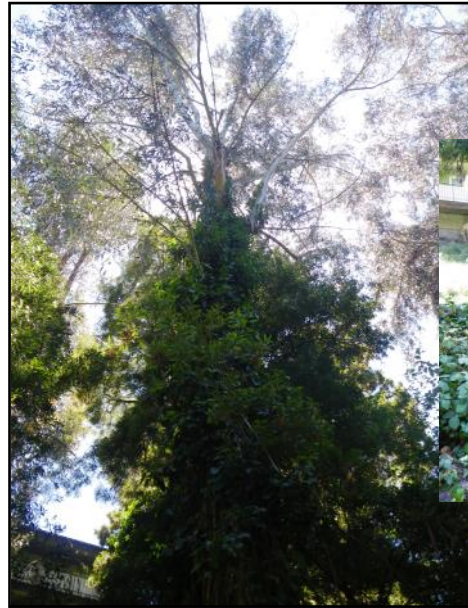
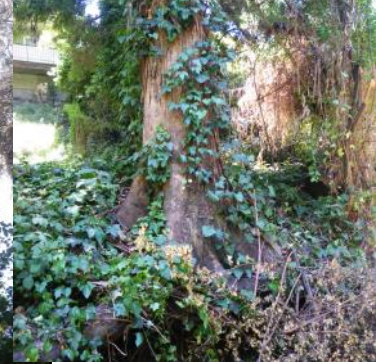
| Comments | Upright form; multiple attachments at 40'; roots on N. side of tree exposed. |

Inset shows roots exposed on the N. side of the tree.

Above: Looking up at the crown of blue gum #453.

| Risk reduction options | To eliminate risk, remove tree. |

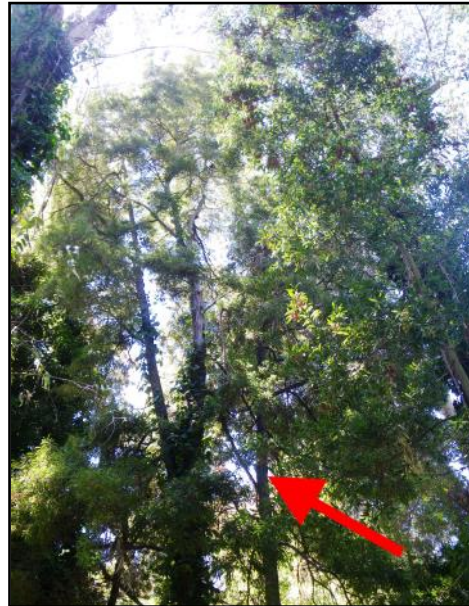
| Comments | Upper crown bowed W.; narrow form. |

Above: Arrow points to blackwood acacia #454.

| Risk reduction options | To reduce risk, prune to reduce branch weight & extension N.; to eliminate risk, remove tree. |

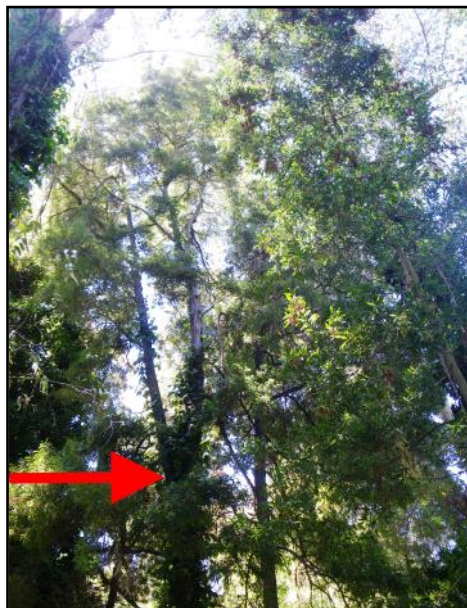
| Comments | Multiple attachments at 20'; upright form; long wound on E. stem at attachment. |

Above: Arrow points to blackwood acacia #455.

| Risk reduction options | To reduce risk, prune to remove or reduce stem E.; to eliminate risk, remove tree. |

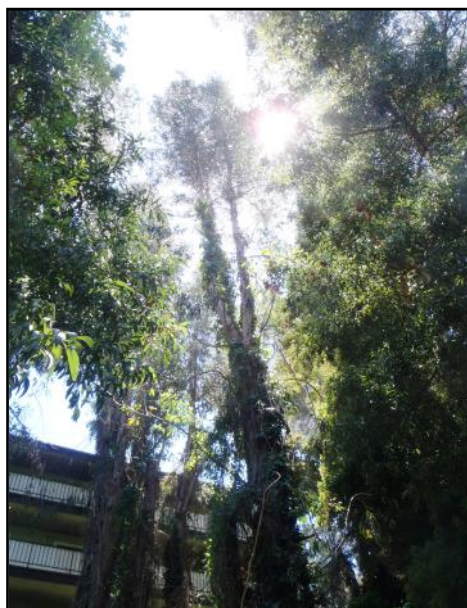
| Comments | Topped at 25'; multiple attachments at topping points; stems weakly attached; engulfed in ivy. |

Above: Blue gum #456 was in poor condition.

| Risk reduction options | To eliminate risk, remove tree. |

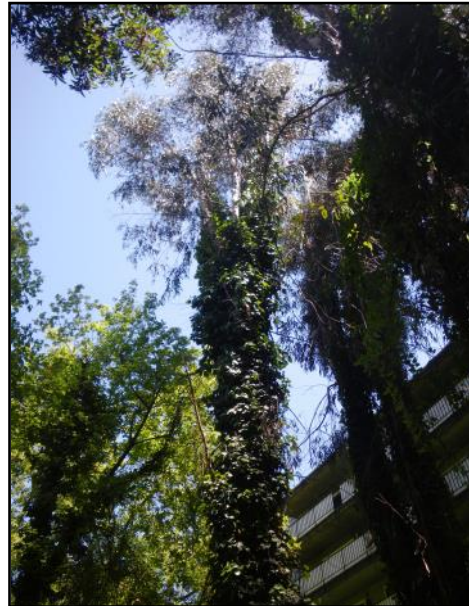
| Comments | Topped at 25'; multiple attachments at topping points; stems weakly attached; engulfed in ivy. |

Above: Blue gum #457 was in poor condition.

| Risk reduction options | To eliminate risk, remove tree. |

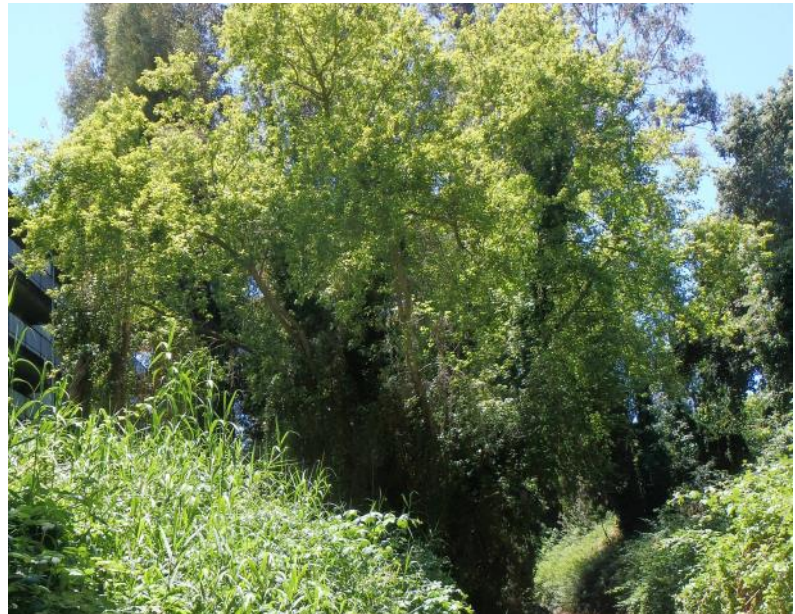
| Comments | Multiple attachments at base; spreading form; engulfed in ivy. |

Above: Looking W. at boxelder #458.

| Risk reduction options | To reduce risk, prune to remove or reduce stems SE.; to eliminate risk, remove tree. |

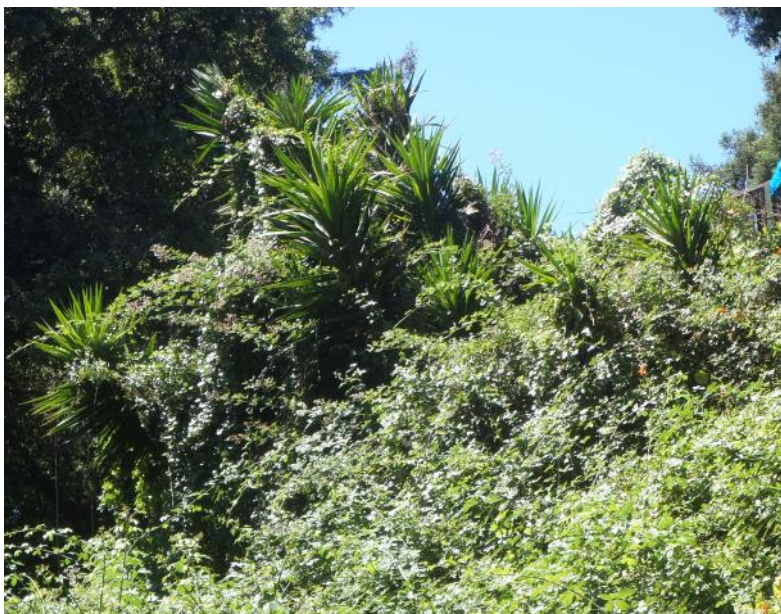
| Comments | No tag; multiple attachments at base; engulfed in ivy. |

Above: This multi-stemmed tree was inaccessible in the vines.

| Risk reduction options | To eliminate risk, remove tree. |

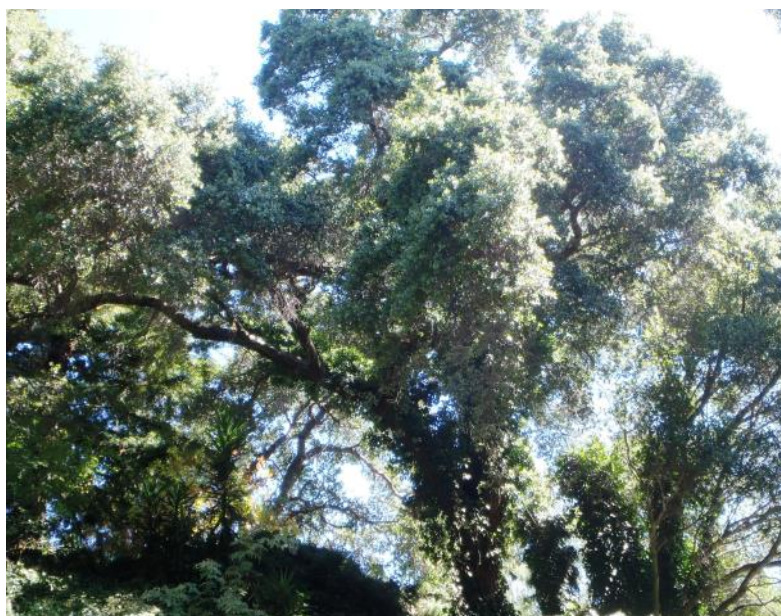
| Comments | Multiple attachments at 10'; good form and structure; long laterals N. & W. |

Above: Looking NE. at coast live oak #460, with long lateral limbs.

| Risk reduction options | To reduce risk, prune to reduce branch weight & extension NW.; to eliminate risk, remove tree. |

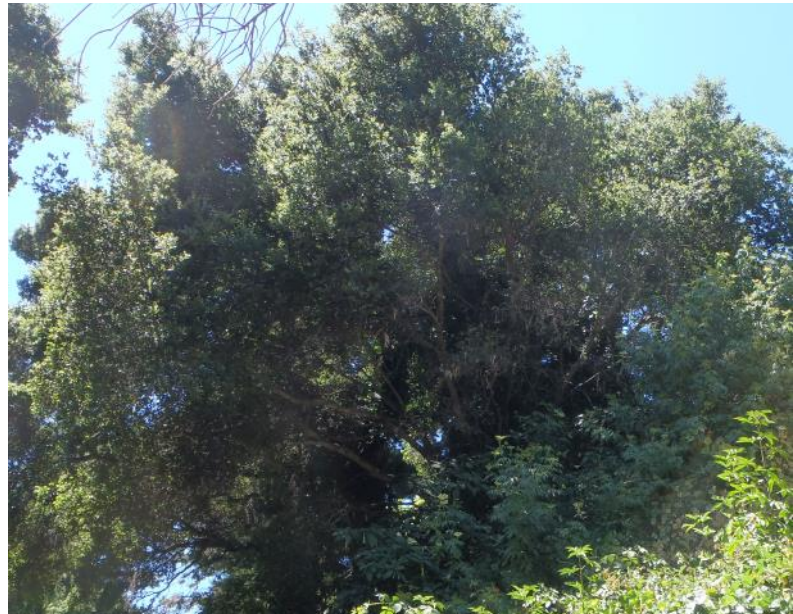
| Comments | Multiple attachments at 4'; one sided SE.; engulfed in ivy. |

Above: Coast live oak #461 competed with its neighbor and was one sided SE.

| Risk reduction options | To reduce risk, prune to remove or reduce stem NE.; to eliminate risk, remove tree. |

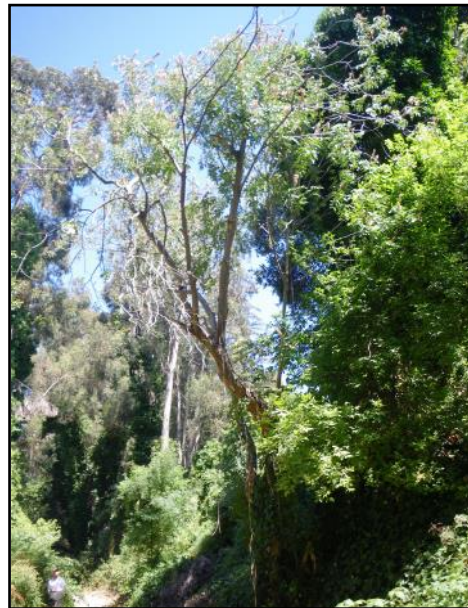
| Comments | Codominant trunks at base; thin crown; base undercut by erosion; engulfed in ivy. |

Above: Buckeye #462 was growing at the edge of the stream channel and was in poor condition.

| Risk reduction options | To eliminate risk, remove tree. |

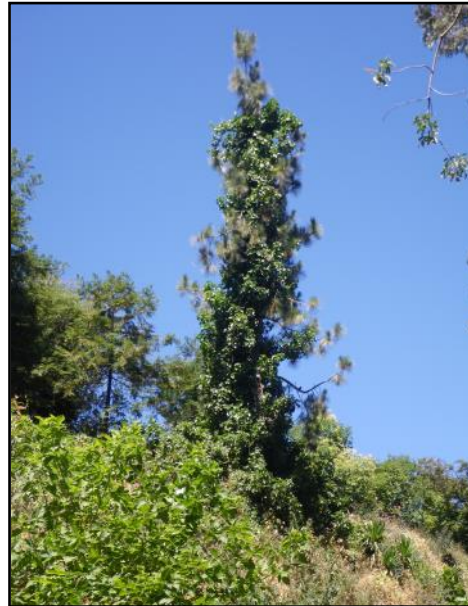
| Comments | No tag; sweeps N. at base; engulfed in ivy. |

Above: Canary Island pine #463 was inaccessible and engulfed in ivy.

| Risk reduction options | To eliminate risk, remove tree. |

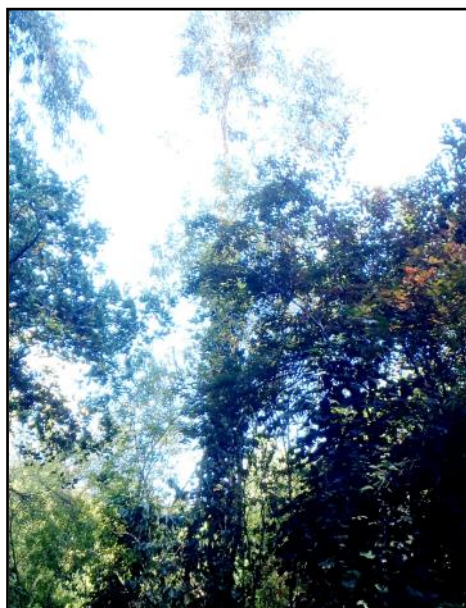
| Comments | Young tree; high crown; engulfed in ivy. |

Above: The upper crown of this young blue gum is hard to see in the photo.

| Risk reduction options | To eliminate risk, remove tree. |

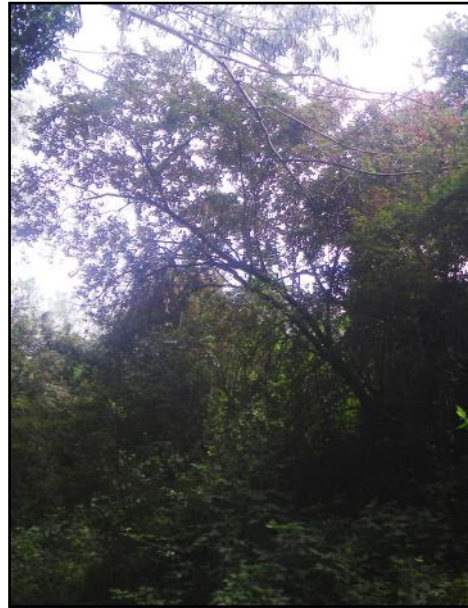
| Comments | Suppressed; crown bowed SW.; engulfed in ivy. |

Above: Purple-leaf plum #465 was suppressed.

| Risk reduction options | To eliminate risk, remove tree. |

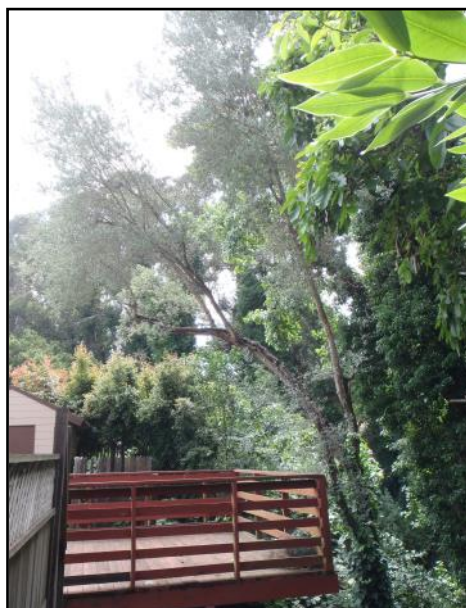
| Comments | Codominant trunks at base; W. stem topped; suppressed; crown bowed N.; engulfed in ivy. |

Above: The crown of this small olive arched over the deck to the N.

| Risk reduction options | To eliminate risk, remove tree. |

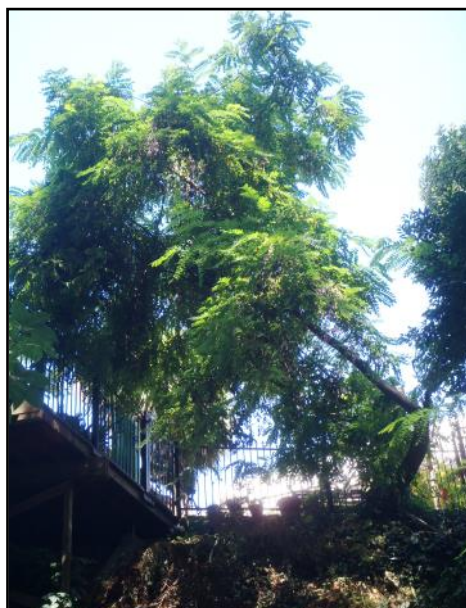
| Comments | Codominant trunks at base; N. stem topped at 8'; S. stem leans S. with trunk wounds. |

Above: Blacklocust #467 had poor form and structure.

| Risk reduction options | To reduce risk, prune to remove or reduce stem S.; to eliminate risk, remove tree. |

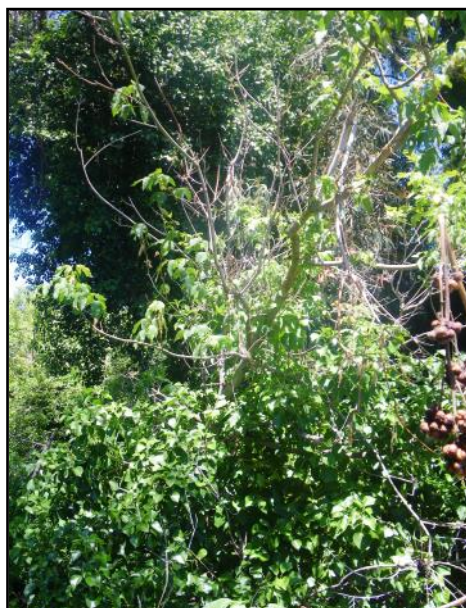
| Comments | Codominant trunks at 2'; crown bowed S.; engulfed in ivy. |

Above: Boxelder #468 is hard to distinguish in the photo.

| Risk reduction options | To reduce risk, prune to remove or reduce stem S.; to eliminate risk, remove tree. |

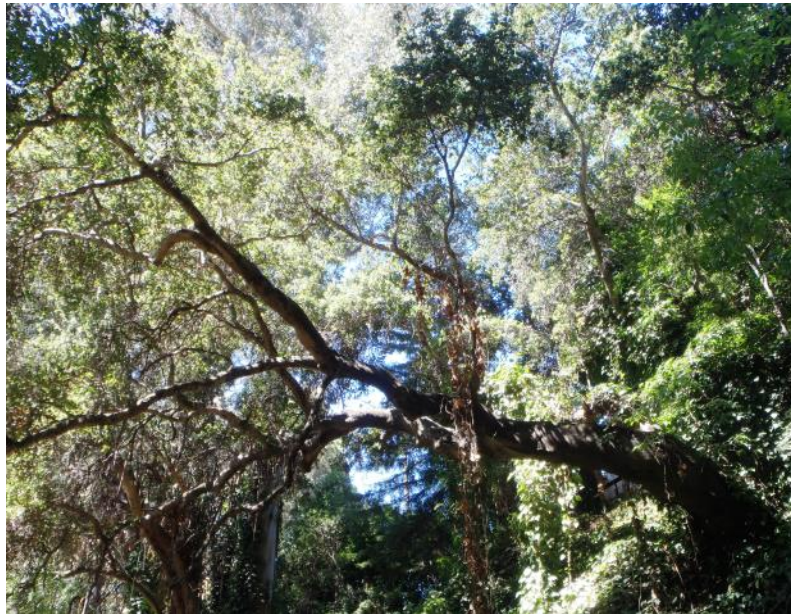
| Comments | Codominant trunks at 2'; 36" stem bowed S. to creek; 20" stem upright; engulfed in ivy. |

Above: Coast live oak #469 was suppressed and leaning S. over the creek.

| Risk reduction options | To reduce risk, prune to reduce stem S.; to eliminate risk, remove tree. |

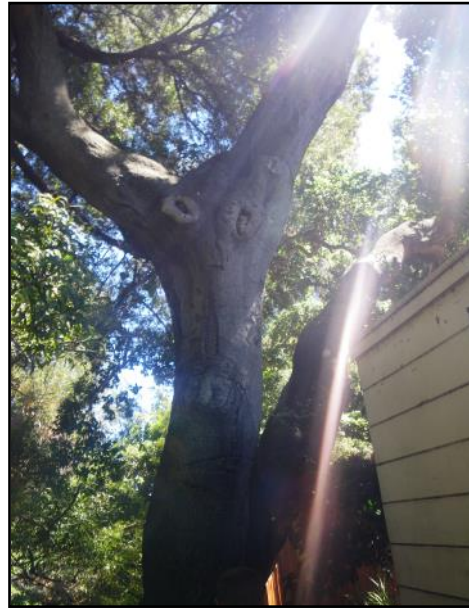
| Comments | Codominant trunks at 6'; very one sided W. over private prop.; basal wound where it grew over metal. |

Above: The crown of coast live oak #471 was one-sided W.

| Risk reduction options | To reduce risk, prune to reduce branch weight & extension W.; to eliminate risk, remove tree. |

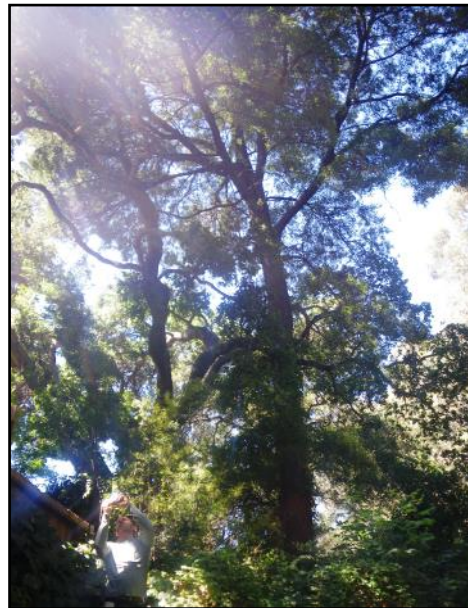
| Comments | Slight lean W.; long laterals W.; seams along trunk. |

Above: Blackwood acacia #472 was a dominant tree.

| Risk reduction options | To reduce risk, prune to reduce branch weight & extension W.; to eliminate risk, remove tree. |

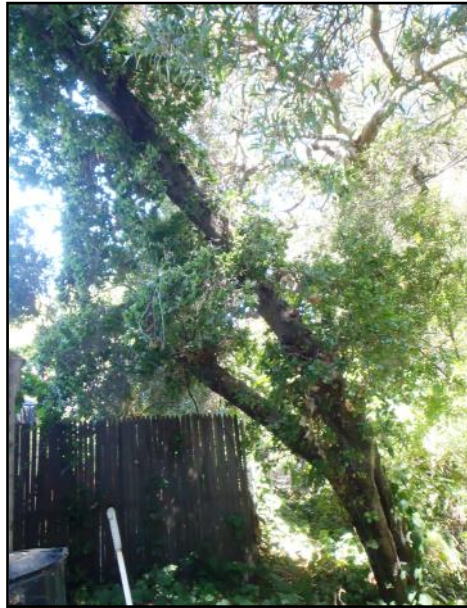
| Comments | Codominant trunks at 2'; one stem topped at fence line; other stem bowed NW. over private prop.; trunk wounds; epicormics. |

Above: Coast live oak #473 leaned N. over the adjacent property.

| Risk reduction options | To eliminate risk, remove tree. |

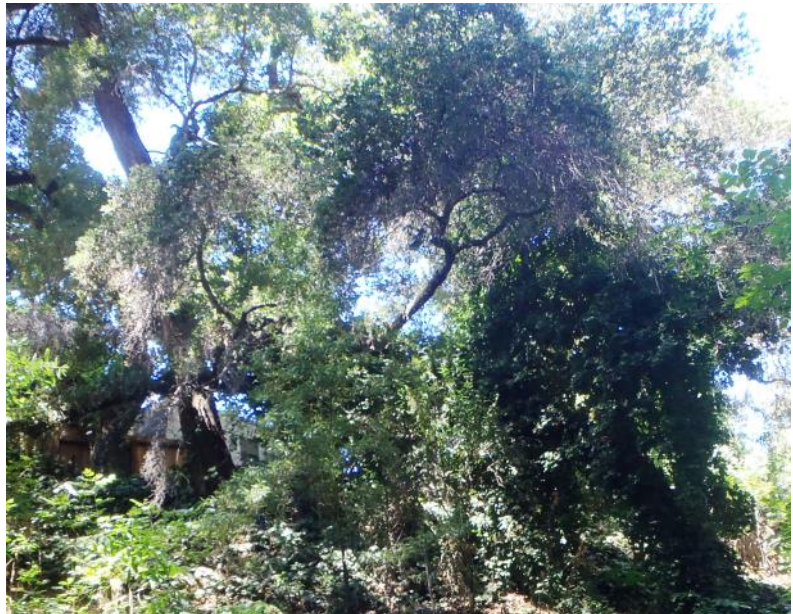
| Comments | Crown bowed S. to horizontal; engulfed in ivy. |

Above: Looking N. at coast live oak #474.

| Risk reduction options | To eliminate risk, remove tree. |

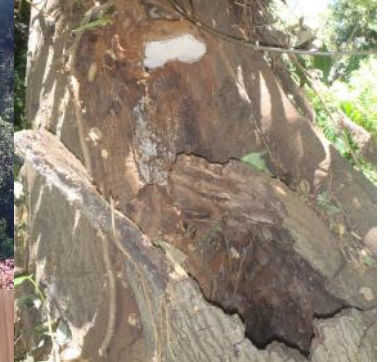
| Comments | Slight lean W. over private prop.; large basal cavity with extensive decay on S. side. |

Inset shows trunk decay and decay fungus.

| Risk reduction options | Recommended tree for removal asap |

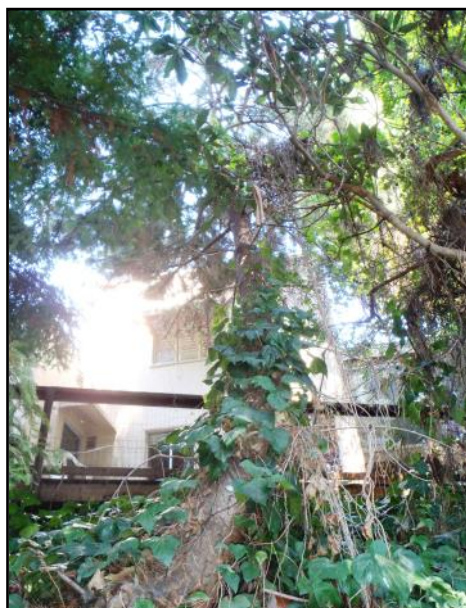
| Comments | Leans N. over private prop.; small crown. |

Above: This small Italian stone pine leaned N. to reach for light.

| Risk reduction options | To eliminate risk, remove tree. |

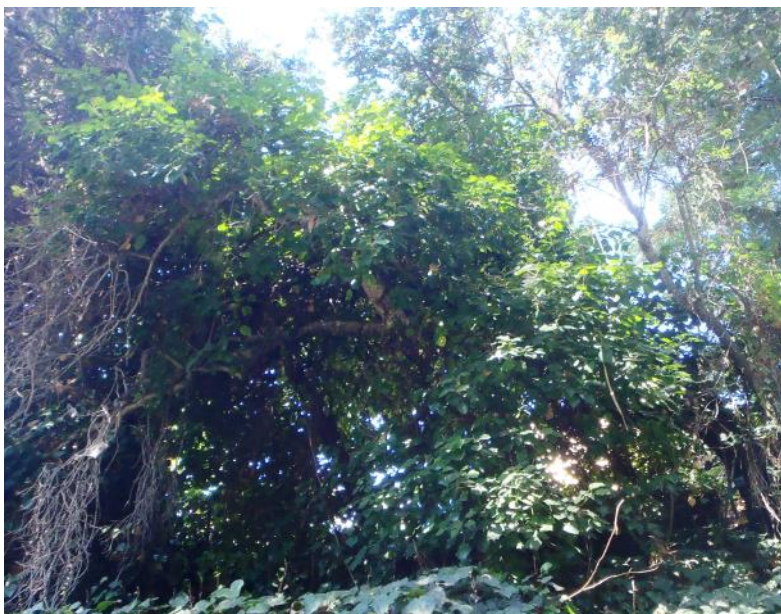
| Comments | Leans W. To horizontal; engulfed in ivy. |

Above: Coast live oak #478 leaned W. and was engulfed in ivy.

| Risk reduction options | To eliminate risk, remove tree. |

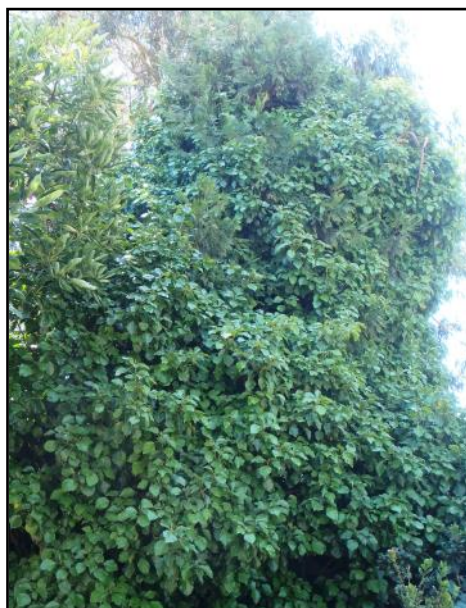
| Comments | Leans W. to horizontal; bark checking; engulfed in ivy. |

Above: Looking S. at tree #479, all you can see is ivy.

| Risk reduction options | To eliminate risk, remove tree. |

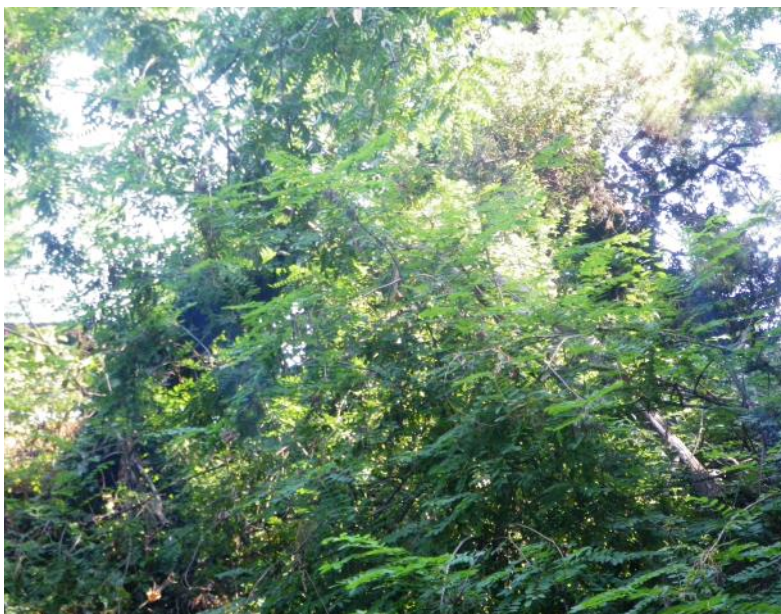
| Comments | Failed at base & stem broken at 15'. |

Above: Blacklocust #480 is hard to distinguish in the photo.

| Risk reduction options | To eliminate risk, remove tree. |

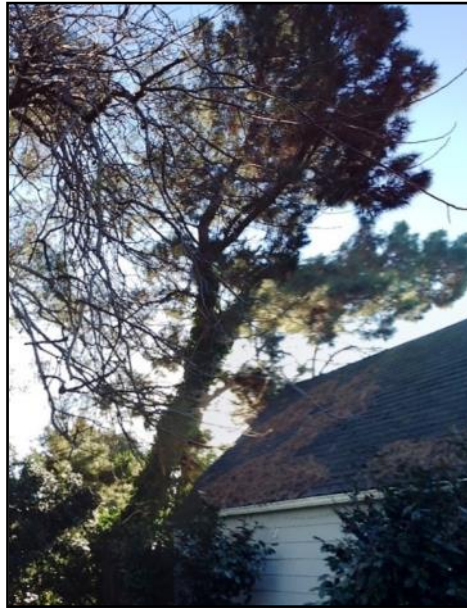
| Comments | Corrected lean N.;<br>codominant trunk at<br>25'; crook in upper<br>crown. |

Above: Looking SW. at Monterey pine #481.

| Risk reduction options | To reduce risk,<br>prune to reduce<br>branch weight & ex-<br>tension N.; to elimi-<br>nate risk, remove<br>tree. |

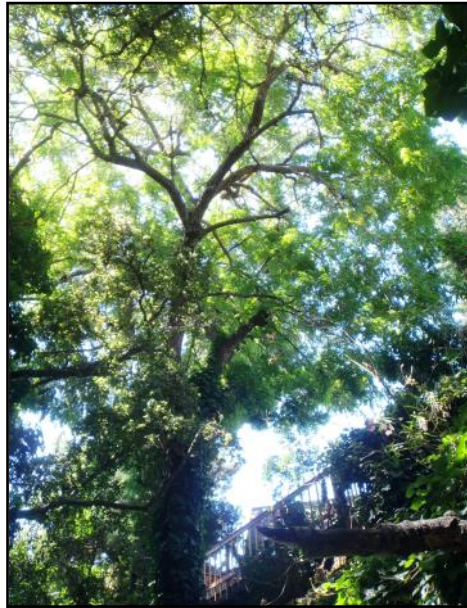
| Comments | Multiple attachments at 20'; weight N. but pruned N.; engulfed in ivy. |

Above: This mature Calif. black walnut was in good condition.

| Risk reduction options | To reduce risk, prune to reduce branch weight & extension N.; to eliminate risk, remove tree. |

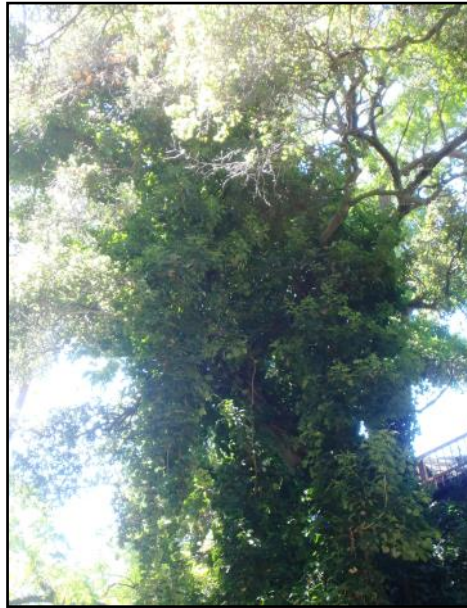
| Comments | Leans S.; crook at 10'; multiple attachments at 30'; weight S. over creek; engulfed in ivy. |

Above: Looking NW. at coast live oak #483.

| Risk reduction options | To reduce risk, prune to reduce crown weight & extension S.; to eliminate risk, remove tree. |

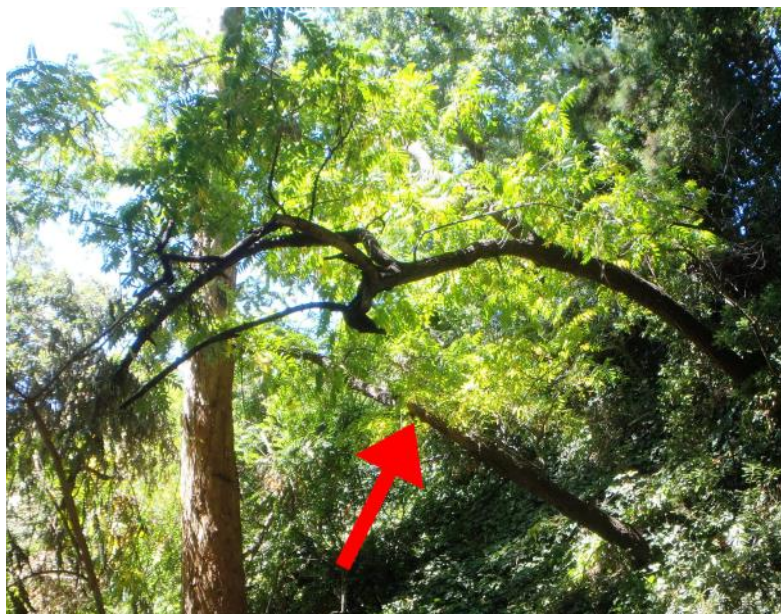
| Comments | Leans heavily S. over creek; lost top. |

Above: Arrow points to Calif. black walnut #484.

| Risk reduction options | To eliminate risk, remove tree. |

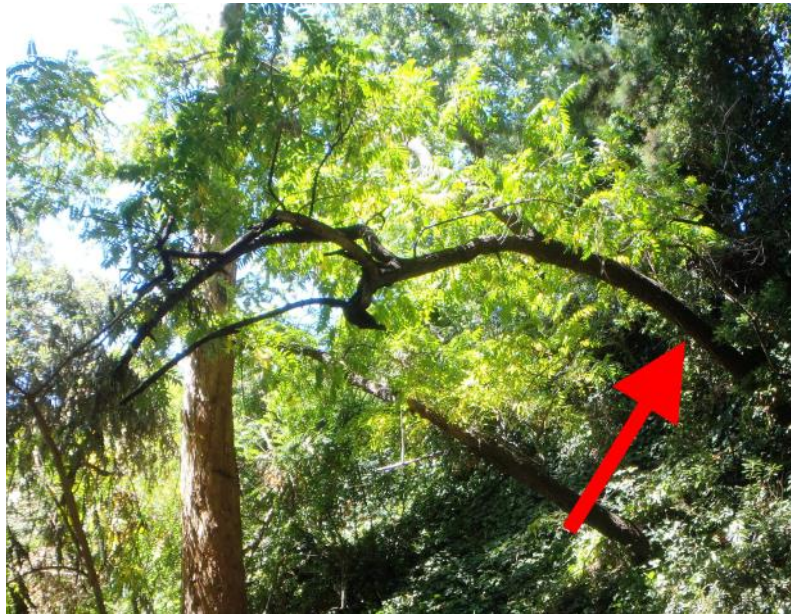
| Comments | Leans heavily S.; trunk decay; lost top. |

Above: Arrow points to Calif. black walnut #485.

| Risk reduction options | To eliminate risk, remove tree. |

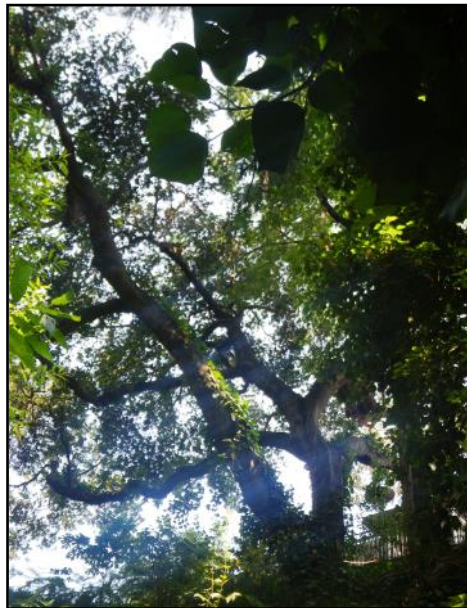
| Comments | Codominant trunks at 3'; one sided N.; pruned at PL; engulfed in ivy. |

Above: Looking N. at coast live oak #486.

| Risk reduction options | To reduce risk, prune to reduce branch weight & extension N.; to eliminate risk, remove tree. |

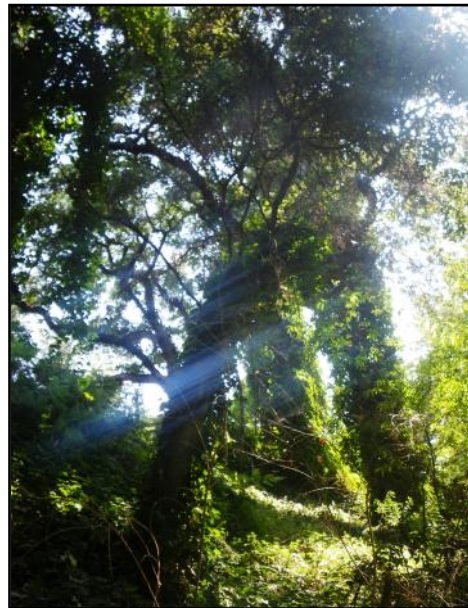
| Comments | Crown bowed E.; poor form & structure; engulfed in ivy. |

Above: The crown of coast live oak #487 bowed away from the camera.

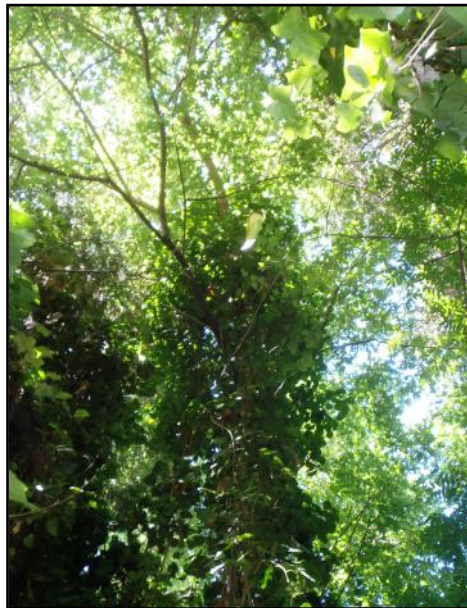
| Comments | One stem upright;<br>others bowed S.;<br>engulfed in ivy. |

Above: Looking up into the crown of this young silver maple.

| Most likely failure | Stem |
| Failure potential | 2 |

| Risk reduction options | To reduce risk, remove or reduce stems S.; to eliminate risk, remove tree. |

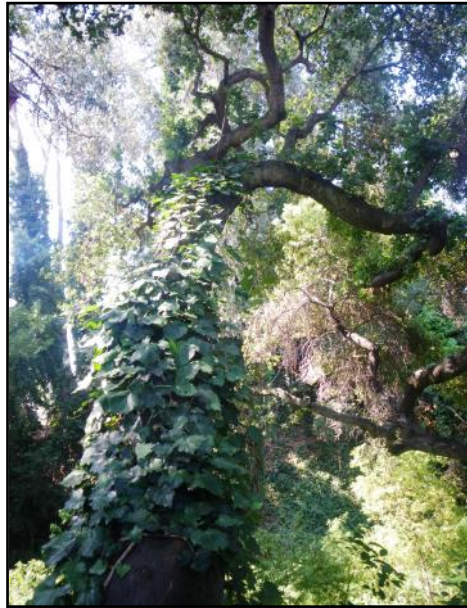
| Comments | Codominant trunks at 4'; main stem bowed N.; heavy lateral limbs N. over private prop.; cabled; ivy. |

Above: A cable was installed between the trunks of this codominant coast live oak.

| Most likely failure | Branch |
| Failure potential | 2 |

| Risk reduction options | To reduce risk, prune to reduce branch weight & extension N.; to eliminate risk, remove tree. |

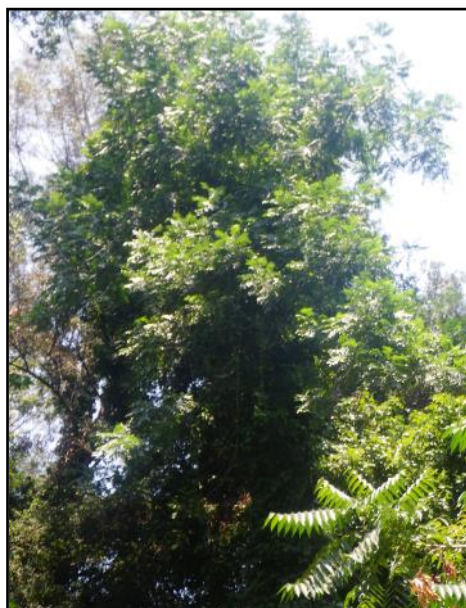
| Comments | Codominant trunks at base; crook at 20'; ivy. |

Above: Calif. black walnut #490 was young and engulfed in ivy.

| Most likely failure | Branch |
| Failure potential | 2 |

| Risk reduction options | To reduce risk, prune to reduce branch weight & extension W.; to eliminate risk, remove tree. |

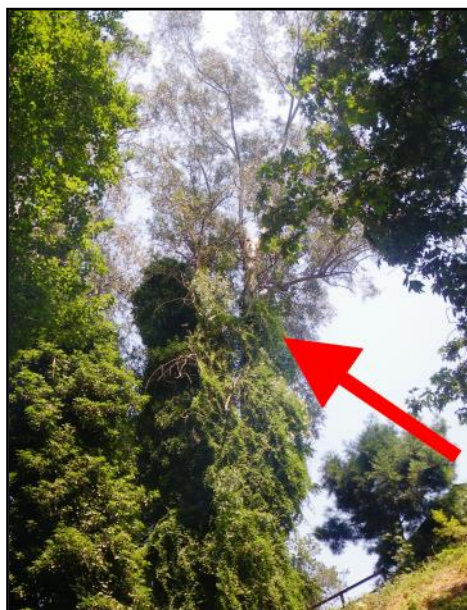
Above: Arrow points to blue gum #491.

| Comments | Codominant trunks at base; topped at 40'; 6-12" regrowth weakly attached; engulfed in ivy. |

| Most likely failure | Branch |
| Failure potential | 3 |

| Risk reduction options | To eliminate risk, remove tree. |

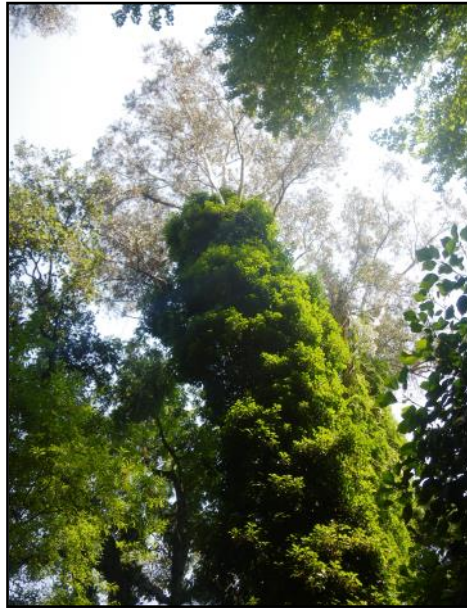
| Comments | Appears to have been topped at 40'; slight lean SW.; 8" regrowth extends NW. over private prop.; engulfed in ivy. |

Above: Looking up into the crown of blue gum #492, which was engulfed in ivy.

| Most likely failure | Branch |
| Failure potential | 3 |

| Risk reduction options | To reduce risk, prune or remove regrowth NW.; to eliminate risk, remove tree. |

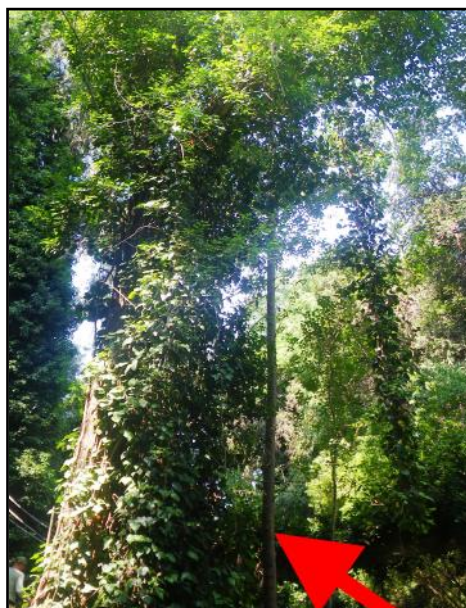
Above: Arrow points to Fremont cottonwood #493.

| Comments | Sweeps from base & one sided W. |

| Most likely failure | Whole tree |
| Failure potential | 1 |

| Risk reduction options | To eliminate risk, remove tree. |

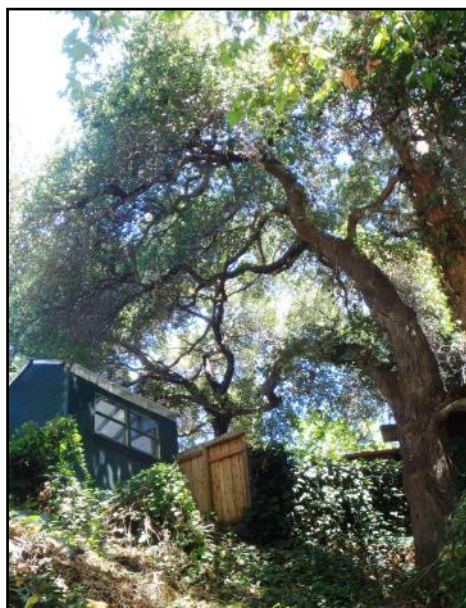
Above: Looking E. at coast live oak #497.

| Comments | Codominant trunks at 10'; crown bowed N. over private prop.; long lateral; ivy. |

| Most likely failure | Branch |
| Failure potential | 2 |

| Risk reduction options | To reduce risk, prune to reduce branch weight & extension N.; to eliminate risk, remove tree. |

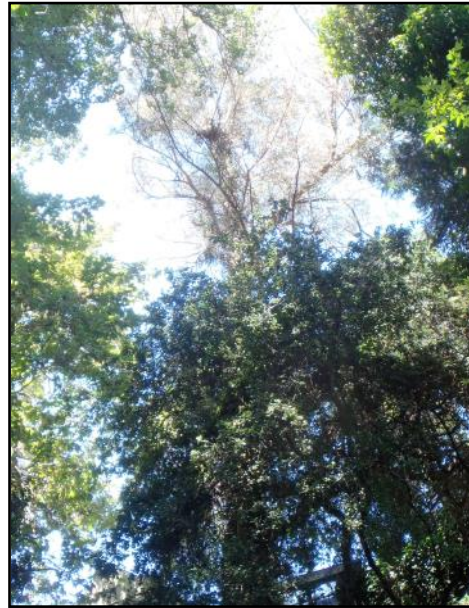
| Comments | Upright form; small laterals N. over private prop. |

Above: The upper crown of blue gum #498 is hard to see.

| Most likely failure | Branch |
| Failure potential | 2 |

| Risk reduction options | To reduce risk, prune to reduce branch weight & extension N.; to eliminate risk, remove tree. |

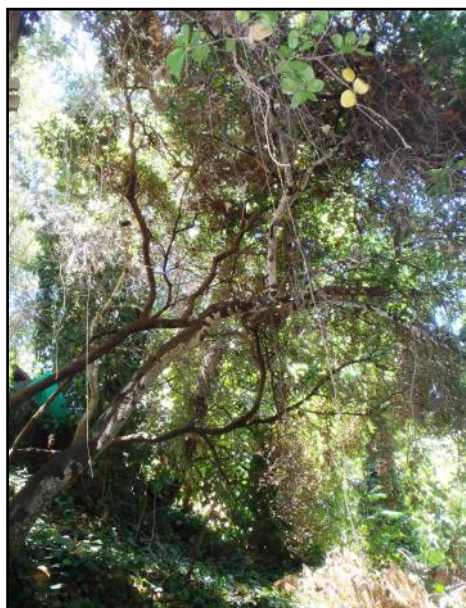
| Comments | Suppressed; crown bowed SE. |

Above: Coast live oak #499 was suppressed and leaned SE.

| Most likely failure | Branch |
| Failure potential | 2 |

| Risk reduction options | To reduce risk, prune to reduce branch weight & extension S.; to eliminate risk, remove tree. |

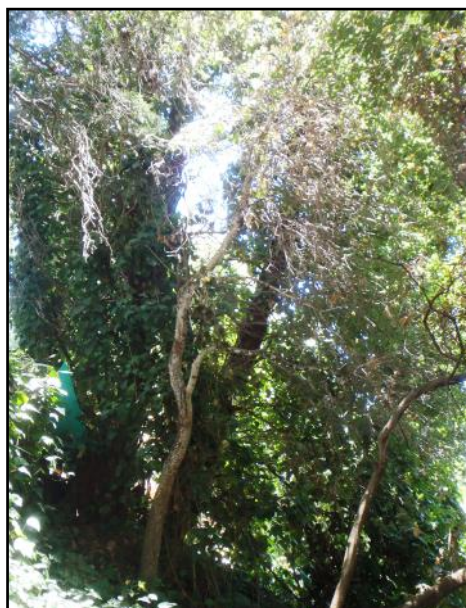
Above: Looking N. at coast live oak #500.

| Comments | Suppressed; crown bowed S. |

| Most likely failure | Whole tree |
| Failure potential | 2 |

| Risk reduction options | To eliminate risk, remove tree. |

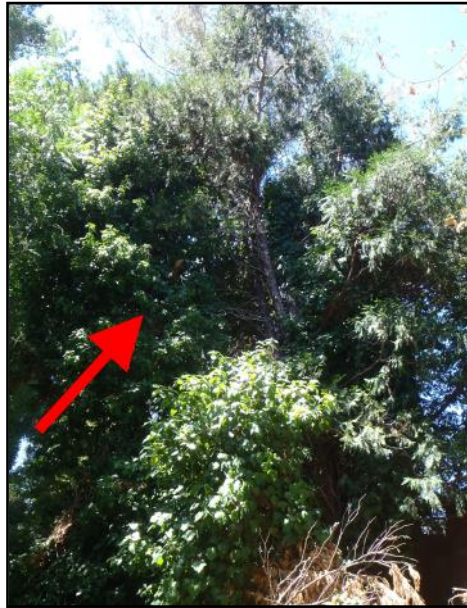
Above: Arrow points to Western red cedar #501.

| Comments | One sided & leaning SW.; bank & tree failure along this property. |

| Most likely failure | Whole tree |
| Failure potential | 3 |

| Risk reduction options | To eliminate risk, remove tree. |

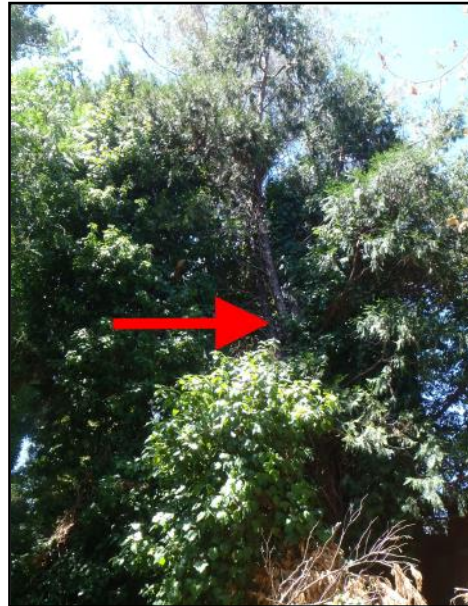
Above: Arrow points to Western red cedar #502.

| Comments | Heavy lean S.; bank & tree failure along this property. |

| Most likely failure | Whole tree |
| Failure potential | 4 |

| Risk reduction options | To eliminate risk, remove tree. |

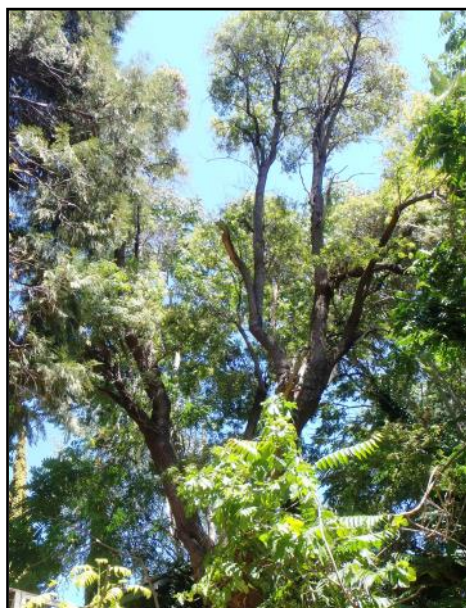
| Comments | Multiple attachments at 7'; trunk & branch wounds & decay; pruned at PL. |

Above: Elderberry #504 was mature, at 24" in diameter.

| Most likely failure | Branch |
| Failure potential | 3 |

| Risk reduction options | To reduce risk, prune to reduce branch weight & extension SE.; to eliminate risk, remove tree. |

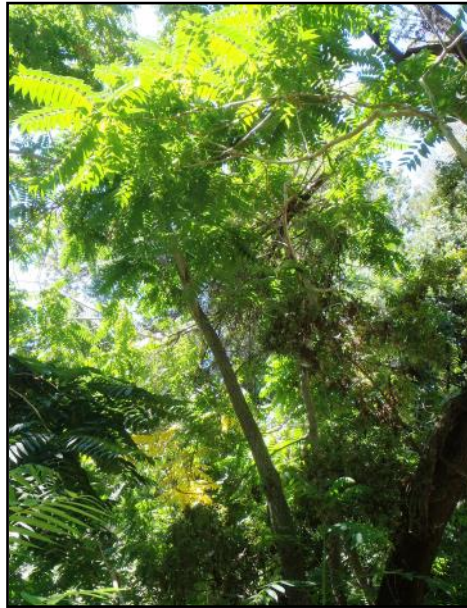
| Comments | Multiple attachments at base; leans S.; poor form and structure. |

Above: Ailanthus #506 was one among several stems of this invasive species.

| Most likely failure | Stem |
| Failure potential | 2 |

| Risk reduction options | To reduce risk, remove or reduce stems S.; to eliminate risk, remove tree. |
