# San Leandro Creek Tree Assessment

February 24, 2015

County of Alameda  
Flood Control and Water Conservation District  
399 Elmhurst Street  
Hayward, CA 94544-1395

URS Corporation  
1333 Broadway, Suite 800  
Oakland, CA 94612

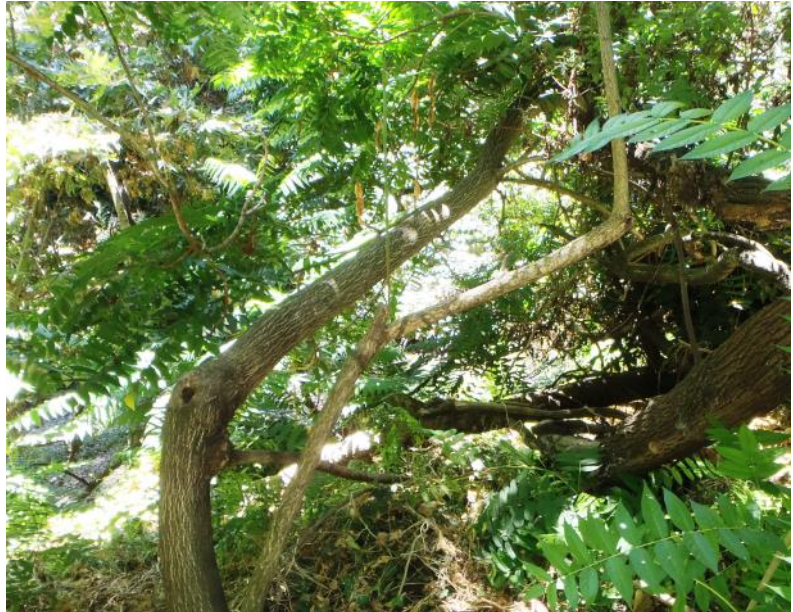
| Comments | Leans S. to horizontal.; poor form and structure. |

Above: Ailanthus #507 leaned S.

| Most likely failure | Whole tree |
| Failure potential | 2 |

| Risk reduction options | To eliminate risk, remove tree. |

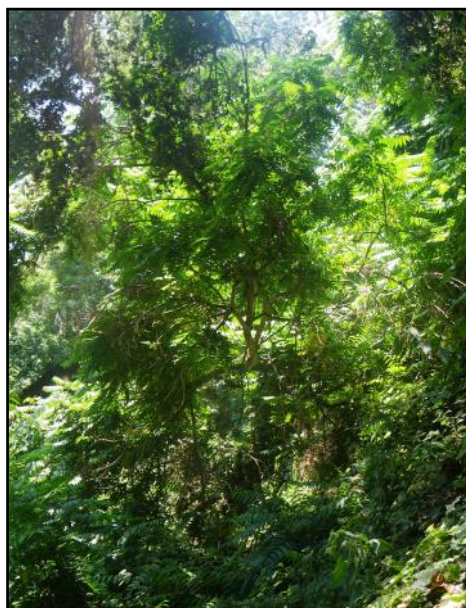
| Comments | Failed at base S.;<br>laying on ground. |

Above: Ailanthus #509 is hard to distinguish.

| Most likely failure | Whole tree |
| Failure potential | 3 |

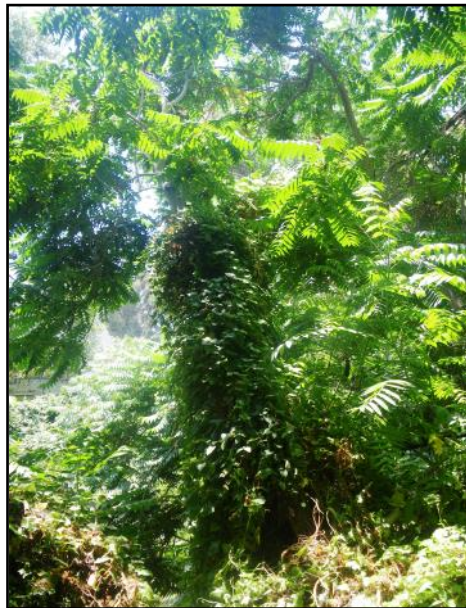
| Comments | Multiple attachments at base; two stems lean S.; other stem N.; engulfed in ivy. |

Above: Looking S. at ailanthus #510.

| Risk reduction options | To reduce risk, remove or reduce stems S.; to eliminate risk, remove tree. |

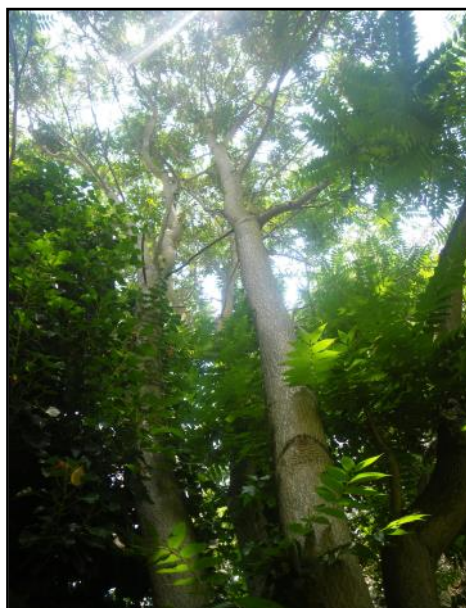
| Comments | Multiple attachments at base; most stems upright; one stem leans S.; ivy. |

Above: Looking up at the canopy of ailanthus #511.

| Risk reduction options | To reduce risk, remove or reduce stems S.; to eliminate risk, remove tree. |

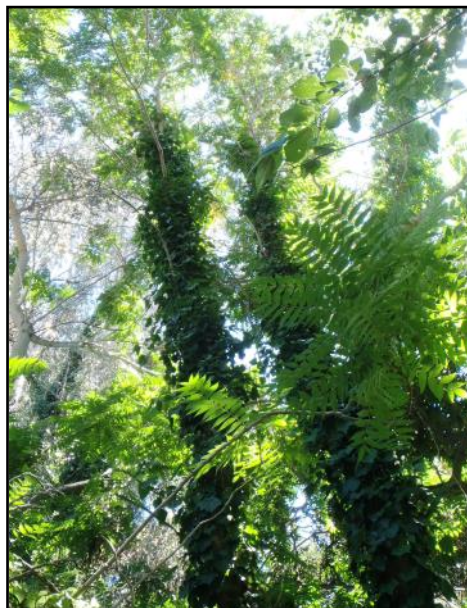
| Comments | Codominant trunks at 8'; ivy. |

Above: Ailanthus #512 was codominant and upright.

| Risk reduction options | To eliminate risk, remove tree. |

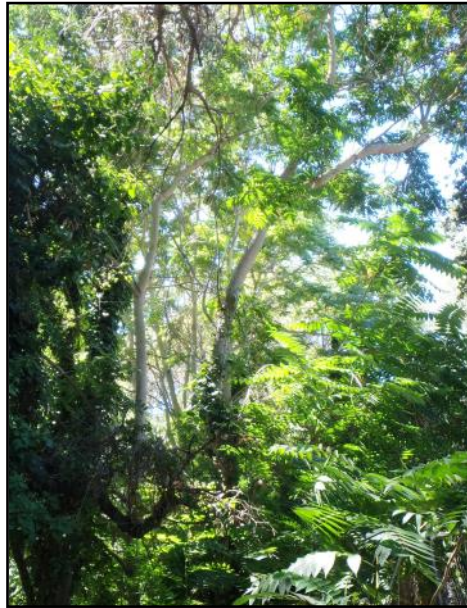
| Comments | Multiple attachments at base; two largest stems bow N.; ivy. |

Above: Ailanthus #513 is hard to distinguish.

| Risk reduction options | To reduce risk, remove or reduce stems N.; to eliminate risk, remove tree. |

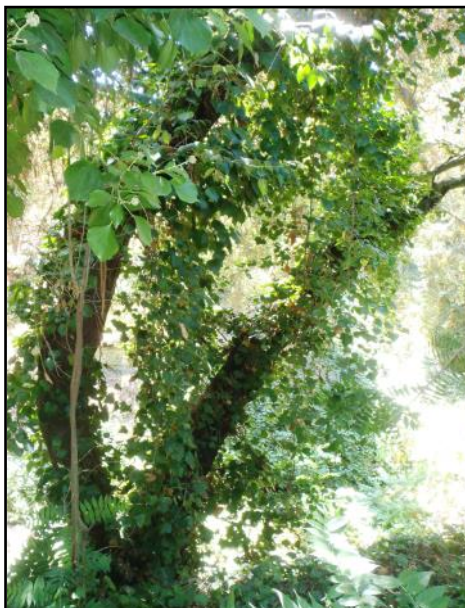
| Comments | Codominant trunks at 3'; crown bowed SW.; laterals; debris piled on uphill side; engulfed in ivy. |

Above: Looking SE. at the base of coast live oak #514.

| Risk reduction options | To reduce risk, remove or reduce stems SW.; to eliminate risk, remove tree. |

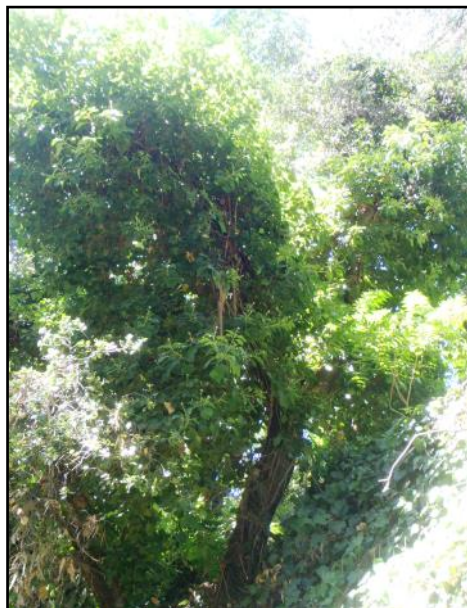
| Comments | Codominant trunks at base; S. stem lost top; N. stem leans N.; engulfed in ivy. |

Above: Looking W. at coast live oak #515.

| Risk reduction options | To reduce risk, remove or reduce stem N.; to eliminate risk, remove tree. |

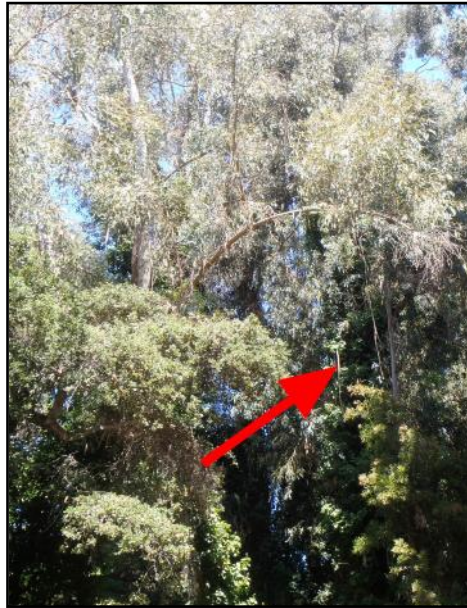
| Comments | Stump sprout; 32" stem leans W.; decay at base of stump; engulfed in ivy. |

Above: Arrow points to blue gum #517.

| Risk reduction options | To eliminate risk, remove tree. |

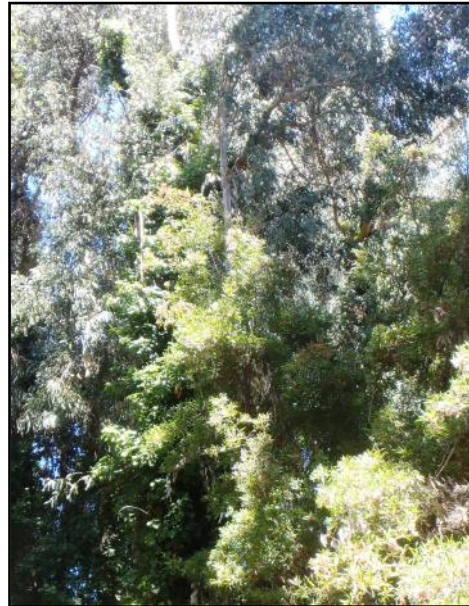
| Comments | Upright but crowded by #517. |

Above: This young blue gum had an upright form.

| Risk reduction options | To eliminate risk, remove tree. |

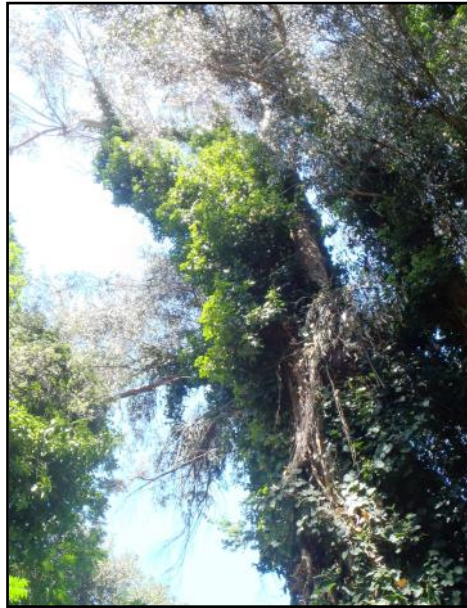
| Comments | Codominant trunks at 12'; debris piled up around base; long laterals SW.; hangers/deadwood over creek; engulfed in ivy. |

Above: Looking W. at the canopy of blue gum #519.

| Risk reduction options | To reduce risk, prune to reduce branch weight & extension SW.; to eliminate risk, remove tree. |

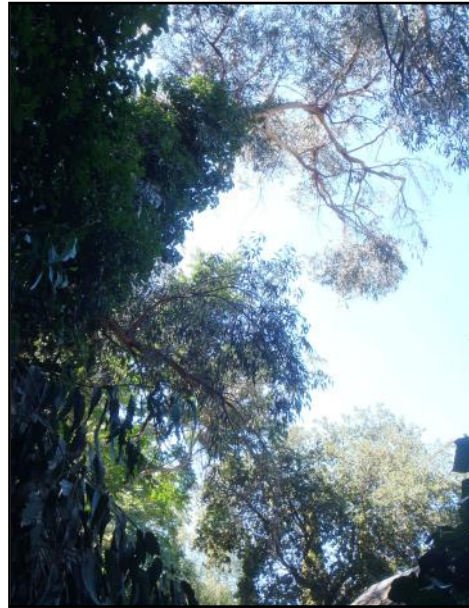
| Comments | Suppressed and leaning NW. over private prop.; debris piled up around base; engulfed in ivy. |

Above: Blue gum #520 leaned N. over private property (lower right).

| Risk reduction options | To eliminate risk, remove tree. |

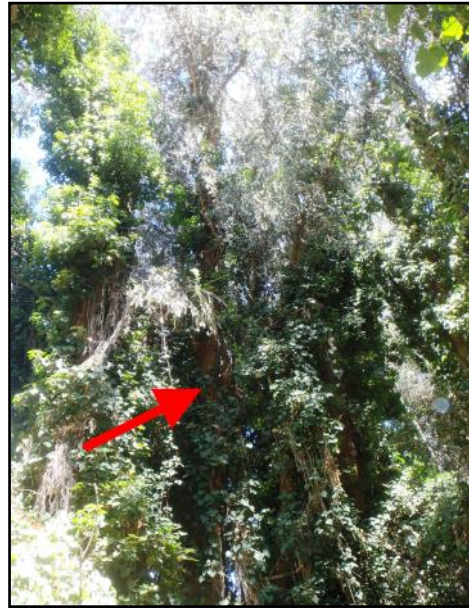
| Comments | Codominant trunks at 6'; N. stem topped at 10'; S. stem bowed SW. over creek; crook at 45'; ivy. |

Above: Arrow points to blue gum #521.

| Risk reduction options | To reduce risk, prune to reduce branch weight & extension SW.; to eliminate risk, remove tree. |

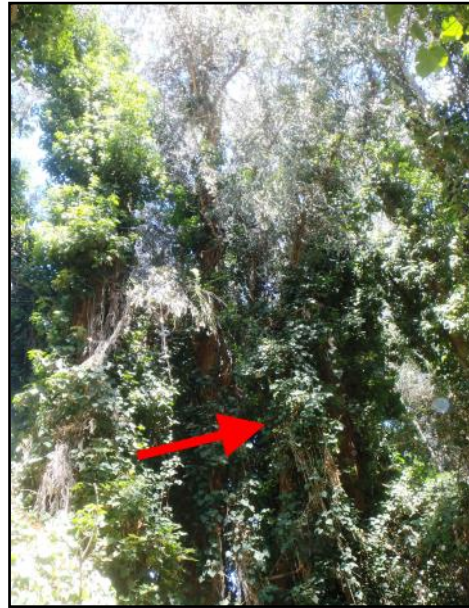
| Comments | Codominant trunks at 1'; suppressed; poor form and structure; ivy. |

Above: Arrow points to blue gum #522.

| Risk reduction options | To eliminate risk, remove tree. |

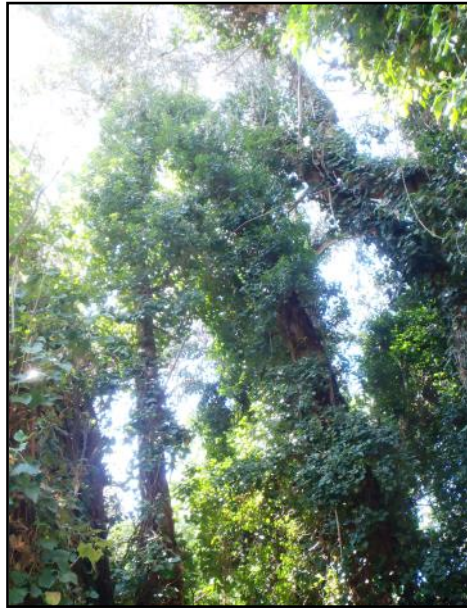
| Comments | Slight lean S. over creek; laterals in upper crown; engulfed in ivy. |

Above: Looking up at the canopy of blue gum #523 (center).

| Risk reduction options | To reduce risk, prune to reduce branch weight & extension S.; to eliminate risk, remove tree. |

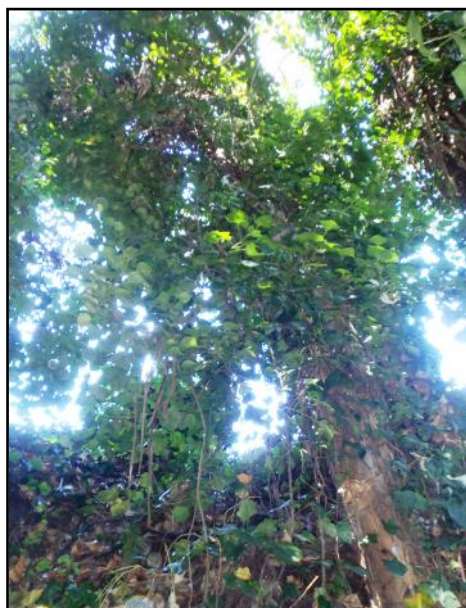
| Comments | Suppressed; topped at 6'; crown bowed NW.; engulfed in ivy. |

Above: This small-diameter blue gum had been topped.

| Risk reduction options | To eliminate risk, remove tree. |

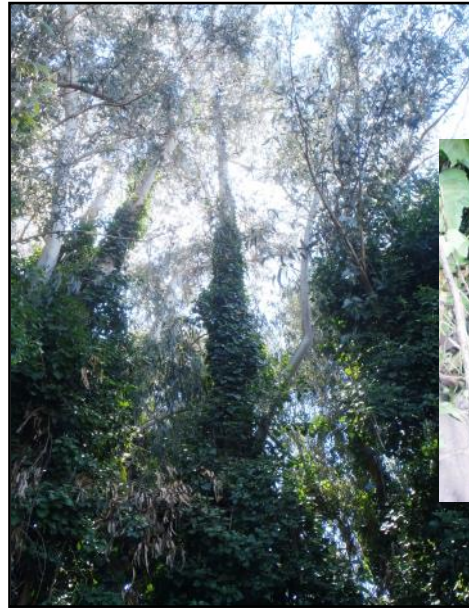
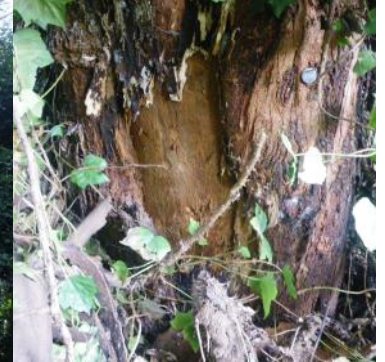
| Comments | Codominant trunks at base; trunk wound; smaller stem topped & dead; 6" lateral N.; engulfed in ivy. |

Inset shows trunk wound.

Above: Looking W. at blue gum #525 (center).

| Risk reduction options | To reduce risk, prune to reduce branch weight & extension N.; to eliminate risk, remove tree. |

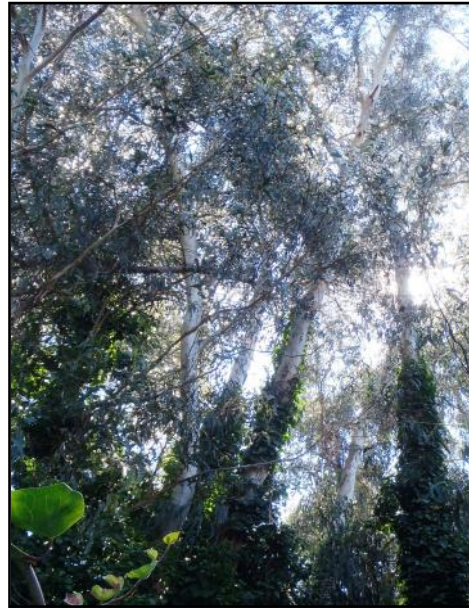
| Comments | Multiple attachments at 20'; 9" stem bowed N.; engulfed in ivy. |

Above: Looking E. at blue gum #527 (center).

| Risk reduction options | To reduce risk, remove or reduce stem N.; to eliminate risk, remove tree. |

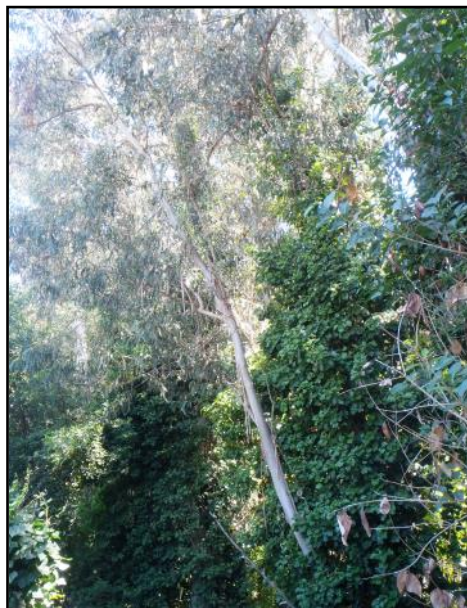
| Comments | Codominant trunks at 3'; suppressed; one stem bowed N.; engulfed in ivy. |

Above: Blue gum #528 (center) had two stems, one of which bowed N.

| Risk reduction options | To reduce risk, remove or reduce stem N.; to eliminate risk, remove tree. |

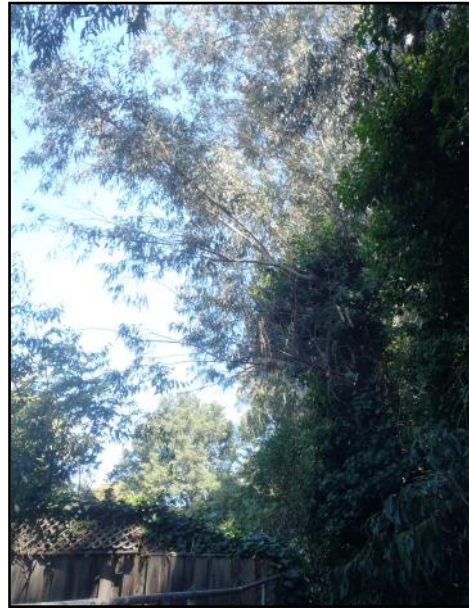
| Comments | Suppressed; crown bowed N.; poor structure; engulfed in ivy. |

Above: Looking E. at blue gum #529.

| Risk reduction options | To eliminate risk, remove tree. |

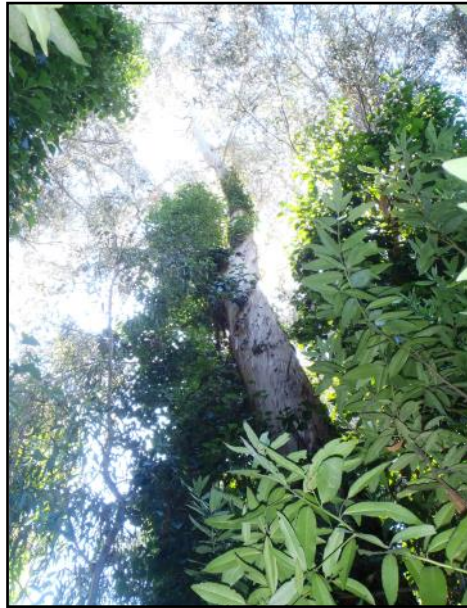
| Comments | Codominant trunks at 35'; one stem up-right; one stem bowed S. over creek; engulfed in ivy. |

Above: Looking up at the canopy of blue gum #530. The upper canopy is hard to see.

| Most likely failure | Stem |
| Failure potential | 2 |

| Risk reduction options | To reduce risk, remove or reduce stem S.; to eliminate risk, remove tree. |

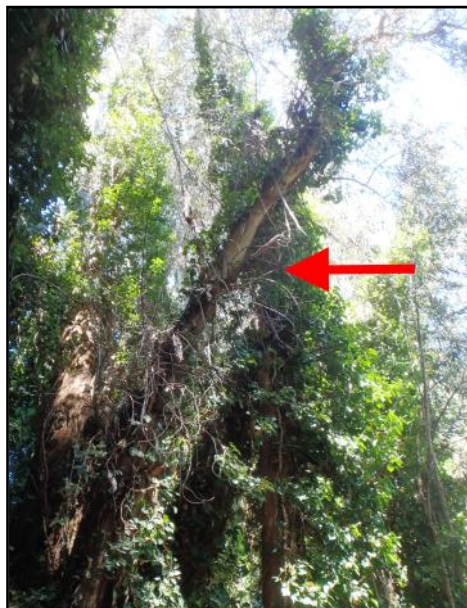
Above: Arrow points to blue gum #532.

| Comments | Codominant trunks at 40'; upright form; engulfed in ivy. |

| Most likely failure | Branch |
| Failure potential | 2 |

| Risk reduction options | To reduce risk, prune to reduce branch weight & extension W.; to eliminate risk, remove tree. |

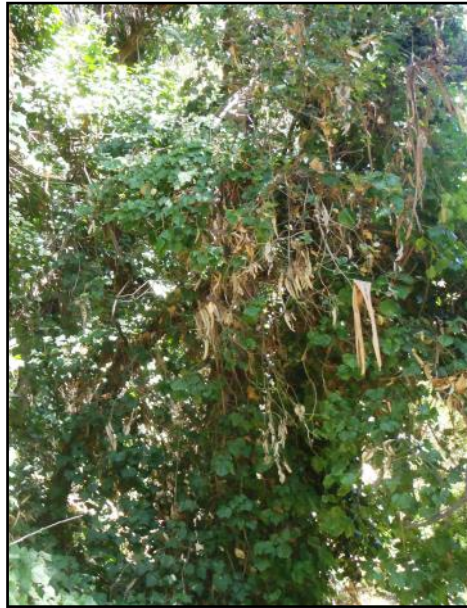
| Comments | Suppressed; crown bowed S. to horizontal; engulfed in ivy. |

Above: Coast live oak #533 was suppressed and leaning S.

| Most likely failure | Whole tree |
| Failure potential | 2 |

| Risk reduction options | To eliminate risk, remove tree. |

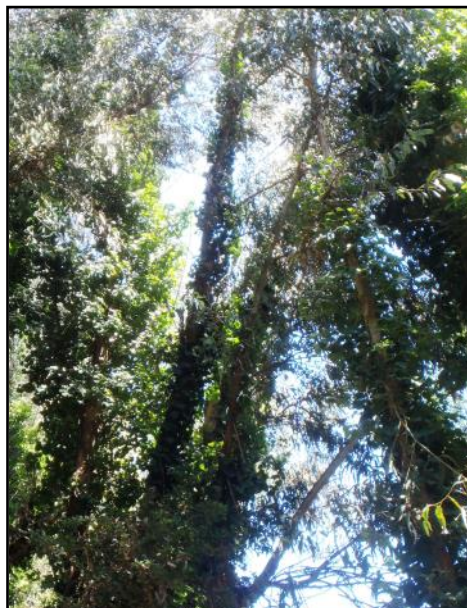
| Comments | Multiple attachments at 4'; one stem up-right; two stems lean SW. over creek; engulfed in ivy. |

Above: Looking E. at blue gum #534 (center).

| Most likely failure | Stem |
| Failure potential | 3 |

| Risk reduction options | To reduce risk, remove or reduce stems SW.; to eliminate risk, remove tree. |

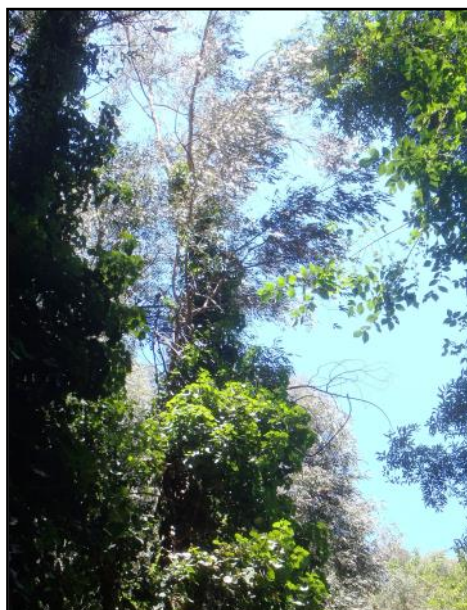
| Comments | Leans S. over creek;<br>engulfed in ivy. |

Above: Looking up at the canopy of blue gum #535.

| Most likely failure | Whole tree |
| Failure potential | 2 |

| Risk reduction options | To eliminate risk,<br>remove tree. |

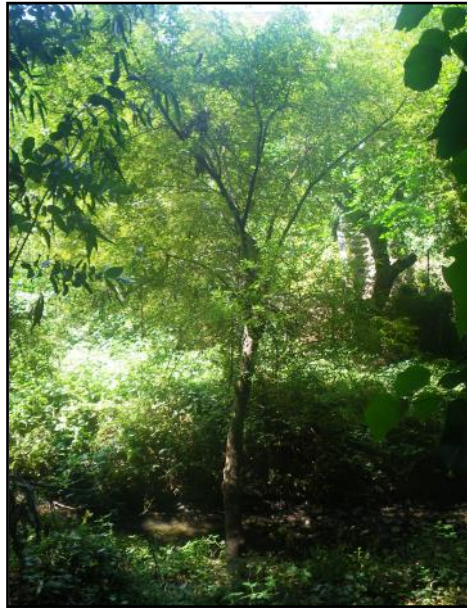
| Comments | Leans S. over creek;<br>trunk wound E. |

Above: This young arroyo willow was in good condition.

| Most likely failure | Branch |
| Failure potential | 2 |

| Risk reduction options | To eliminate risk, remove tree. |

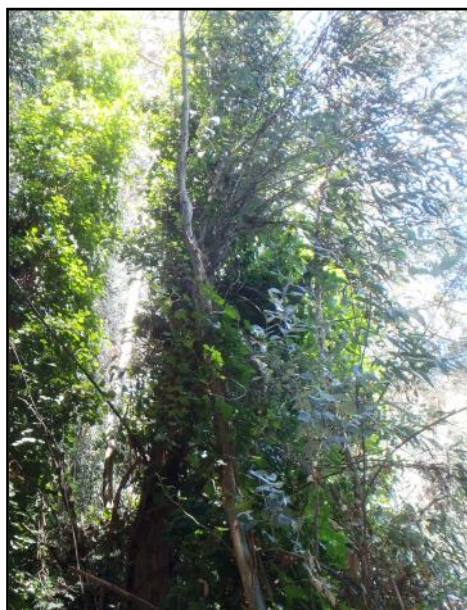
| Comments | Codominant trunks at base; leans S. over creek; trunk wounds; engulfed in ivy. |

Above: Looking E. at blue gum #537 (center).

| Most likely failure | Stem |
| Failure potential | 2 |

| Risk reduction options | To reduce risk, remove or reduce stems S.; to eliminate risk, remove tree. |

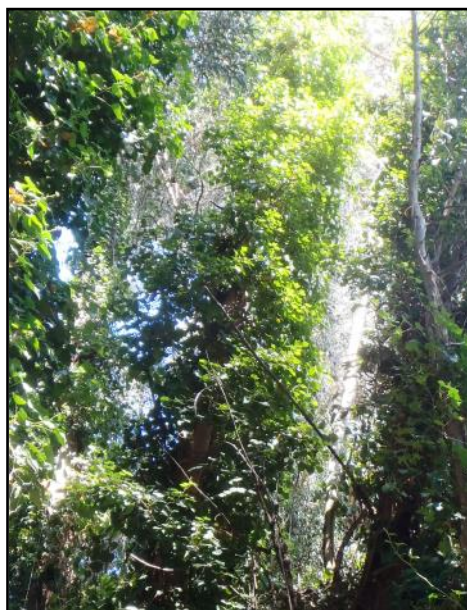
| Comments | Slight lean S. over creek; engulfed in ivy. |

Above: Blue gum #538 (center) is hard to distinguish.

| Most likely failure | Branch |
| Failure potential | 1 |

| Risk reduction options | To eliminate risk, remove tree. |

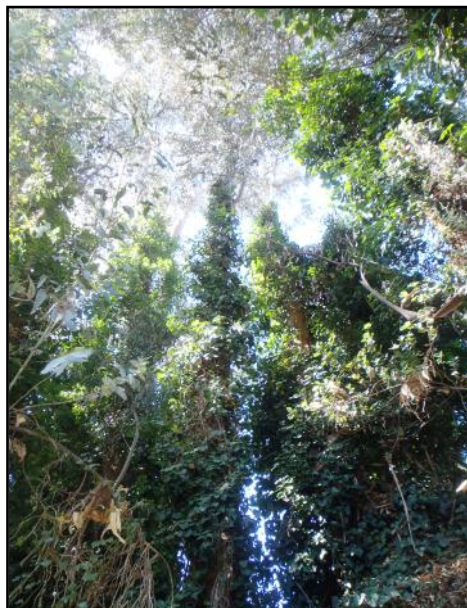
| Comments | Upright form; trunk wound W. @ 4'; engulfed in ivy. |

Above: Blue gum #539 (center) had an upright form.

| Most likely failure | Branch |
| Failure potential | 2 |

| Risk reduction options | To reduce risk, prune to reduce branch weight & extension SE.; to eliminate risk, remove tree. |

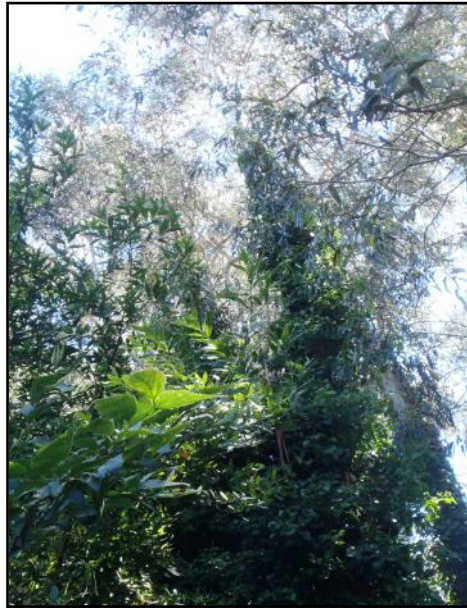
| Comments | Codominant trunks at 3'; topped at 20'; small regrowth on N. stem; engulfed in ivy. |

Above: Blue gum #540 was engulfed in ivy and is hard to distinguish.

| Most likely failure | Branch |
| Failure potential | 3 |

| Risk reduction options | To reduce risk, prune to shorten or remove regrowth from topping points; to eliminate risk, remove tree. |

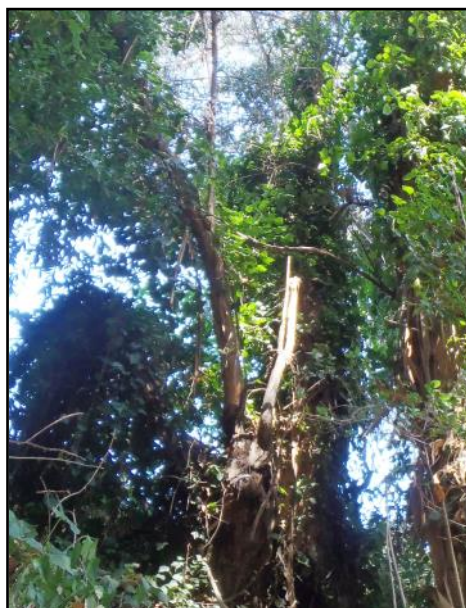
| Comments | Codominant trunks at base; one stem dead; other topped at 20'; small re-growth; small basal cavity; engulfed in ivy. |

Above: This blue gum was in poor condition, with one stem dead.

| Most likely failure | Branch |
| Failure potential | 2 |

| Risk reduction options | To reduce risk, prune to shorten or remove regrowth from topping points; to eliminate risk, remove tree. |

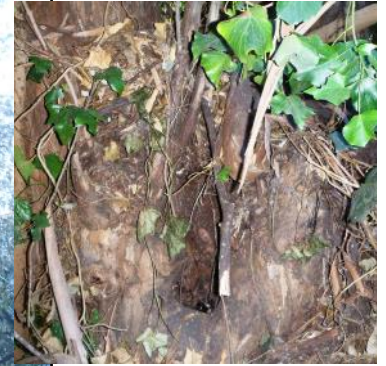
| Comments | Codominant trunks at 3'; basal wounds & decay N.; topped at 20'; 2-6" re-growth; engulfed in ivy. |

Inset shows basal cavity and decay.

Above: The 2-6" regrowth can be seen emerging from the topping point at ~20'.

| Most likely failure | Branch |
| Failure potential | 3 |

| Risk reduction options | To reduce risk, prune to shorten or remove regrowth from topping points; to eliminate risk, remove tree. |

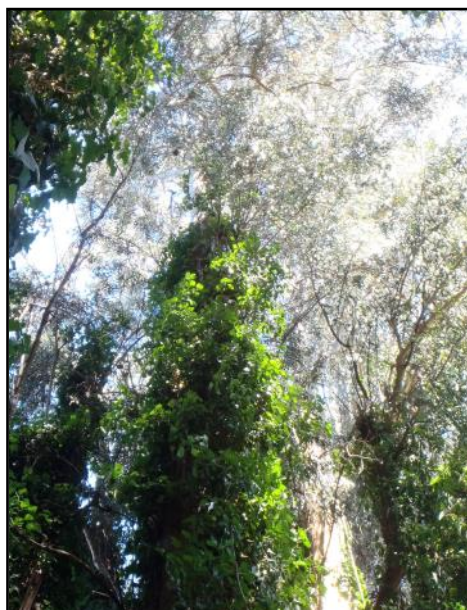
| Comments | Upright form; majority of crown SW.; engulfed in ivy. |

Above: Looking up at the canopy of blue gum #543 (center).

| Most likely failure | Branch |
| Failure potential | 2 |

| Risk reduction options | To reduce risk, prune to reduce branch weight & extension SW.; to eliminate risk, remove tree. |

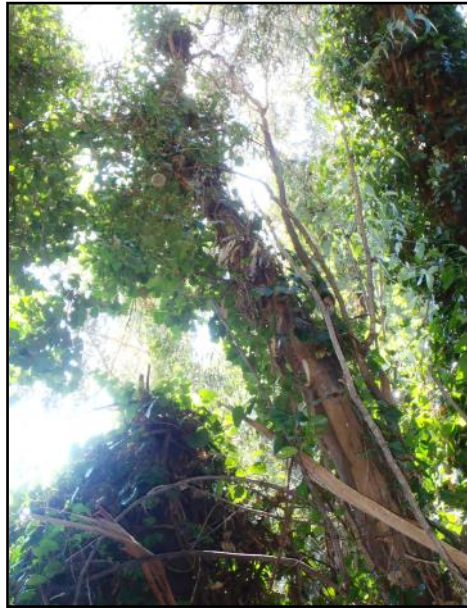
| Comments | Stump sprout; basal decay; 8" regrowth leans S. To creek; engulfed in ivy. |

Above: This stump sprout was in poor condition and leaned S.

| Most likely failure | Stem |
| Failure potential | 3 |

| Risk reduction options | To eliminate risk, remove tree. |

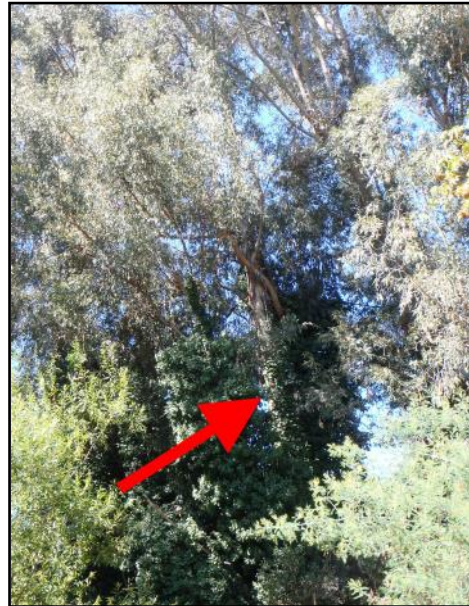
Above: Arrow points to blue gum #545.

| Comments | Codominant trunks at 3'; 10" stem bowed S. to creek; 40" stem one sided; engulfed in ivy. |

| Most likely failure | Branch |
| Failure potential | 2 |

| Risk reduction options | To reduce risk, prune to reduce branch weight & extension S.; to eliminate risk, remove tree. |

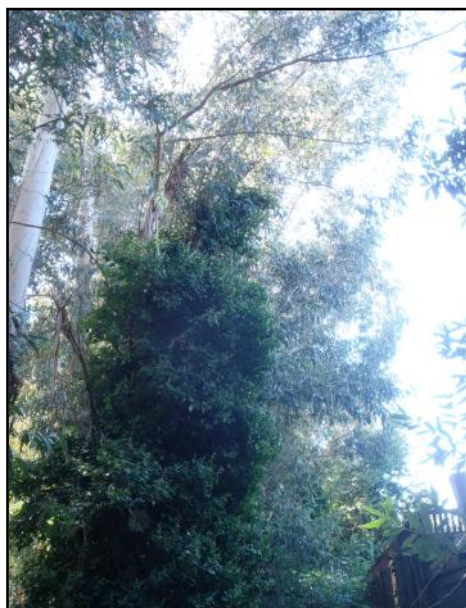
| Comments | Codominant trunks at base; topped at 20'; 2-6" regrowth; engulfed in ivy. |

Above: Looking W. at the canopy of blue gum #546.

| Most likely failure | Branch |
| Failure potential | 3 |

| Risk reduction options | To reduce risk, prune to shorten or remove regrowth from topping points; to eliminate risk, remove tree. |

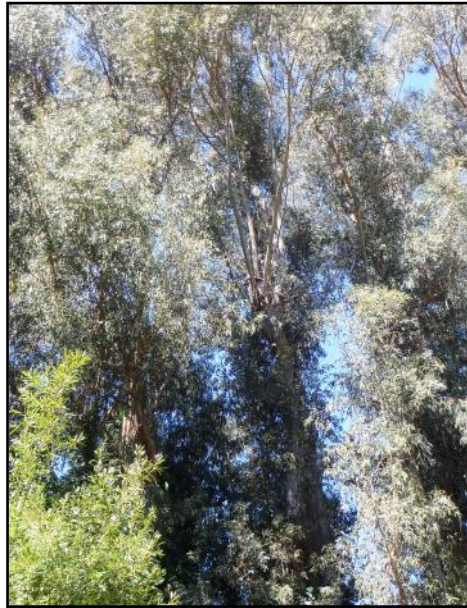
| Comments | Codominant trunks at 6'; N. stem up-right; S. stem crooked at 30' toward creek; engulfed in ivy. |

Above: Looking N. at blue gum #547 (center).

| Most likely failure | Branch |
| Failure potential | 2 |

| Risk reduction options | To reduce risk, prune to reduce branch weight & extension S.; to eliminate risk, remove tree. |

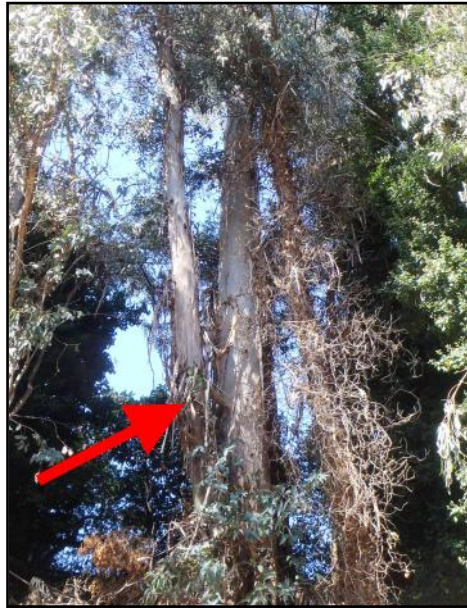
Above: Arrow points to base of blue gum #548.

| Comments | Codominant trunks at 4'; N. stem up-right; S. stem bowed toward creek. |

| Most likely failure | Branch |
| Failure potential | 2 |

| Risk reduction options | To reduce risk, prune to reduce branch weight & extension S.; to eliminate risk, remove tree. |

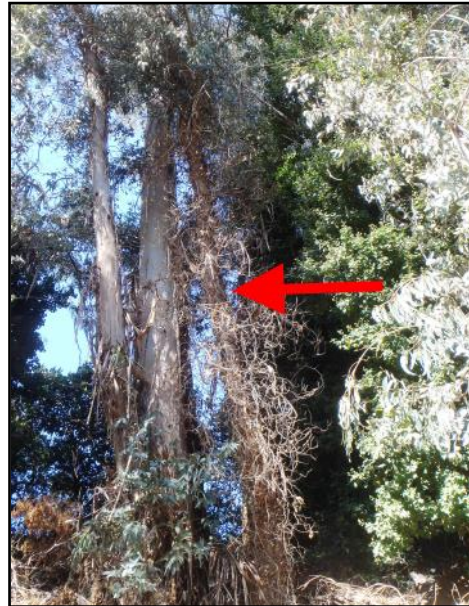
Above: Arrow points to blue gum #549.

| Comments | Suppressed; lost top; leans S. toward creek. |

| Most likely failure | Branch |
| Failure potential | 2 |

| Risk reduction options | To eliminate risk, remove tree. |

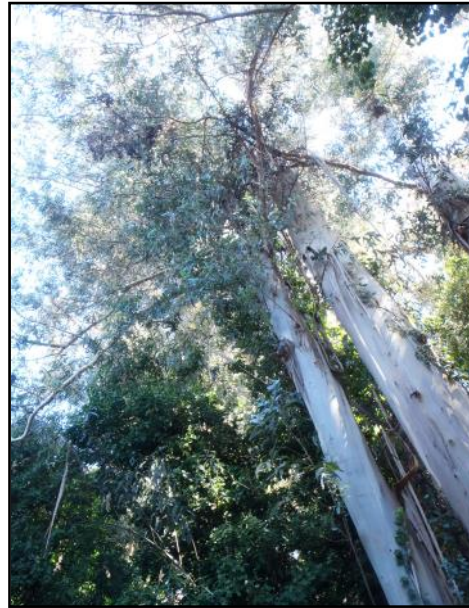
| Comments | Codominant trunks at 2'; N. stem topped at 20' w/ small re-growth; S. stem up-right. |

Above: Looking up at the canopy of this two-trunked blue gum.

| Most likely failure | Branch |
| Failure potential | 2 |

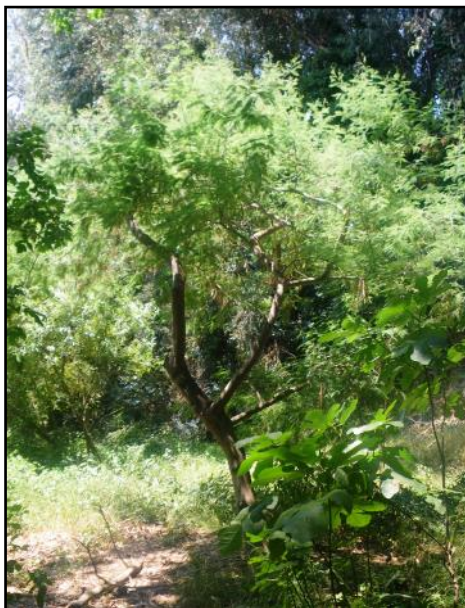
| Comments | Leans SW.; lost top. |

Above: This small Bailey acacia was growing on the bench below the blue gums.

| Risk reduction options | To reduce risk, prune to reduce branch weight & extension N.; to eliminate risk, remove tree. |

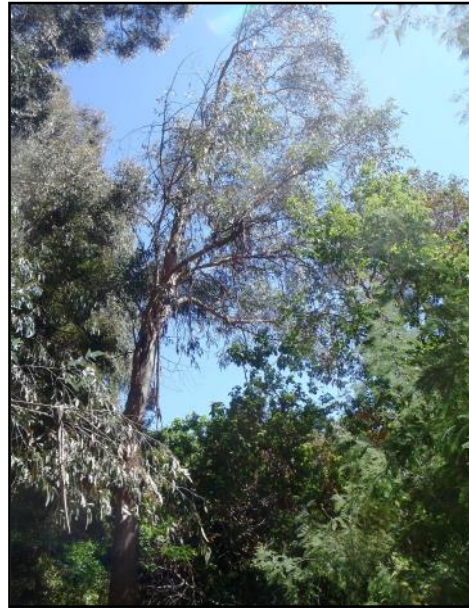
| Comments | Crown bowed S.;<br>long lateral SE. |

Above: The crown of blue gum #552 was bowed SE.

| Risk reduction options | To reduce risk, prune to reduce branch weight & extension SE.; to eliminate risk, remove tree. |

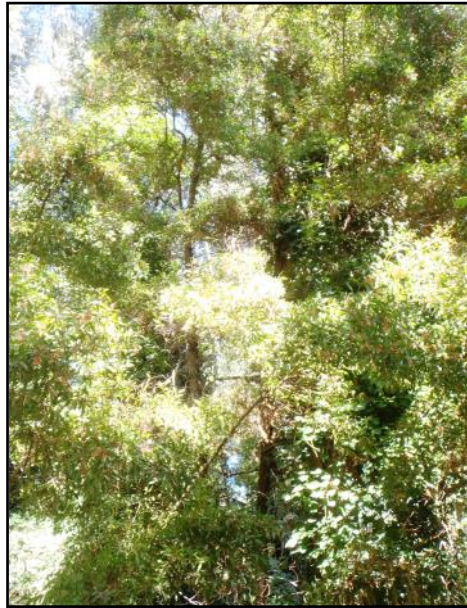
| Comments | Codominant trunks at base; S. stem lost top & leans S.; |

Above: The crown of blackwood acacia #553 fills the photo.

| Risk reduction options | To reduce risk, remove or reduce stem S.; to eliminate risk, remove tree. |

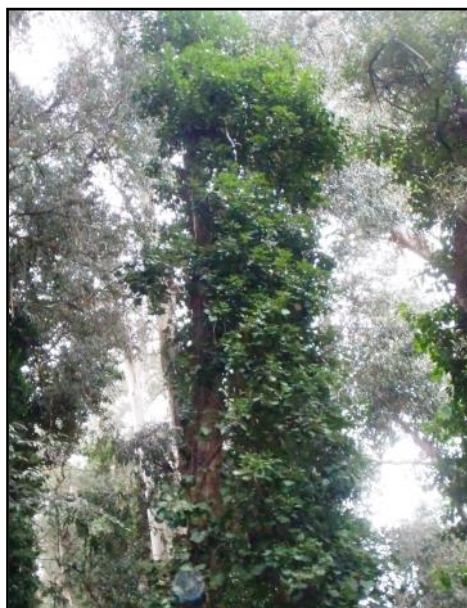
| Comments | Stump sprout;<br>stump decayed; lateral S.; engulfed in ivy. |

Above: Stump sprout #554 was engulfed in ivy.

| Risk reduction options | To eliminate risk, remove tree. |

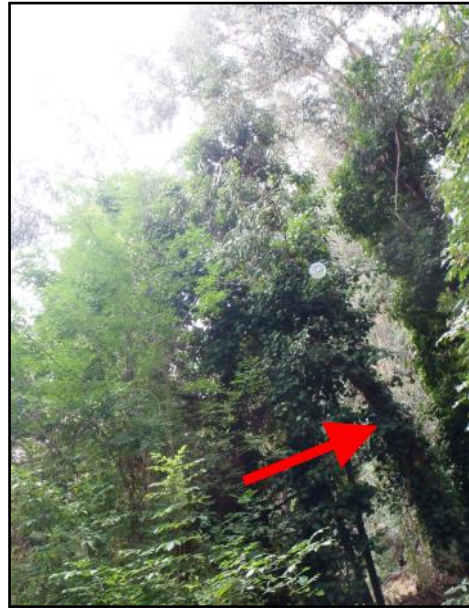
| Comments | Codominant trunks at 10'; narrow attachment; S. stem lost top & leans S.; engulfed in ivy. |

Above: Arrow points to base of blue gum #555.

| Risk reduction options | To reduce risk, remove or reduce stem S.; to eliminate risk, remove tree. |

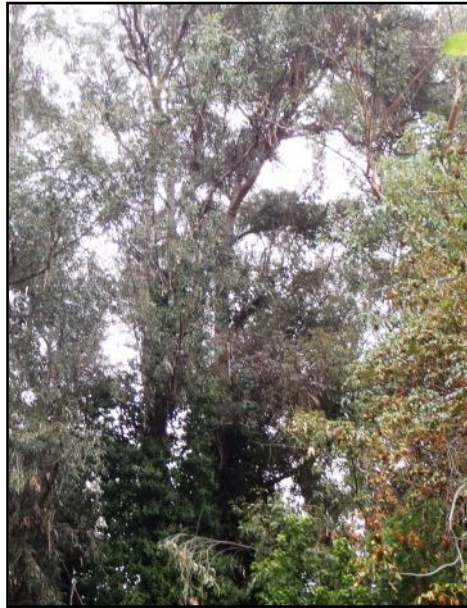
| Comments | Suppressed; upper crown bowed S.; dead wood; engulfed in ivy. |

Above: Looking E. at blue gum #556 (center).

| Risk reduction options | To reduce risk, prune to reduce branch weight & extension S.; to eliminate risk, remove tree. |

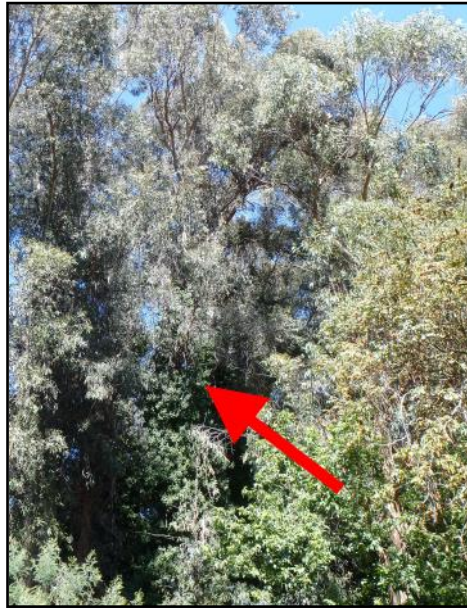
| Comments | Upright form; one sided SE.; laterals S. & E. in upper crown; engulfed in ivy. |

Above: Arrow points to base of blue gum #557.

| Risk reduction options | To reduce risk, prune to reduce branch weight & extension S. & E.; to eliminate risk, remove tree. |

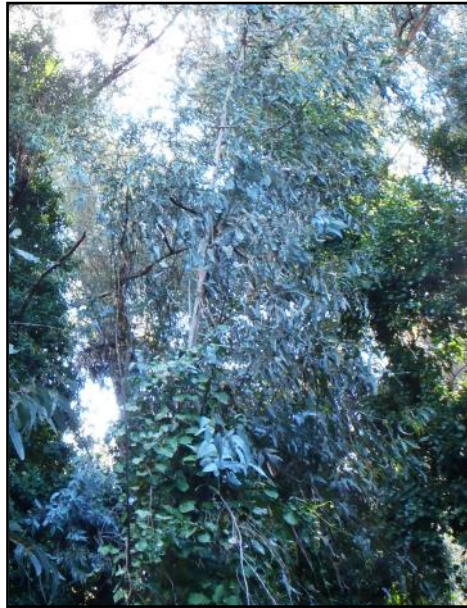
| Comments | Suppressed; upper crown bowed S. to horizontal; basal cankers; engulfed in ivy. |

Above: Blue gum #558 was suppressed and engulfed in ivy.

| Risk reduction options | To reduce risk, prune to reduce branch weight & extension S.; to eliminate risk, remove tree. |

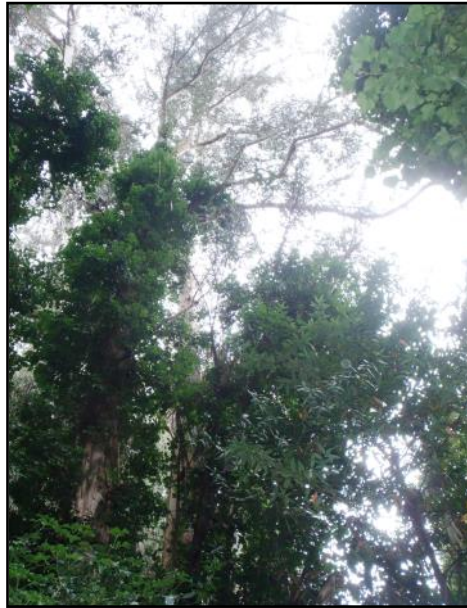
| <b>Comments</b> | Codominant trunks at base; 30" stem one sided N. w/ laterals N.; 10" stem suppressed; engulfed in ivy. |

Above: Looking up at the canopy of blue gum #559.

| <b>Risk reduction options</b> | To reduce risk, prune to reduce branch weight & extension N.; to eliminate risk, remove tree. |

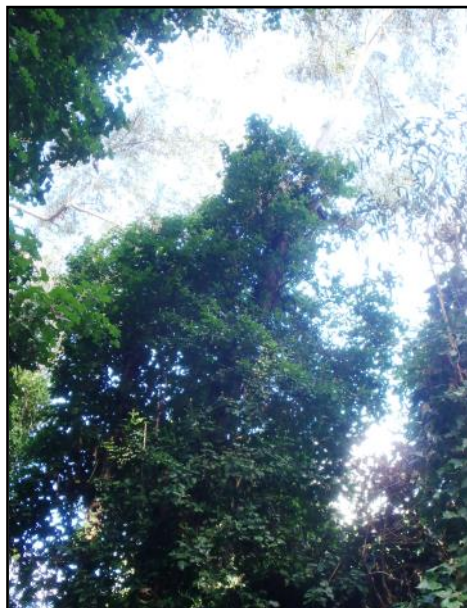
| Comments | Codominant trunks at base; suppressed & leaning N.; engulfed in ivy. |

Above: The upper crown on blue gum #560 is hard to distinguish.

| Risk reduction options | To eliminate risk, remove tree. |

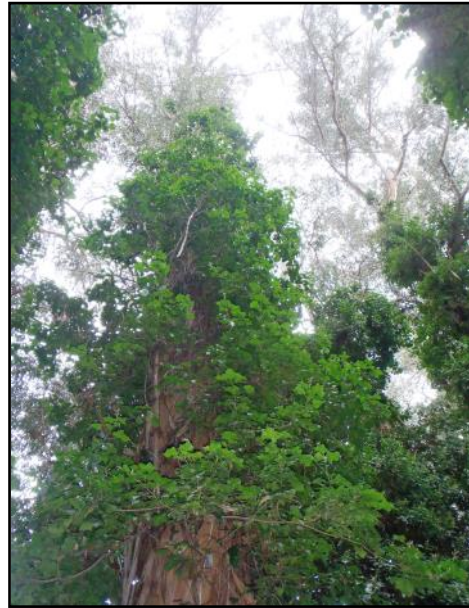
| Comments | High, narrow crown;<br>epicormics; small<br>laterals N.; engulfed<br>in ivy. |

Above: Blue gum #561 was upright, with a narrow crown.

| Risk reduction options | To reduce risk, prune to reduce branch weight & extension N.; to eliminate risk, remove tree. |

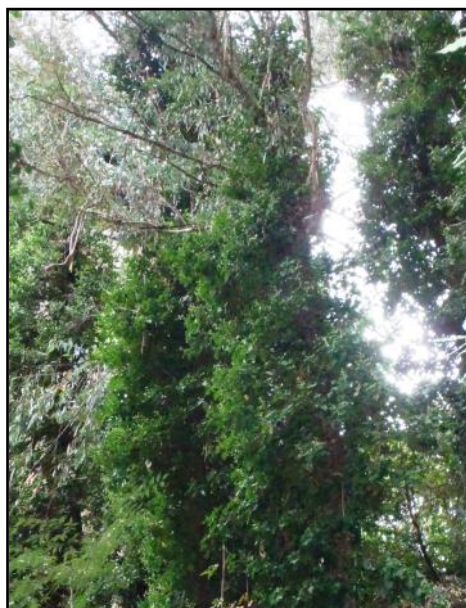
| Comments | Suppressed; upper crown bowed S.; engulfed in ivy. |

Above: Looking W. at this young blue gum.

| Risk reduction options | To eliminate risk, remove tree. |

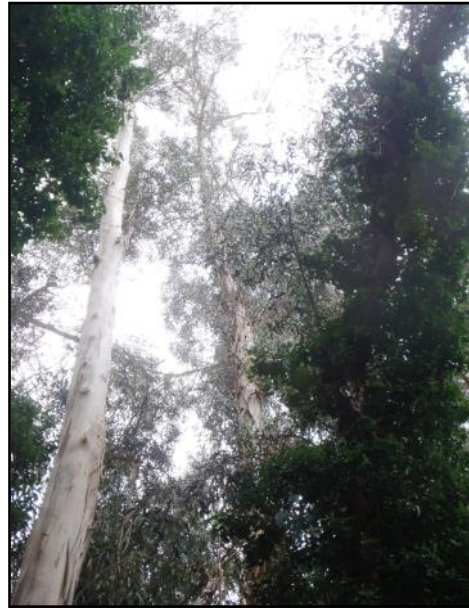
| Comments | High crown bowed N.; epicormics; laterals N.; engulfed in ivy. |

Above: Looking up at the canopy of blue gum #563 (center).

| Risk reduction options | To reduce risk, prune to reduce branch weight & extension N.; to eliminate risk, remove tree. |

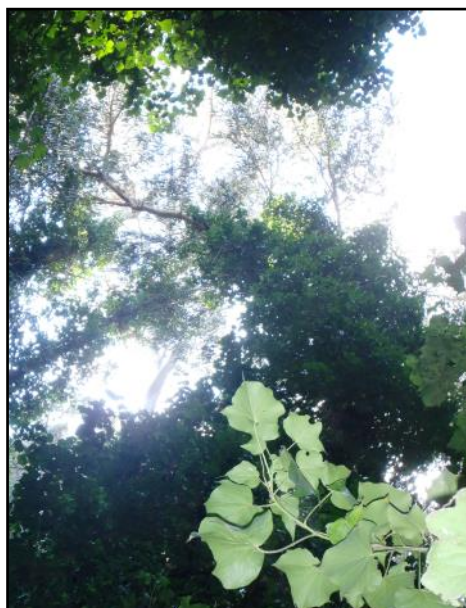
| Comments | Suppressed; crown bowed N. to horizontal; engulfed in ivy. |

Above: Looking up at the canopy of blue gum #564.

| Risk reduction options | To eliminate risk, remove tree. |

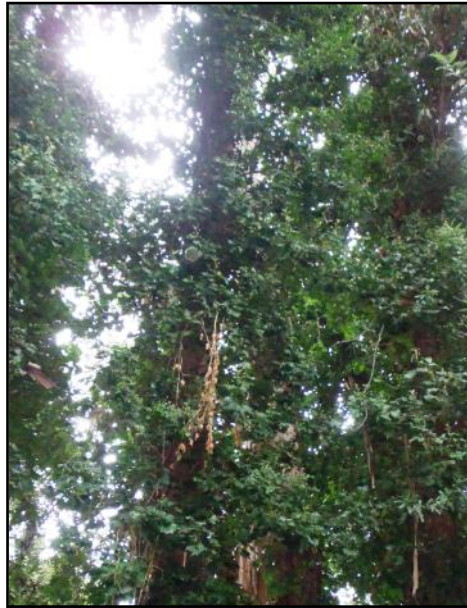
| Comments | Suppressed; leans S.; engulfed in ivy. |

Above: Blue gum #565 (center) was suppressed and engulfed in ivy.

| Risk reduction options | To eliminate risk, remove tree. |

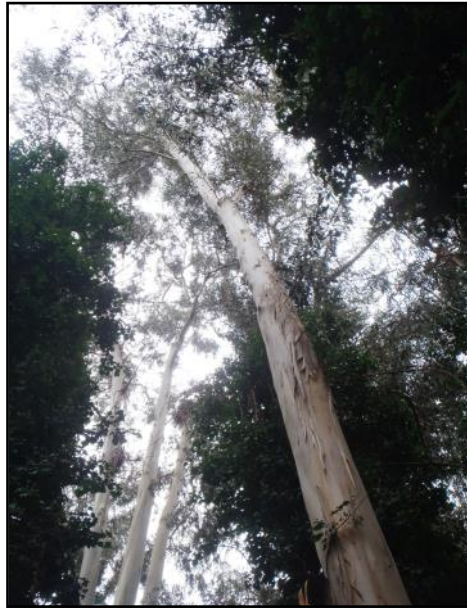
| Comments | High crown bowed E.; ribbing on tension side at 20'; ivy. |

Above: Looking up at the high crown of blue gum #566.

| Risk reduction options | To reduce risk, prune to reduce crown weight & extension E.; to eliminate risk, remove tree. |

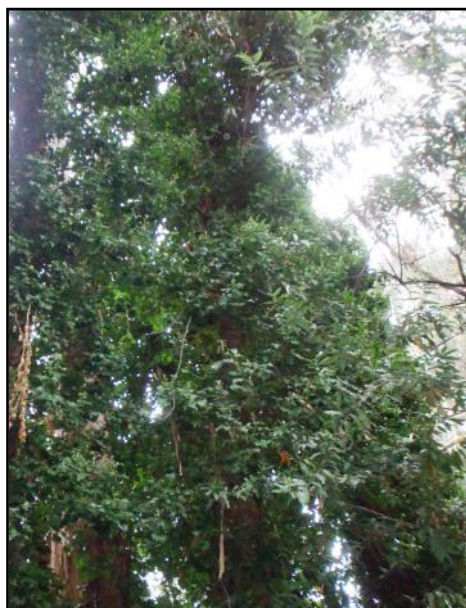
| Comments | Suppressed; small crown; one sided S.; engulfed in ivy. |

Above: Blue gum #567 (center) was suppressed and engulfed in ivy.

| Risk reduction options | To eliminate risk, remove tree. |

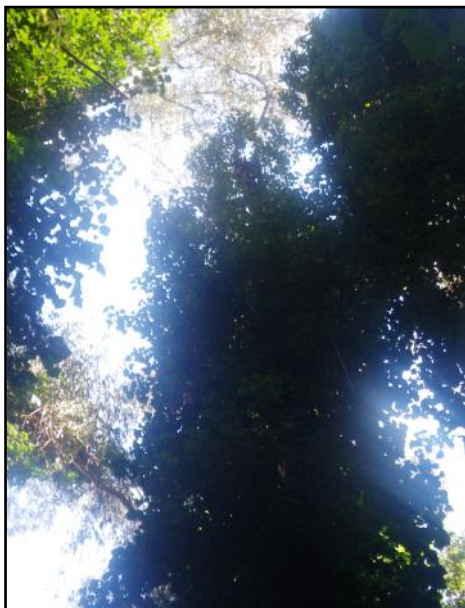
| Comments | Suppressed; small crown; leans N.; engulfed in ivy. |

Above: Blue gum #568 was engulfed in ivy.

| Risk reduction options | To eliminate risk, remove tree. |

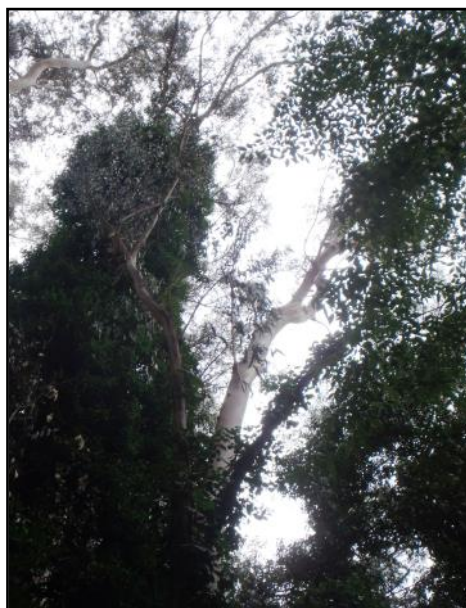
| Comments | Upright form; laterals E. in upper crown; engulfed in ivy. |

Above: Looking up at the crown of blue gum #569, the tree was engulfed in ivy.

| Risk reduction options | To reduce risk, prune to reduce branch weight & extension N.; to eliminate risk, remove tree. |

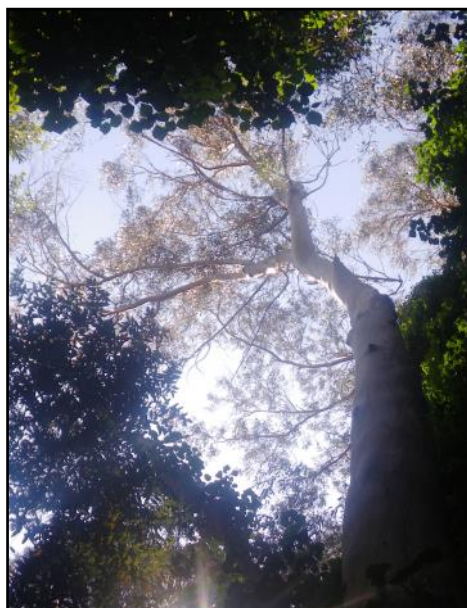
| Comments | Leans N.; crook at 35'; poor form and structure. |

Above: Looking up at the canopy of blue gum #570, showing the crook and lateral limbs.

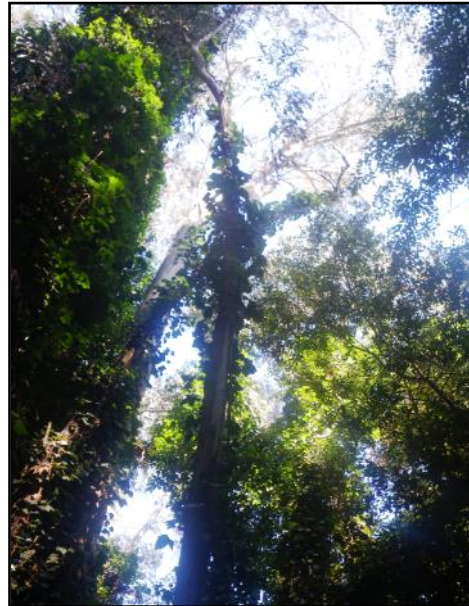
| Comments | Suppressed; small crown; leans E.; ivy. |

Above: Blue gum #571 (center) was small and suppressed.

| Risk reduction options | To eliminate risk, remove tree. |

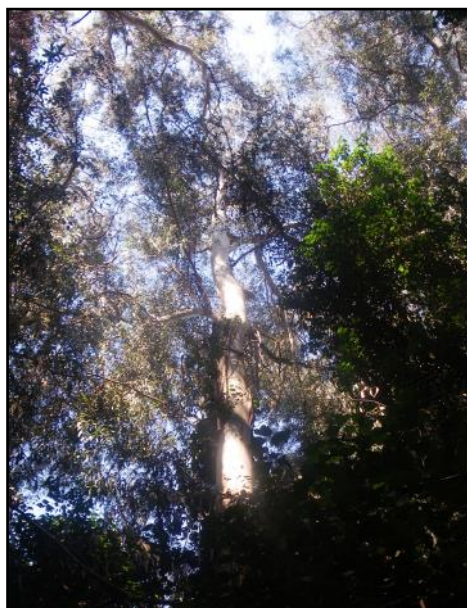
| Comments | Upright form; basal canker; deadwood & laterals W.; ivy. |

Above: Blue gum #572 (center) is difficult to distinguish.

| Risk reduction options | To reduce risk, prune to reduce branch weight & extension W.; to eliminate risk, remove tree. |

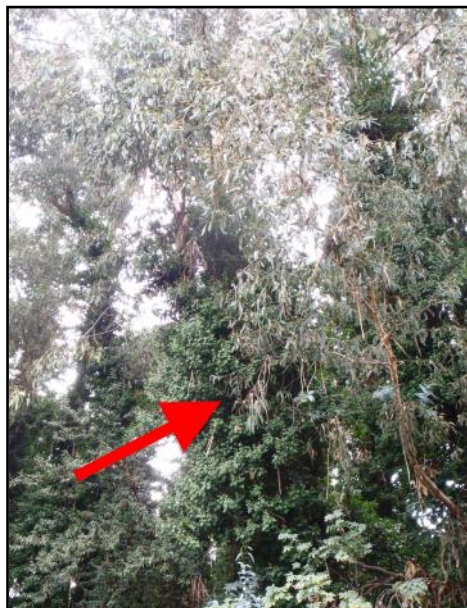
| Comments | Leans S.; basal decay; engulfed in ivy. |

Above: Arrow points to base of blue gum #573.

| Risk reduction options | To eliminate risk, remove tree. |

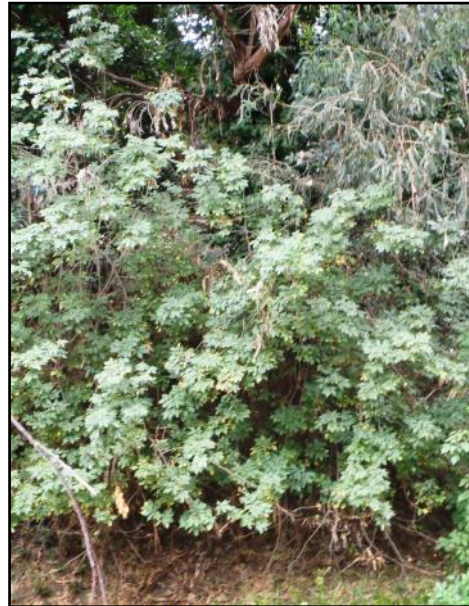
| Comments | Suppressed; crown bowed S.; basal decay. |

Above: This small buckeye was growing along the lower bank.

| Risk reduction options | To eliminate risk, remove tree. |
