# San Leandro Creek Tree Assessment

February 24, 2015

County of Alameda  
Flood Control and Water Conservation District  
399 Elmhurst Street  
Hayward, CA 94544-1395

URS Corporation  
1333 Broadway, Suite 800  
Oakland, CA 94612

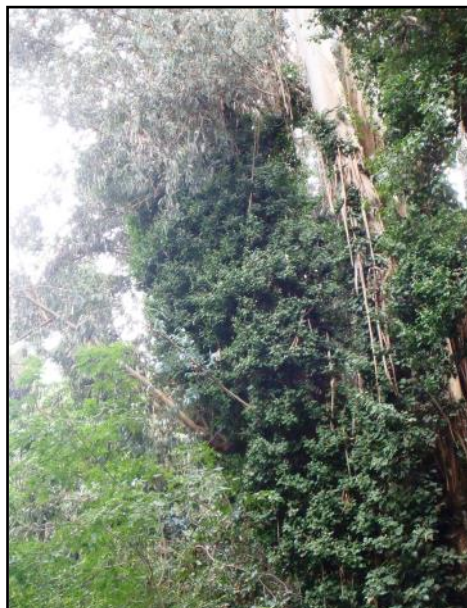
| Comments | Leans S.; sup-pressed; engulfed in ivy. |

Above: Looking W. at blue gum #575 (Left).

| Risk reduction options | To eliminate risk, remove tree. |

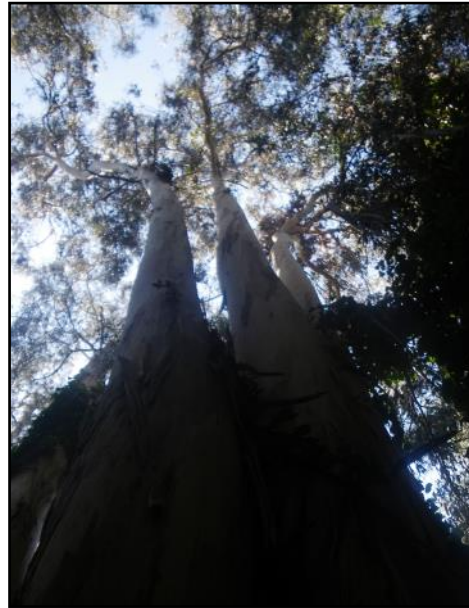
| Comments | Three stems upright w/ included bark; one stem suppressed and leaning S.; laterals S. & W. in upper crown. |

Above: Looking up at the canopy of blue gum #576.

| Risk reduction options | To reduce risk, prune to reduce branch weight & extension S. & W.; to eliminate risk, remove tree. |

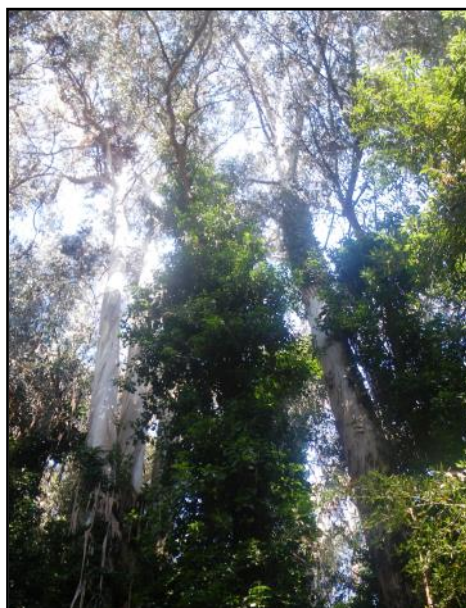
| Comments | Upper crown bowed S.; suppressed; engulfed in ivy. |

Above: Blue gum #577 (center) was suppressed among its larger neighbors.

| Risk reduction options | To reduce risk, prune to reduce branch weight & extension S.; to eliminate risk, remove tree. |

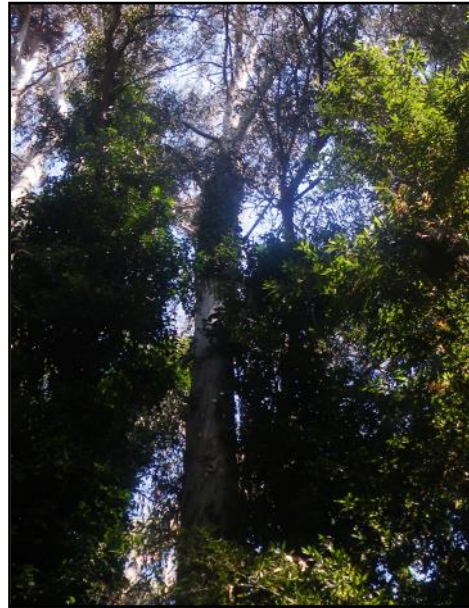
| Comments | One stem upright;<br>one stem sup-<br>pressed and bowed<br>N.; heavy lateral<br>limb SE. in upper<br>crown. |

Above: Only the upright stem of blue gum #578 (center) is shown.

| Risk reduction options | To reduce risk, prune to reduce branch weight & extension SE.; to eliminate risk, remove tree. |

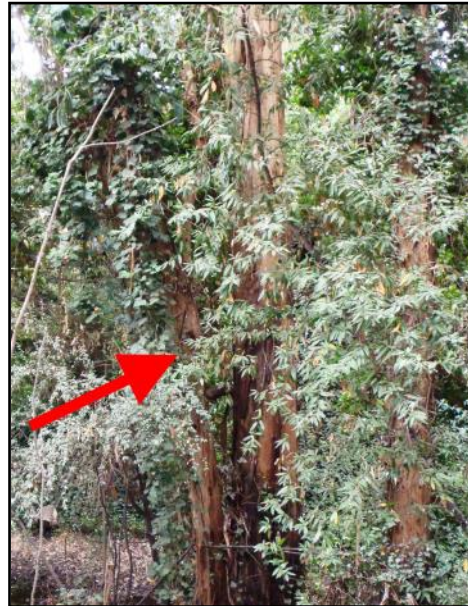
| Comments | Suppressed; small crown bowed SE.; ivy. |

Above: Arrow points to blue gum #579.

| Risk reduction options | To eliminate risk, remove tree. |

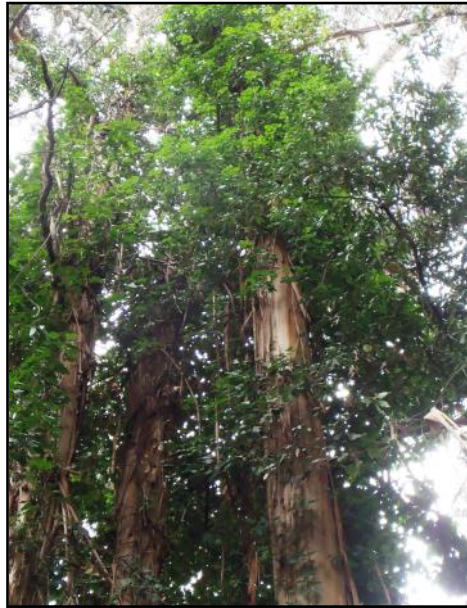
| Comments | Upright form; small laterals N. in upper crown; engulfed in ivy. |

Above: Looking up at the canopy of blue gum #580.

| Risk reduction options | To reduce risk, prune to reduce branch weight & extension N.; to eliminate risk, remove tree. |

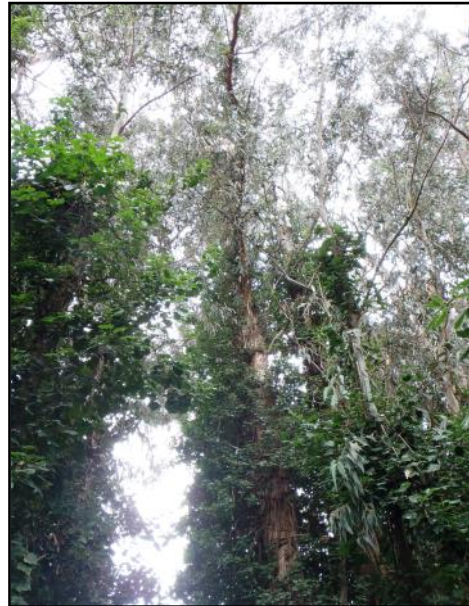
| Comments | Codominant trunks at 8'; laterals N. & S.; engulfed in ivy. |

Above: Blue gum #581 (center) had a narrow form.

| Risk reduction options | To reduce risk, prune to reduce branch weight & extension S. & N.; to eliminate risk, remove tree. |

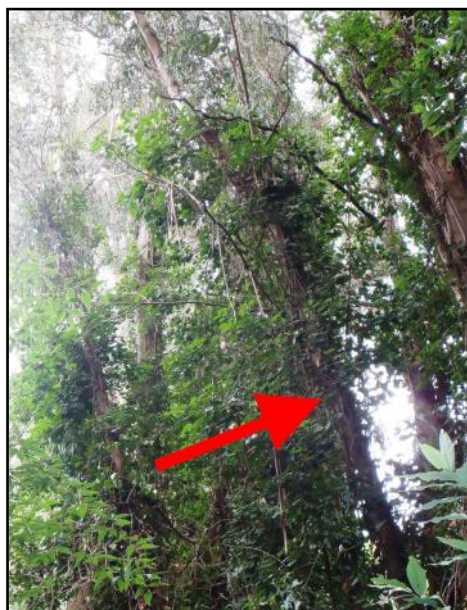
| Comments | Suppressed; crook at 25'; crown bowed N. |

Above: Arrow points to blue gum #583.

| Risk reduction options | To reduce risk, prune to reduce branch weight & extension N.; to eliminate risk, remove tree. |

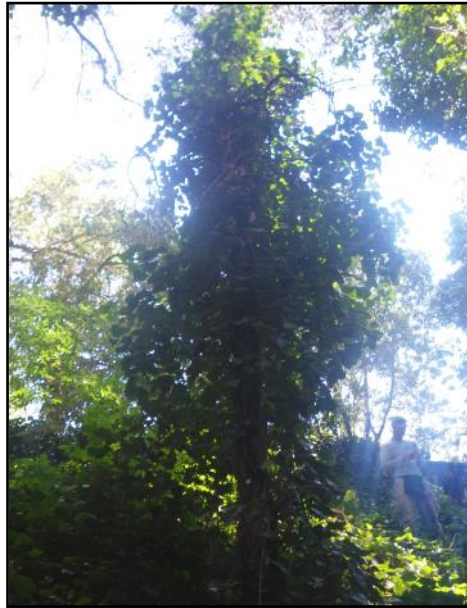
| Comments | Suppressed; small crown; slight lean N. |

Above: Looking N. at this small blue gum.

| Risk reduction options | To eliminate risk, remove tree. |

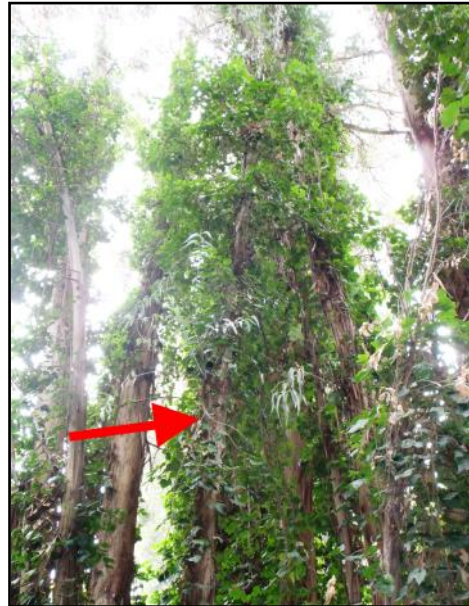
| Comments | Suppressed; lost top; engulfed in ivy. |

Above: Arrow points to blue gum #585.

| Risk reduction options | To eliminate risk, remove tree. |

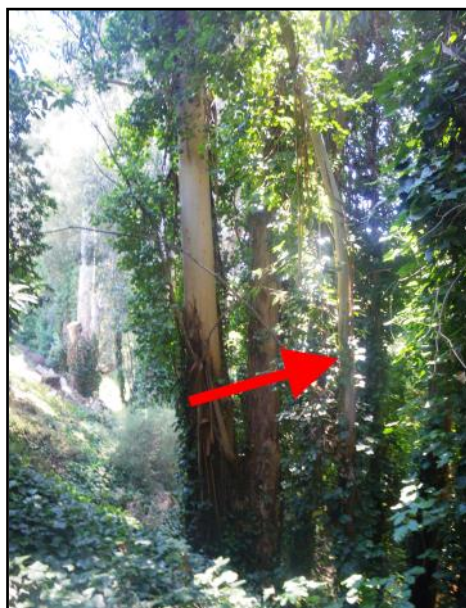
| Comments | Suppressed; crook at 20'; crown bowed N.; ivy. |

Above: Arrow points to blue gum #586.

| Risk reduction options | To eliminate risk, remove tree. |

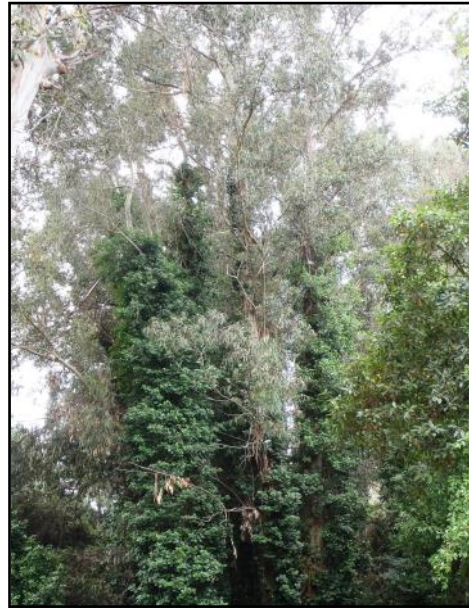
| Comments | Multiple attachments at 5'; one stem suppressed and leaning E.; laterals S. in upper crown; engulfed in ivy. |

Above: Looking W. at blue gum #587 (foreground).

| Risk reduction options | To reduce risk, prune to reduce branch weight & extension S.; to eliminate risk, remove tree. |

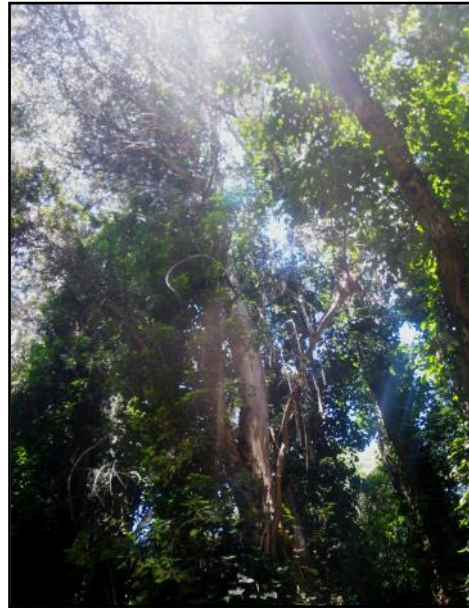
| Comments | Trunk wound w/ decay W.; one sided S.; poor form and structure; engulfed in ivy. |

Above: Looking up at the canopy of blue gum #588.

| Risk reduction options | To eliminate risk, remove tree. |

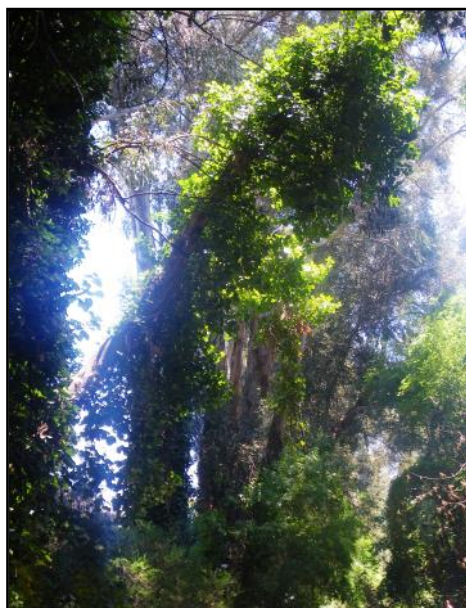
| Comments | Leans SE.; failing at base. |

Above: This small blue gum was failing at the base.

| Risk reduction options | To eliminate risk, remove tree. |

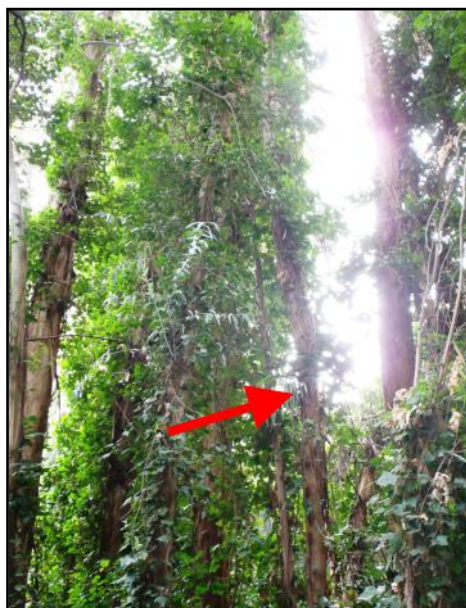
| Comments | Suppressed; narrow crown; ivy. |

Above: Arrow points to blue gum #590.

| Risk reduction options | To eliminate risk, remove tree. |

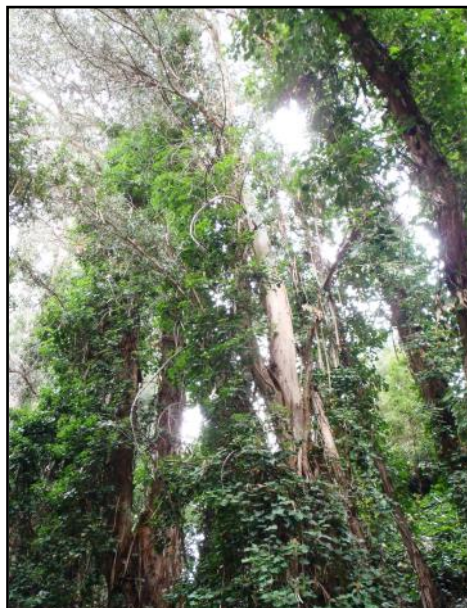
| Comments | Growing against #588; one sided S.; engulfed in ivy. |

Above: Blue gum #591 (center) was one sided S.

| Risk reduction options | If #588 is removed, may have to remove tree. |

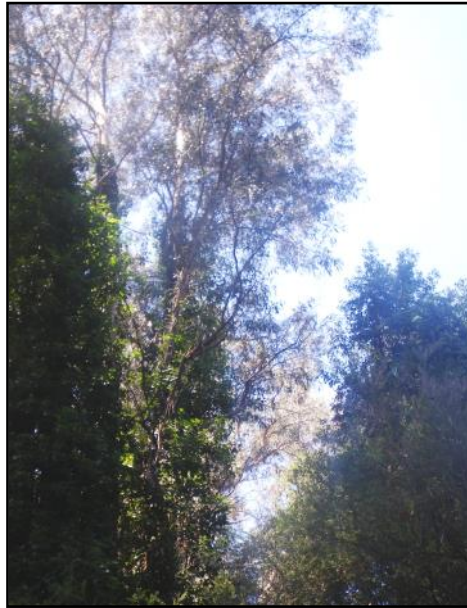
| Comments | One sided S.; laterals S.; engulfed in ivy. |

Above: Looking E. at blue gum #592.

| Risk reduction options | To reduce risk, prune to reduce branch weight & extension S.; to eliminate risk, remove tree. |

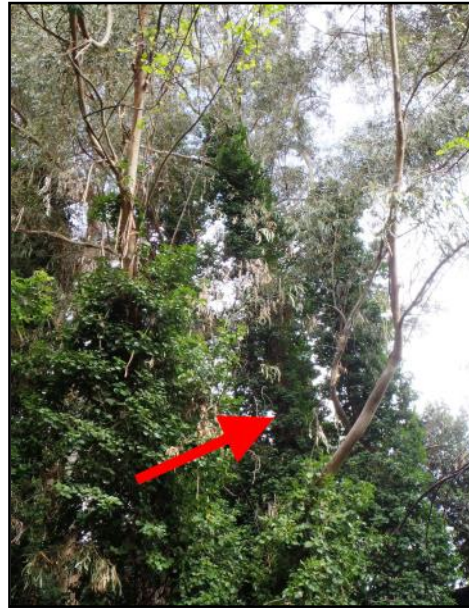
| Comments | Crook at 40'; one sided S.; laterals S.; engulfed in ivy. |

Above: Arrow points to blue gum #593.

| Risk reduction options | To reduce risk, prune to reduce branch weight & extension S.; to eliminate risk, remove tree. |

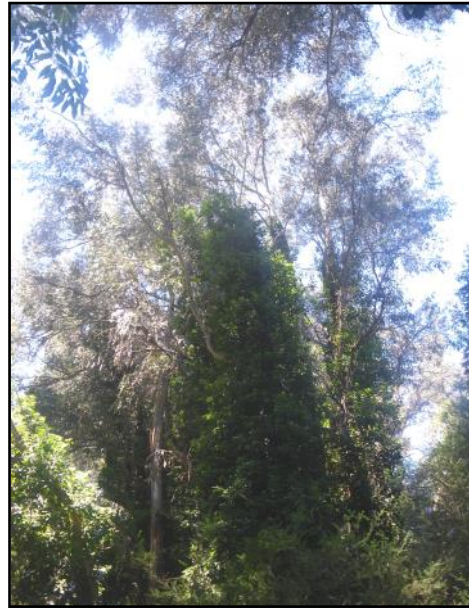
| Comments | One sided SE.; lateral S. @ 25'; engulfed in ivy. |

Above: Looking W. at blue gum #594.

| Risk reduction options | To reduce risk, prune to reduce branch weight & extension S.; to eliminate risk, remove tree. |

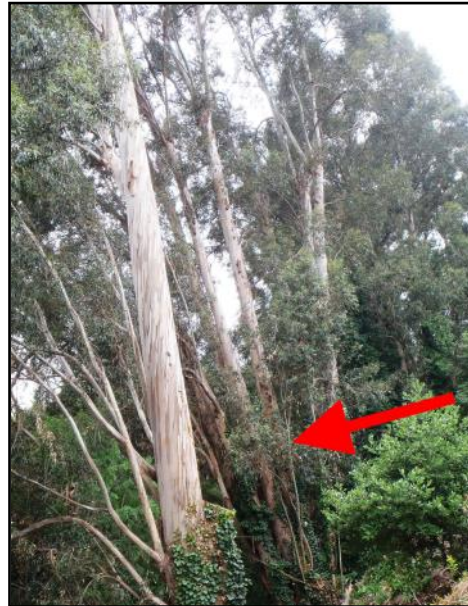
| Comments | Multiple attachments at 6'; old topping points at 50'; one sided S.; 20" stem suppressed & bowed S.; engulfed in ivy; debris piled on uphill side. |

Above: Arrow points to blue gum #596.

| Risk reduction options | To reduce risk, remove or reduce stem S.; to eliminate risk, remove tree. |

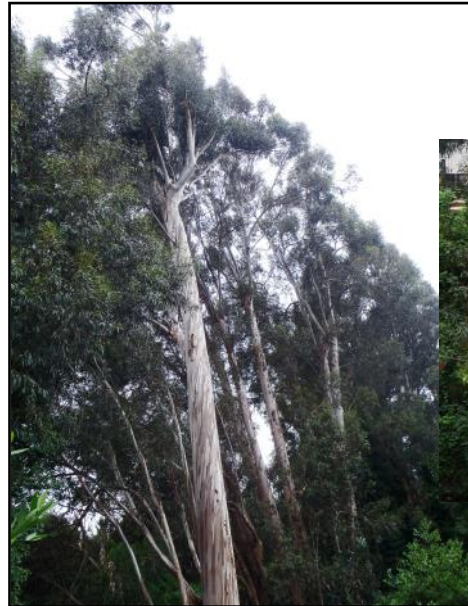
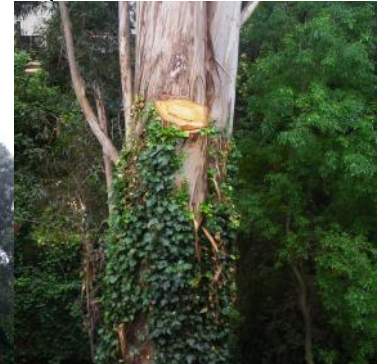
| Comments | Two stems & branches N. recently removed; laterals S.; lower trunk engulfed in ivy; debris piled on uphill side. |

Inset shows the large stem removed.

Above: Looking up at the canopy of blue gum #597.

| Risk reduction options | To reduce risk, prune to reduce branch weight & extension S.; to eliminate risk, remove tree. |

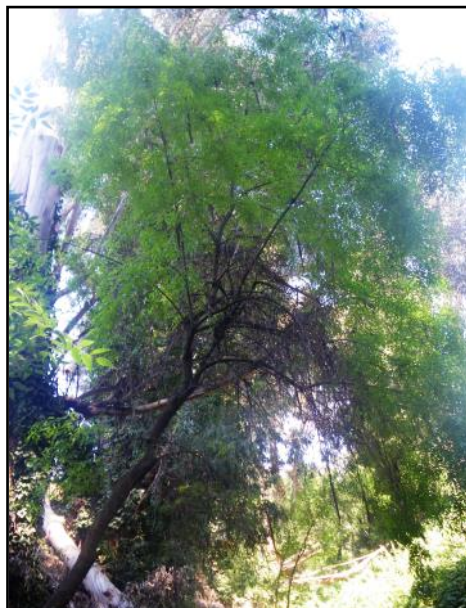
| Comments | Suppressed; leans S.; crook at 20'. |

Above: This small ash was suppressed and leaning S.

| Risk reduction options | To eliminate risk, remove tree. |

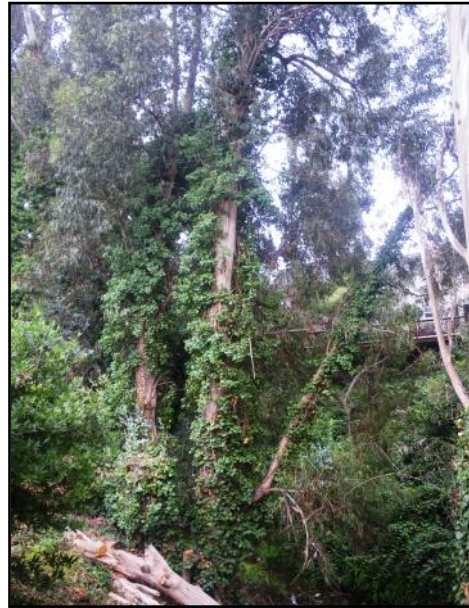
| Comments | Codominant trunks at base; N. stem removed; both stems topped; low lateral SW.; engulfed in ivy; debris piled on uphill side. |

Above: One stem of blue gum #599 had been removed and the remaining stems topped.

| Risk reduction options | To reduce risk, prune to reduce branch weight & extension SW.; to eliminate risk, remove tree. |

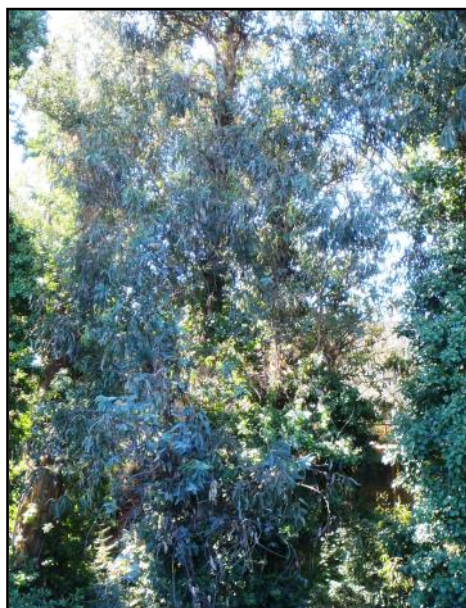
| Comments | Codominant trunks at base; S. stem topped; lateral S.; small crown; engulfed in ivy; debris piled on uphill side. |

Above: The trunk of blue gum #600 is hard to distinguish.

| Risk reduction options | To reduce risk, prune to reduce branch weight & extension S.; to eliminate risk, remove tree. |

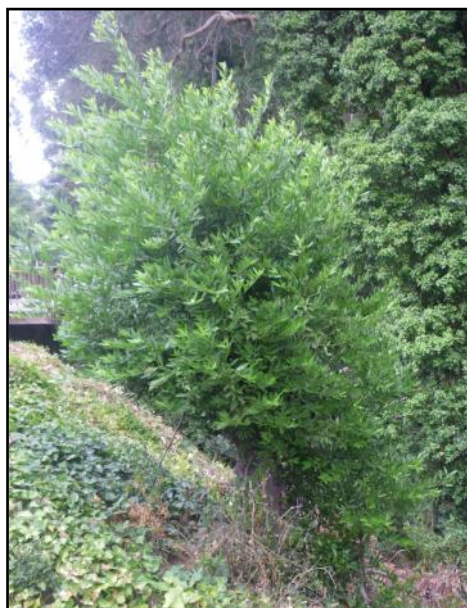
| Comments | Topped at 8'; only epicormics remain. |

Above: This young Calif. bay had been topped.

| Risk reduction options | To eliminate risk, remove tree. |

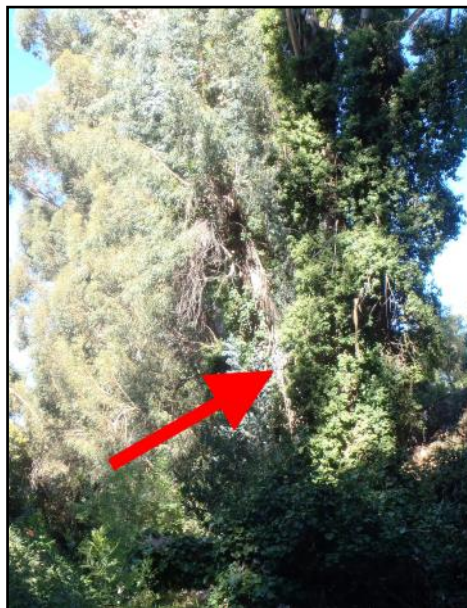
| Comments | Leans S.; topped at 35'; engulfed in ivy. |

Above: Arrow points to blue gum #602.

| Risk reduction options | To eliminate risk, remove tree. |

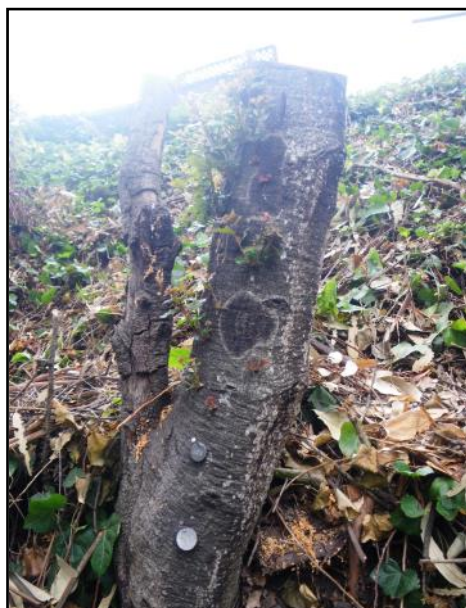
| Comments | Topped at 3'; only epicormics remain. |

Above: This young coast live oak had been topped and was just beginning to sprout.

| Risk reduction options | To eliminate risk, remove tree. |

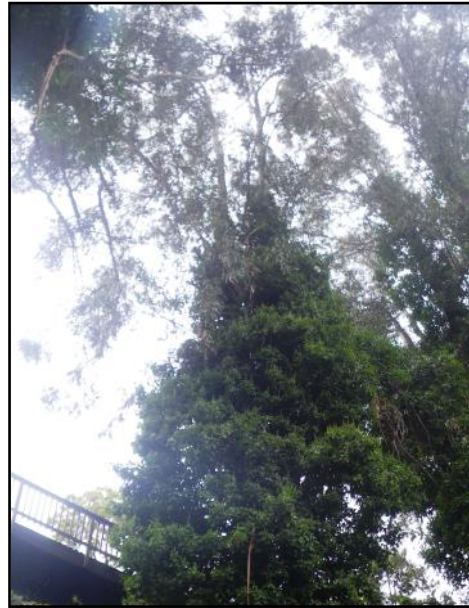
| Comments | Codominant trunks at 4'; upright, narrow form; engulfed in ivy. |

Above: Looking up at the canopy of blue gum #605.

| Risk reduction options | To reduce risk, prune to reduce branch weight & extension N.; to eliminate risk, remove tree. |

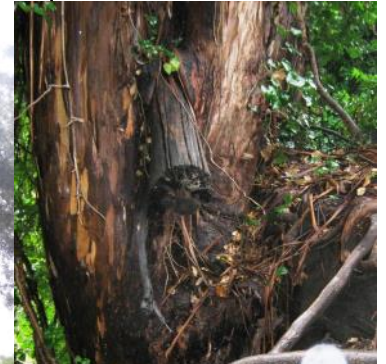
| Comments | Multiple attachment at 10'; section of log embedded in attachment; several stems topped at 20'; decay at topping points; engulfed in ivy; debris piled on uphill |

Inset shows the section of log wedged between the stems.

Above: This multi-stemmed blue gum had been topped at 20'.

| Risk reduction options | To reduce risk, prune to reduce branch weight & extension N.; to eliminate risk, remove tree. |

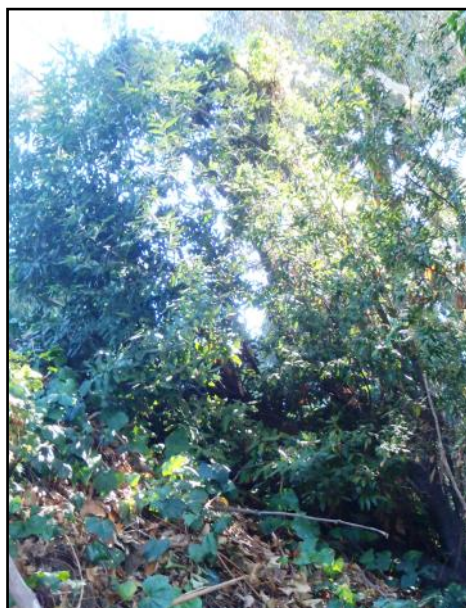
| Comments | Suppressed and leaning N.; topped at 8'. |

Above: Looking E. at Calif. bay #607.

| Risk reduction options | To eliminate risk, remove tree. |

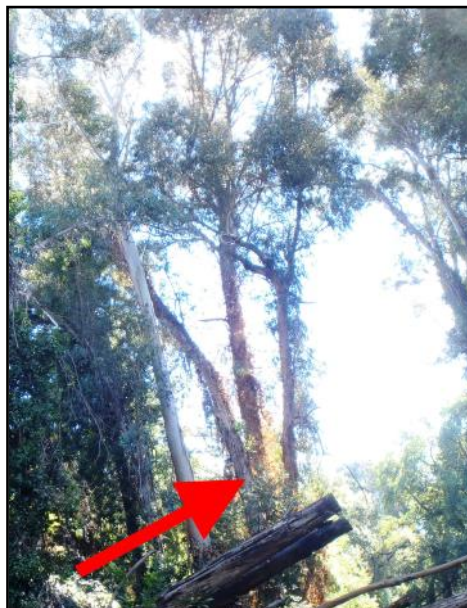
| Comments | Stump sprout; multiple attachments at base; basal wounds w/ decay; lateral N.; engulfed in ivy. |

Above: Arrow points to blue gum #608.

| Risk reduction options | To eliminate risk, remove tree. |

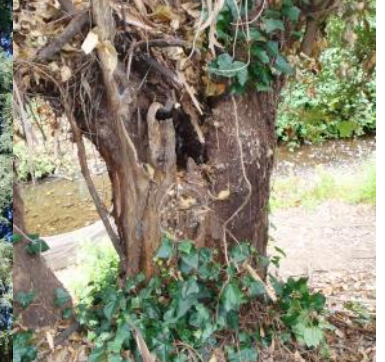
| Comments | Stump sprout; N. half of base decayed; lateral N.; corrected lean N.; ivy. |

Inset shows basal decay.

| Risk reduction options | To eliminate risk, remove tree. |

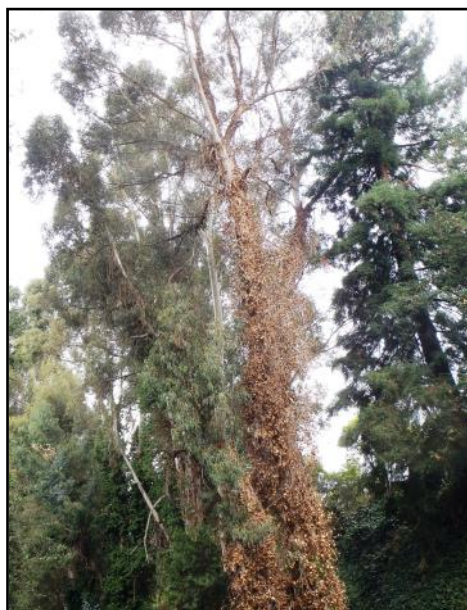
| Comments | Codominant trunks at 15'; one stem up-right; one stem leans SW. w/ dead wood & weak attachments; ivy. |

Above: Looking W. at blue gum #610.

| Risk reduction options | To reduce risk, remove or reduce stem SW.; to eliminate risk, remove tree. |

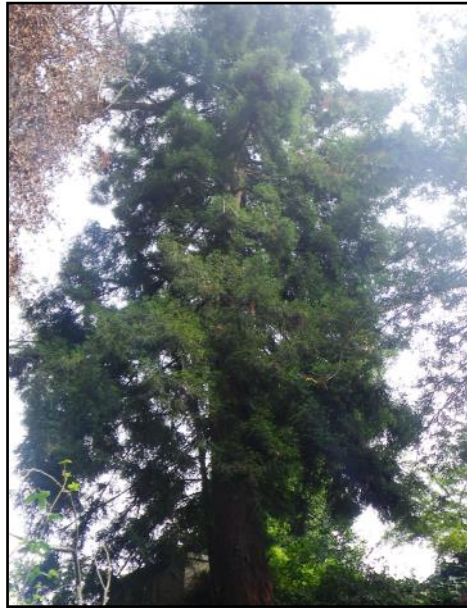
| Comments | Good form and structure; small sprout leans S. from base. |

Above: Looking N. at coast redwood #611.

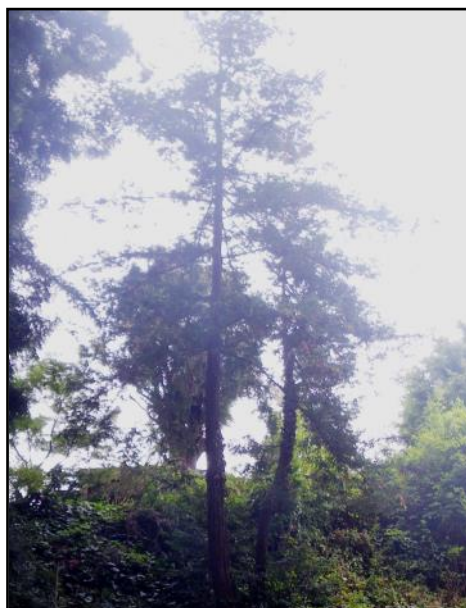
| Comments | Codominant trunks at base; thin canopy. |

Above: This small coast redwood had two trunks.

| Risk reduction options | To eliminate risk, remove tree. |

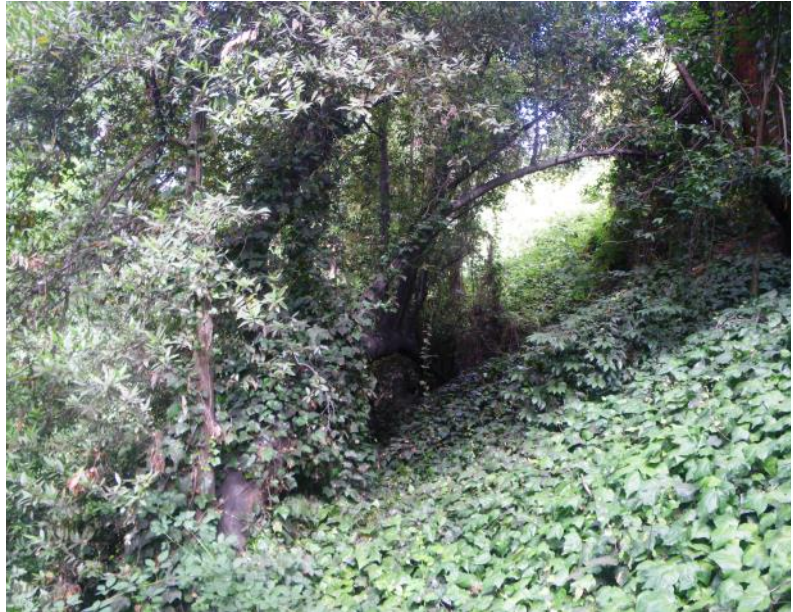
Above: Looking W. at Calif. bay #614.

| <b>Comments</b> | Codominant trunks at base; failed at base & laying on ground; epicormics going vertical; ivy. |

| <b>Risk reduction options</b> | To eliminate risk, remove tree. |

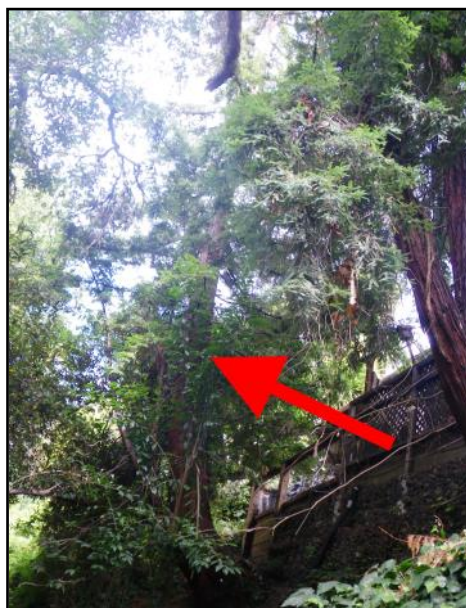
Above: Arrow points to coast redwood #615.

| Comments | Corrected lean S.;<br>root injury & decay N. |

| Risk reduction options | To eliminate risk, remove tree. |

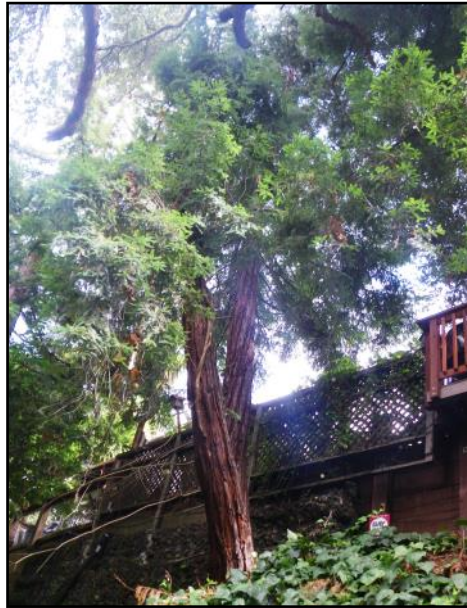
Above: Looking N. at coast redwood #616.

| Comments | Codominant trunks at 2'; N. stem up-right; S. stem leans SW.; basal wound w/ decay on S. stem. |

| Risk reduction options | To reduce risk, remove or reduce stem S.; to eliminate risk, remove tree. |

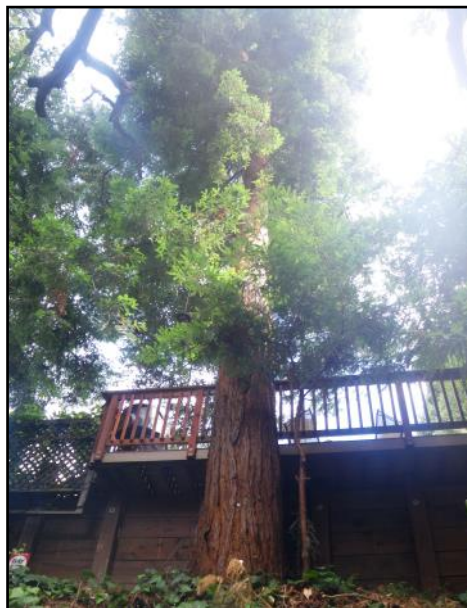
Above: Looking N. at coast redwood #617.

| Comments | Good form and structure; trunk with-in 1" of deck. |

| Risk reduction options | To eliminate risk, remove tree. |

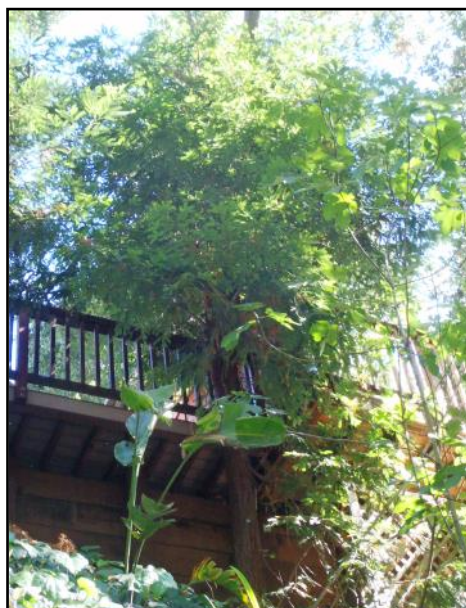
| Comments | Topped at 10'; 2" regrowth weakly attached. |

Above: Coast redwood #618 had been topped.

| Risk reduction options | To eliminate risk, remove tree. |

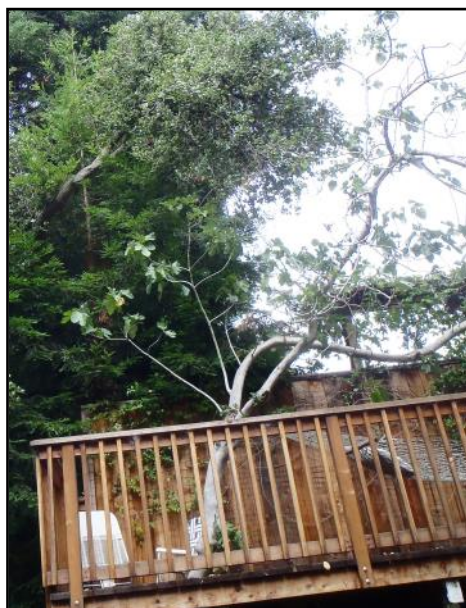
| Comments | Deck built around trunk; hammock tied to stem. |

Above: The deck had been constructed around this fig.

| Risk reduction options | To eliminate risk, remove tree. |

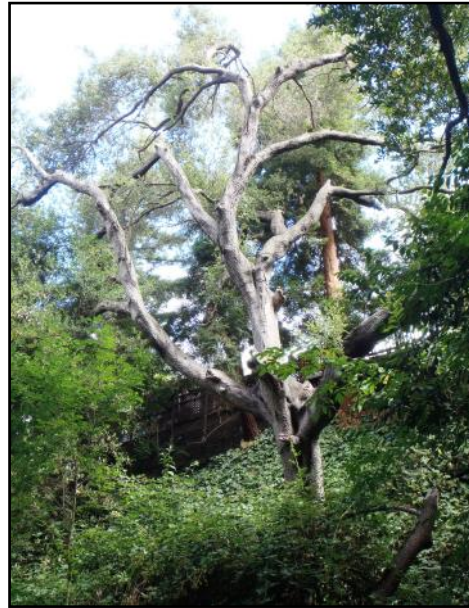
| Comments | Multiple attachments at 10'; asymmetric crown; history of branch failure; weight & laterals N. |

Above: Coast live oak #620 was bare on the S. side, with weight to the N.

| Risk reduction options | To reduce risk, prune to reduce branch weight & extension N.; to eliminate risk, remove tree. |

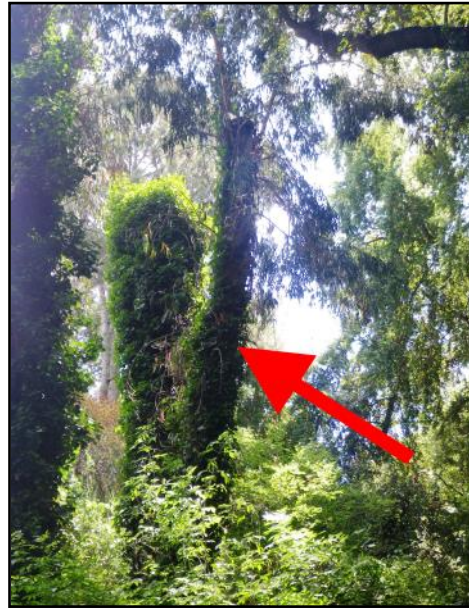
Above: Arrow points to blue gum #622.

| Comments | Topped at 30'; 2-5" regrowth weakly attached; engulfed in ivy. |

| Risk reduction options | To eliminate risk, remove tree. |

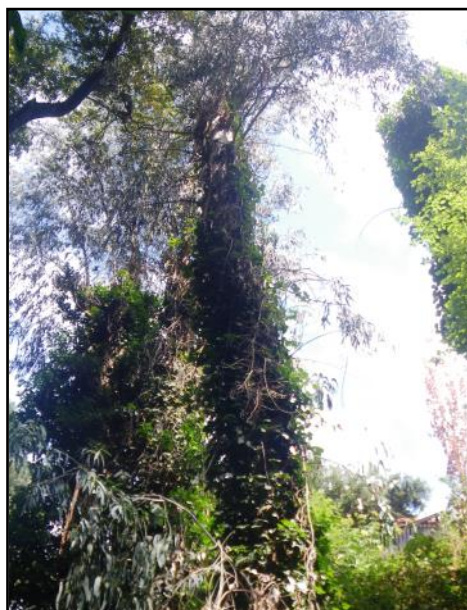
Above: Looking NW. at blue gum #623.

| Comments | Topped at 30'; slight lean S.; trunk wounds & decay; 2" regrowth weakly attached; engulfed in ivy. |

| Risk reduction options | To eliminate risk, remove tree. |

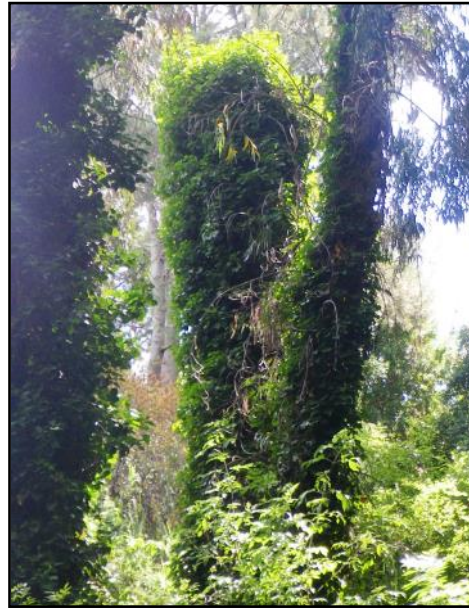
| Comments | Topped at 30'; standing dead stump; engulfed in ivy. |

Above: Blue gum #624 was a standing dead stump.

| Risk reduction options | To eliminate risk, remove tree. |

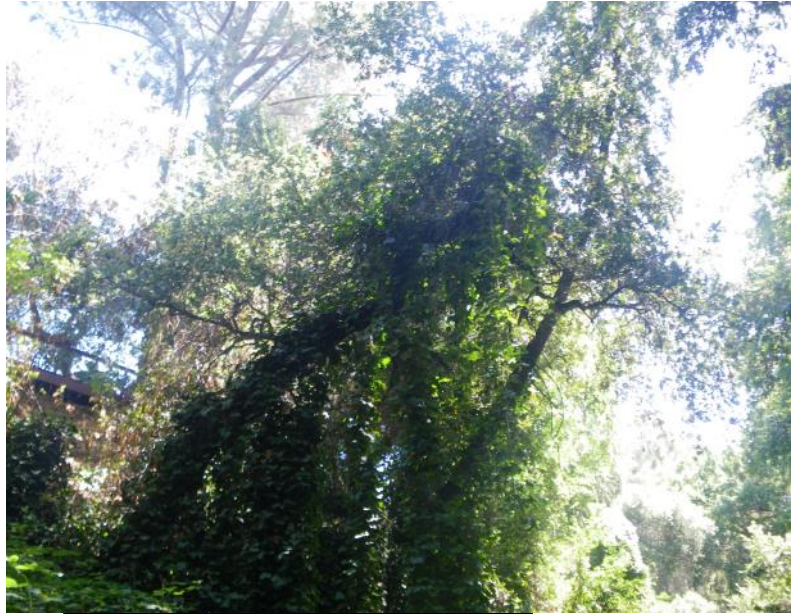
| Comments | Suppressed and leaning S.; dead-wood; weight & laterals S.; engulfed in ivy. |

Above: Coast live oak #626 leaned S.

| Risk reduction options | To reduce risk, prune to reduce crown weight & extension S.; to eliminate risk, remove tree. |

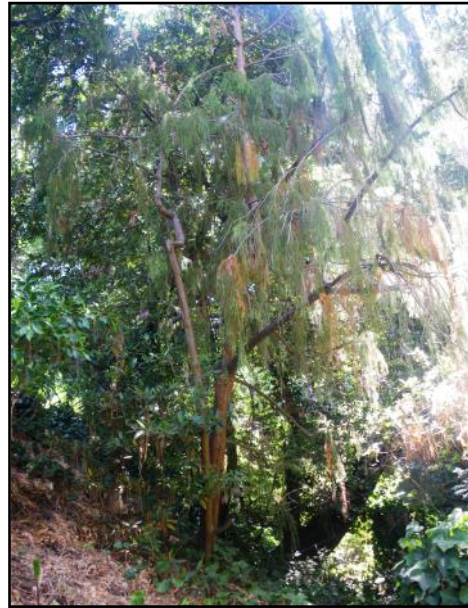
| Comments | Topped at 10';<br>crooks at topping<br>points; suppressed. |

Above: This cryptomeria appeared to be part of someones landscape.

| Risk reduction options | To eliminate risk,<br>remove tree. |

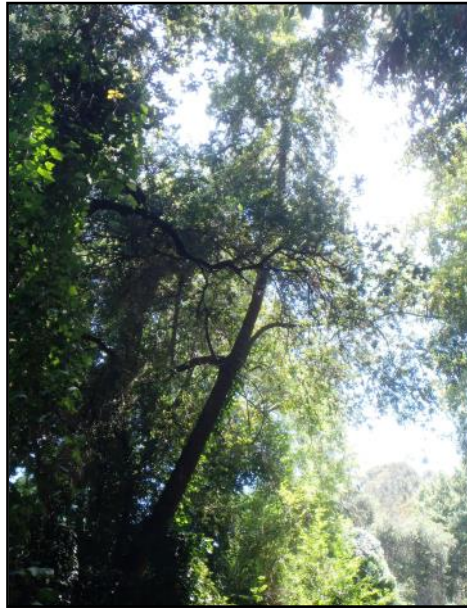
Above: Looking NE. at Calif. bay #629.

| Comments | 10" stem bowed N.;<br>24" stem leans S.<br>over creek; ivy. |

| Risk reduction options | To reduce risk, prune to reduce branch weight & extension SE.; to eliminate risk, remove tree. |

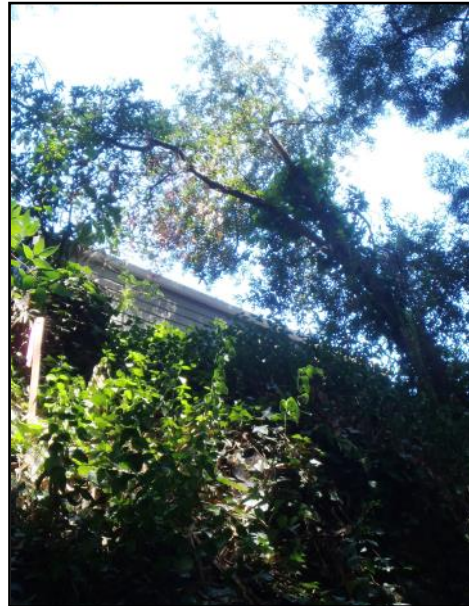
| Comments | Codominant trunks at base; stems twisted around each other; leans N.; basal decay. |

Above: Toyon #630 was suppressed and leaning N.

| Risk reduction options | To eliminate risk, remove tree. |

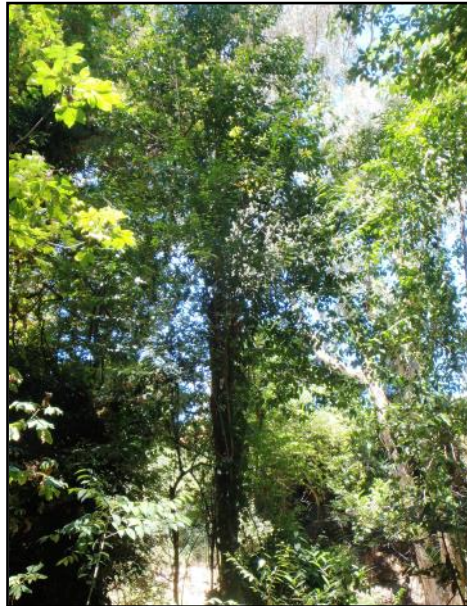
| Comments | Codominant trunks at base; lost top. |

Above: Privet #631 was upright.

| Risk reduction options | To eliminate risk, remove tree. |

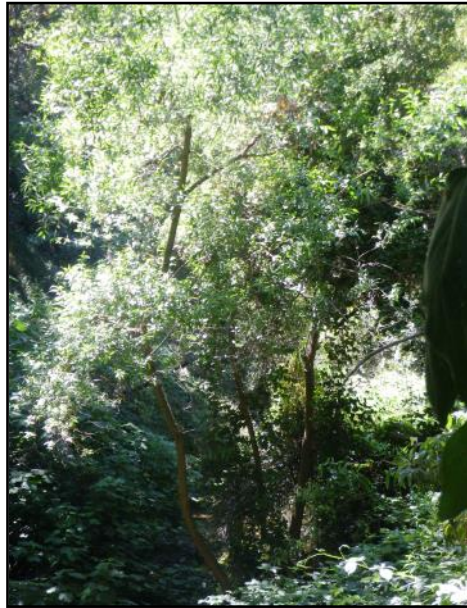
| <b>Comments</b> | Codominant trunks at base; one stem upright; other growing E. along ground; ivy. |

Above: Arroyo willow #632 was growing in the creek channel.

| <b>Risk reduction options</b> | To eliminate risk, remove tree. |

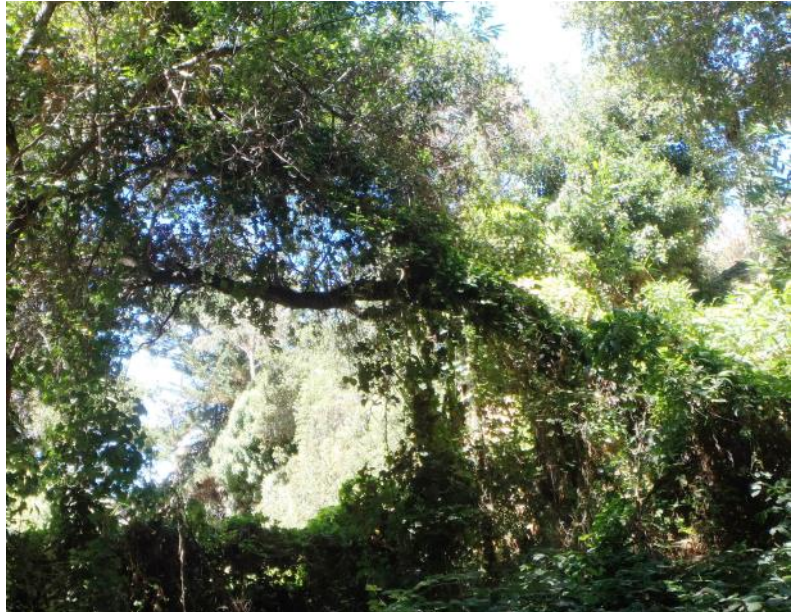
| Comments | Codominant trunks at 12'; crown bowed W. to horizontal; ivy. |

Above: Coast live oak #633 leaned W. to horizontal.

| Risk reduction options | To reduce risk, prune to reduce crown weight & extension W.; to eliminate risk, remove tree. |

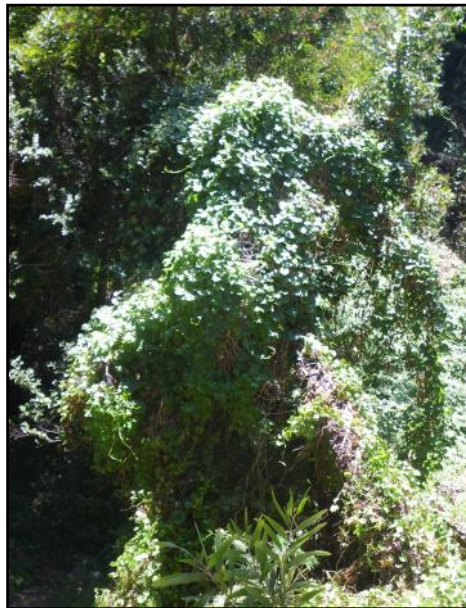
| Comments | Crown bowed S. to horizontal; engulfed in ivy. |

Above: Looking S. at coast live oak #634, it was engulfed in ivy.

| Risk reduction options | To reduce risk, prune to reduce crown weight & extension S.; to eliminate risk, remove tree. |

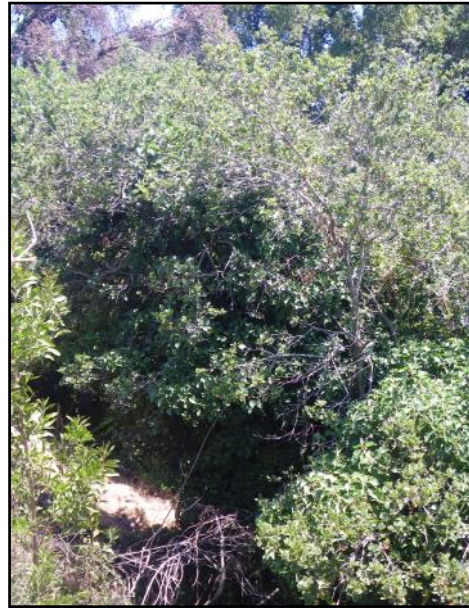
| Comments | Codominant trunks at 2'; small crown; trunk wounds & decay; engulfed in ivy. |

Above: Looking S. at coast live oak #636; it was engulfed in ivy.

| Risk reduction options | To reduce risk, remove or reduce stem S.; to eliminate risk, remove tree. |

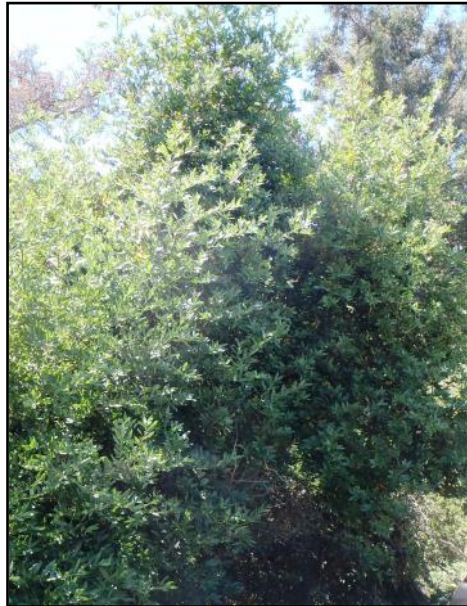
| Comments | Codominant trunks at base; suppressed; leans W.; engulfed in ivy. |

Above: This Calif. bay was one of several along the edge of the parking lot.

| Risk reduction options | To reduce risk, remove or reduce stem W.; to eliminate risk, remove tree. |

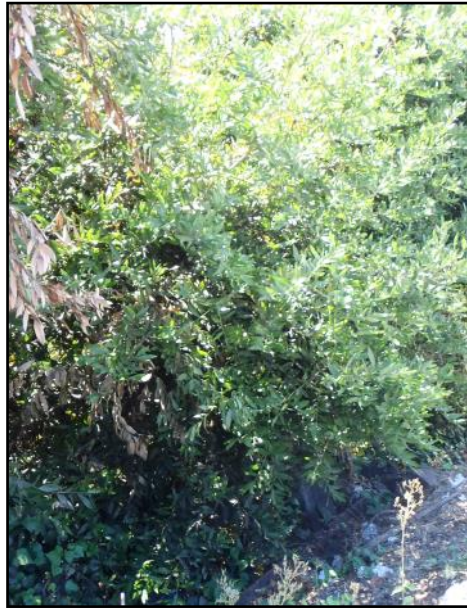
| Comments | Suppressed; leans N.; topped at fence line; engulfed in ivy. |

Above: Calif. bay #639 was suppressed.

| Risk reduction options | To eliminate risk, remove tree. |

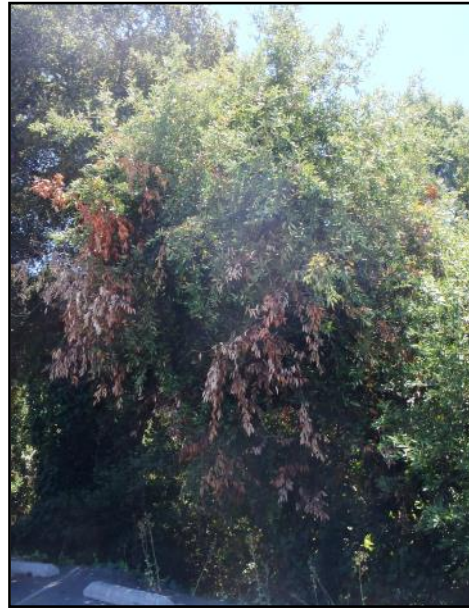
| <b>Comments</b> | Codominant trunks at 8'; one sided N.; engulfed in ivy. |

Above: This Calif. bay was one of several along the edge of the parking lot.

| <b>Risk reduction options</b> | To eliminate risk, remove tree. |

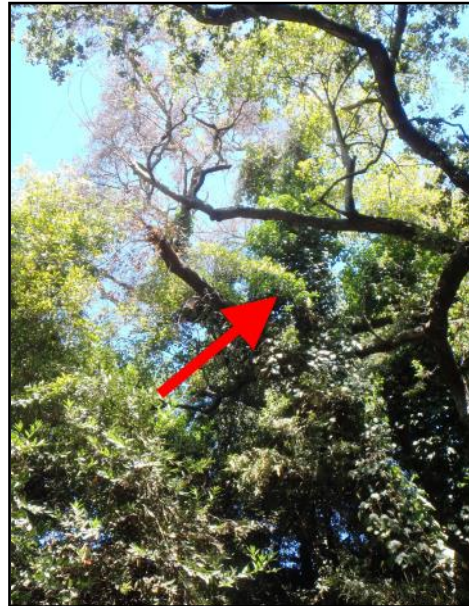
| Comments | Standing dead;<br>leans W.; engulfed<br>in ivy. |

Above: Looking up at the canopy of coast live oak #641 (arrow).

| Risk reduction options | To eliminate risk, remove tree. |

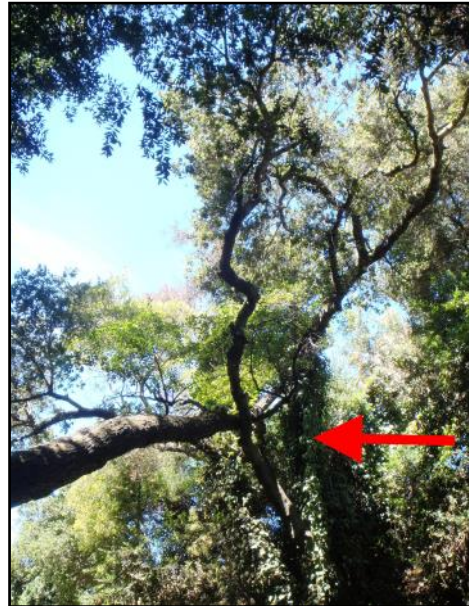
| Comments | Multiple attachments at 4'; majority of weight S.; one stem extends N. but topped at fence line; tree across creek failed & hung-up in crown; engulfed in |

Above: Arrow points to the canopy of coast live oak #642.

| Risk reduction options | To eliminate risk, remove tree. |

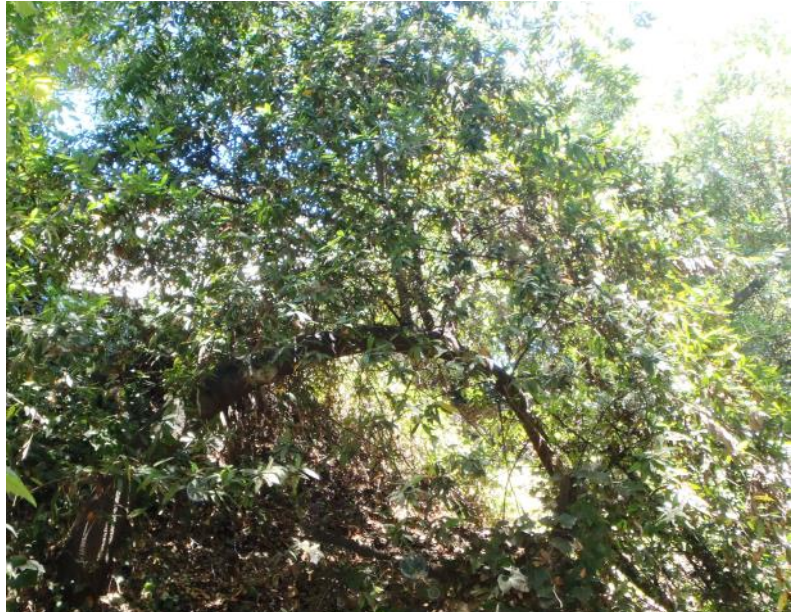
| Comments | Suppressed & leans E. to horizontal. |

Above: Calif. bay #643 was suppressed and leaned E.

| Risk reduction options | To eliminate risk, remove tree. |

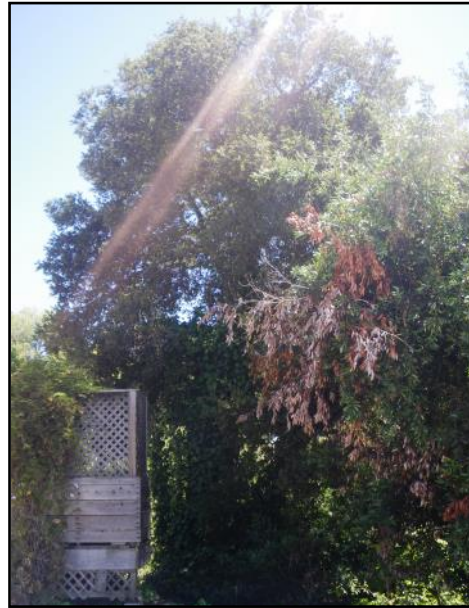
| Comments | Codominant trunks at 4'; E. stem upright; W. stem lost top; pruned N. at property line; engulfed in ivy. |

Above: Looking E. at the canopy of coast live oak #644.

| Risk reduction options | To reduce risk, prune to reduce branch weight & extension S.; to eliminate risk, remove tree. |

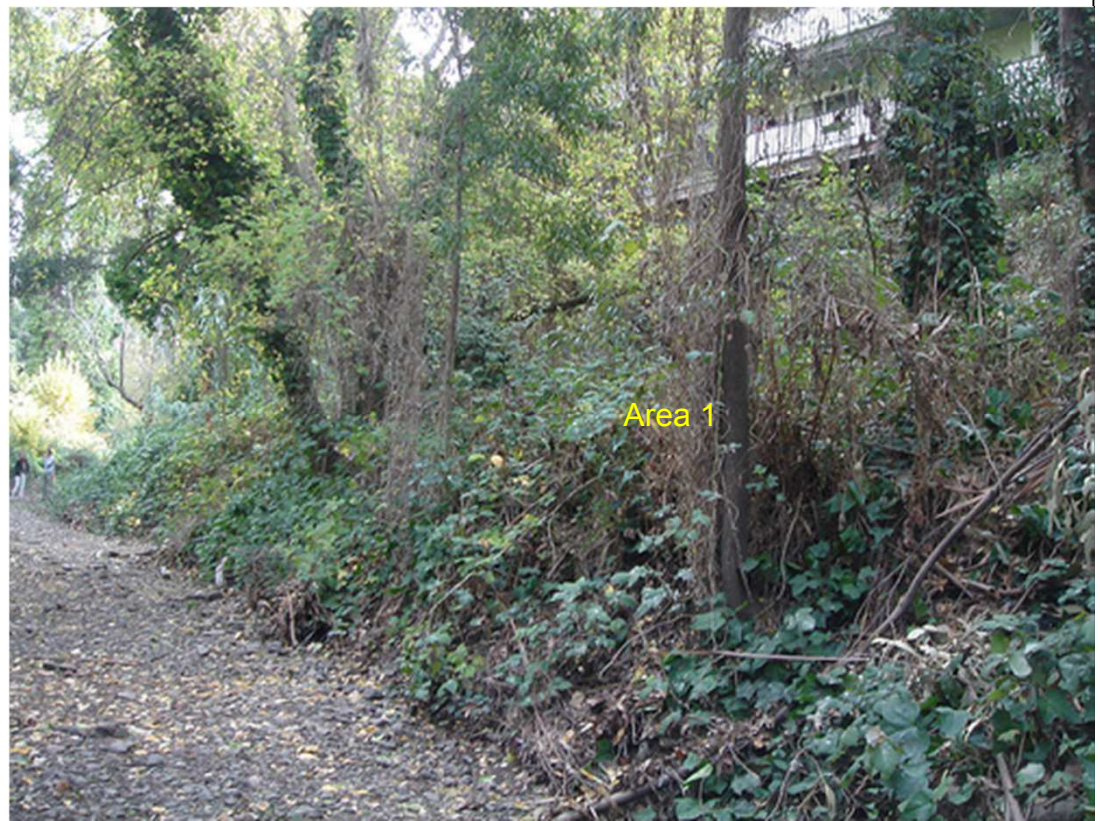
**Photo 2.**

Potential staging/landing area 1. Looking east from tree #453. Thick underbrush and leaf litter covers the terraced area at this potential staging area.
