# San Leandro Creek Tree Assessment

February 24, 2015

County of Alameda  
Flood Control and Water Conservation District  
399 Elmhurst Street  
Hayward, CA 94544-1395

URS Corporation  
1333 Broadway, Suite 800  
Oakland, CA 94612

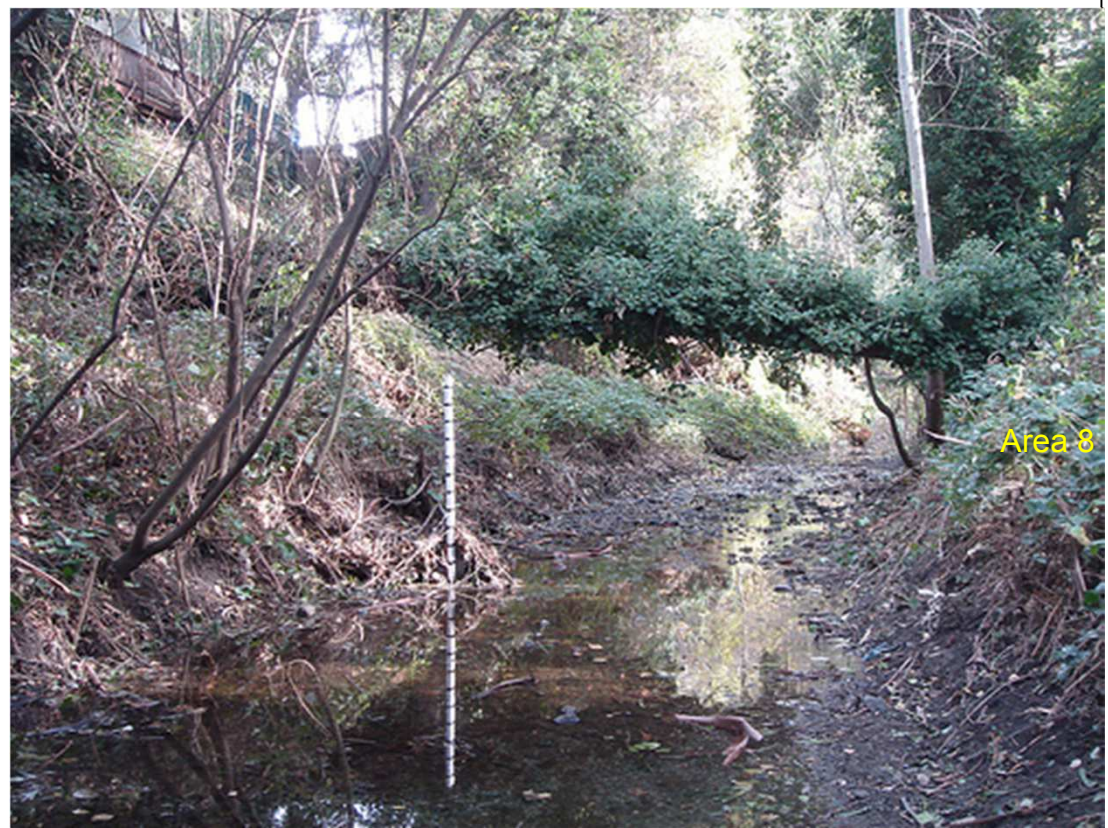
**Photo 12.**

Potential staging/landing area 8. Looking east from tree #486. Note old fallen eucalyptus bridging creek which is denoted on map as an access barrier (map Sheet 7).

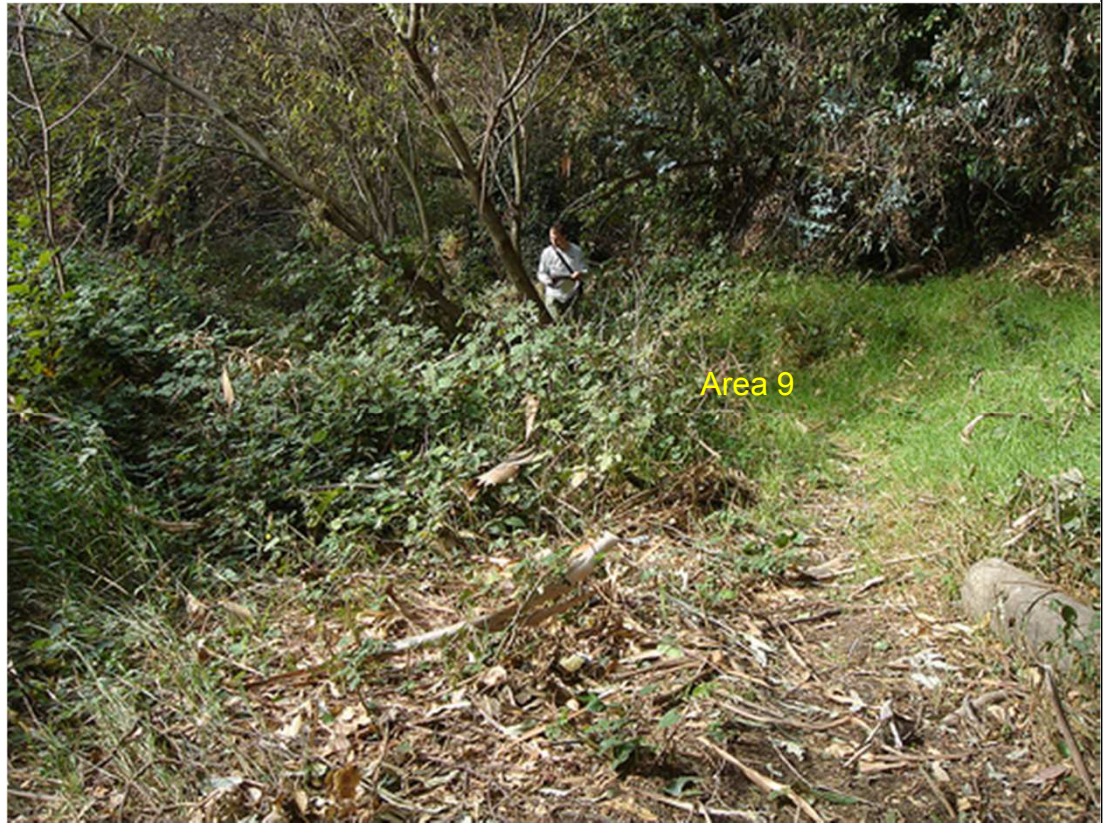
**Photo 15.**

Potential staging/landing area 9. Looking northwest at tree #551 on map Sheet 8. Creek channel is to the left.

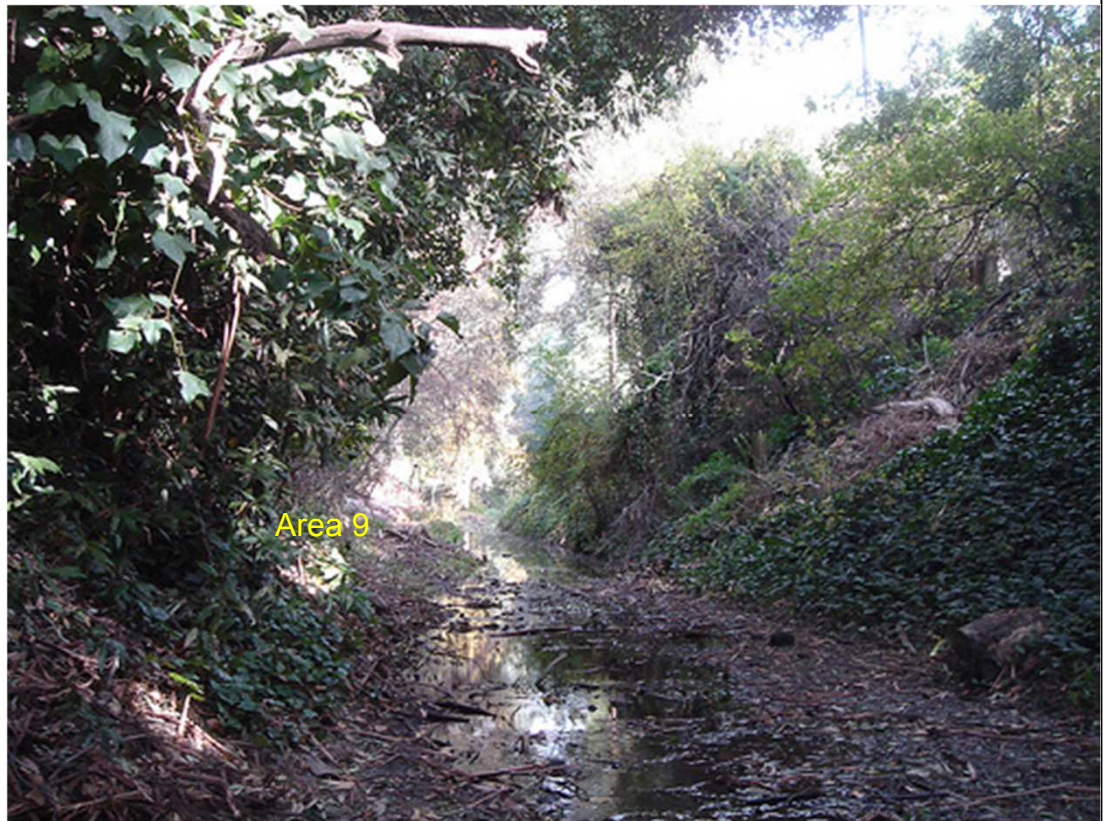
**Photo 16.**

Potential staging/landing area 9. Looking east from tree #577 (map Sheet 8).

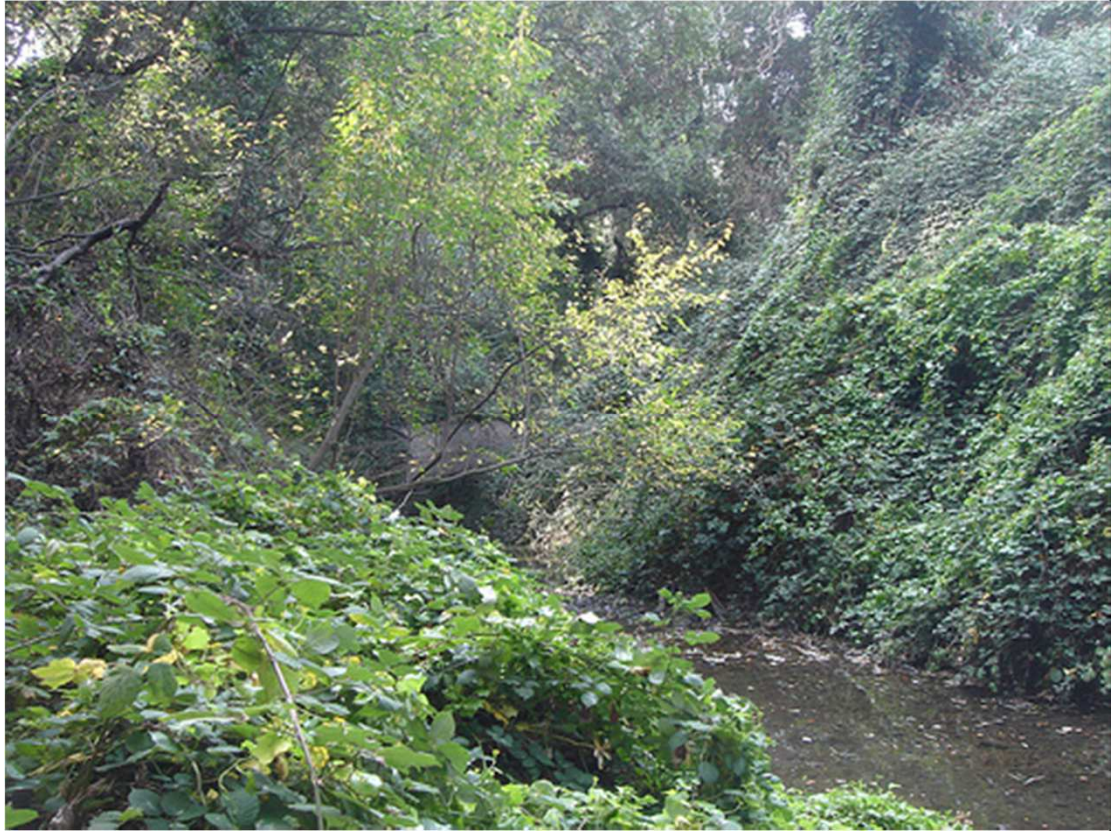
**Photo 17.**

Looking west from the area between the proposed staging areas 11 and 12 (map Sheet 9).

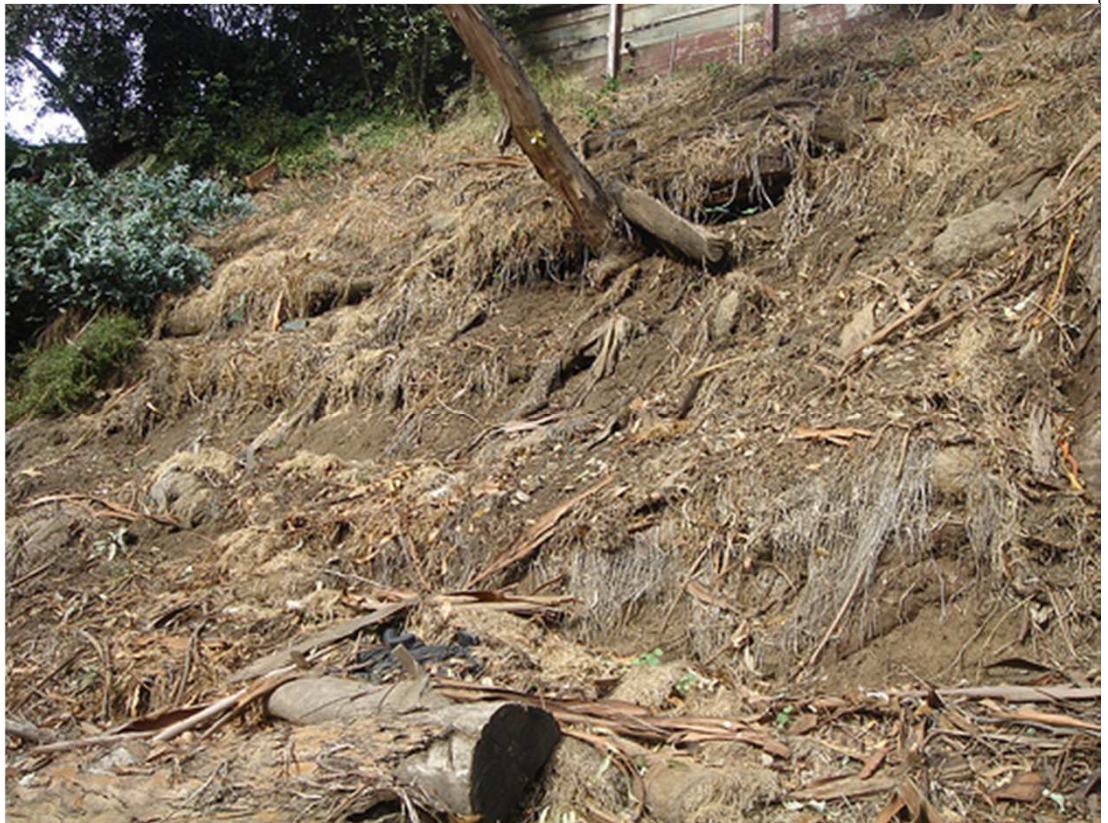
**Photo 18.**

Looking west at unstable slope from approximately tree #250, which abuts proposed staging area 13 (map Sheet 10).

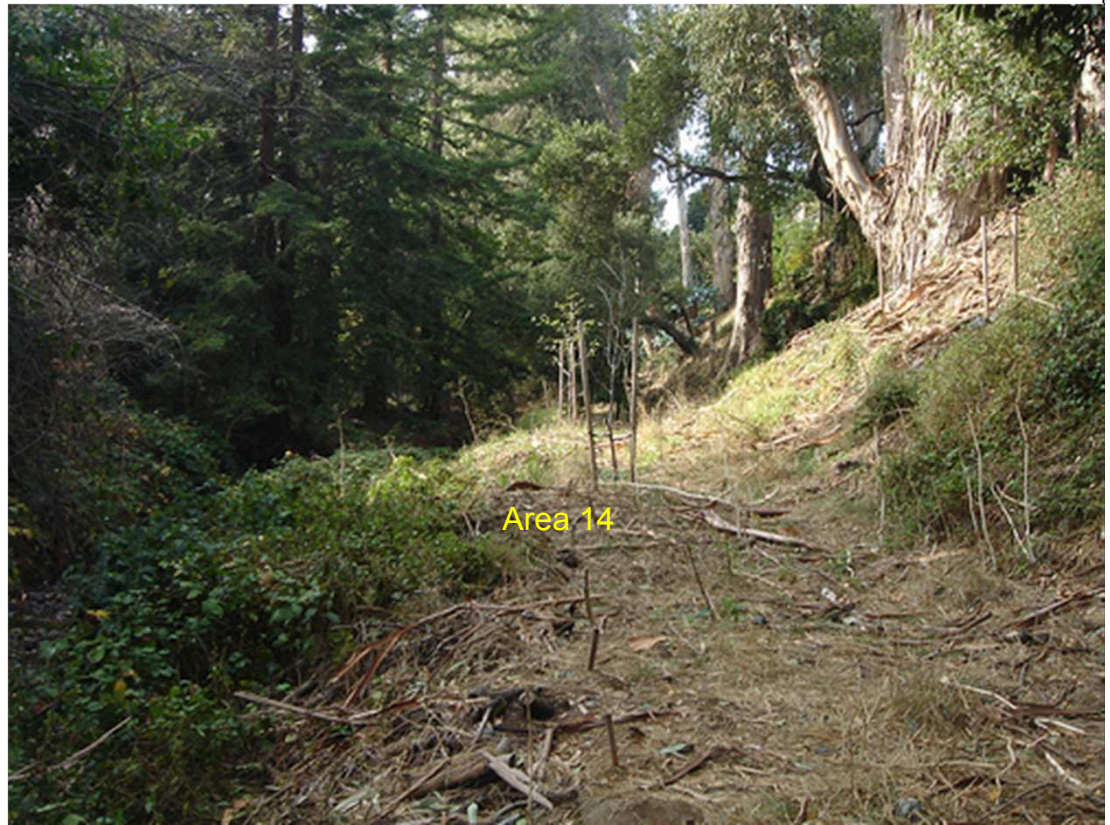
**Photo 19.**

Potential  
staging/landing area  
14. Looking  
northwest from tree  
#318 on map Sheet  
10.

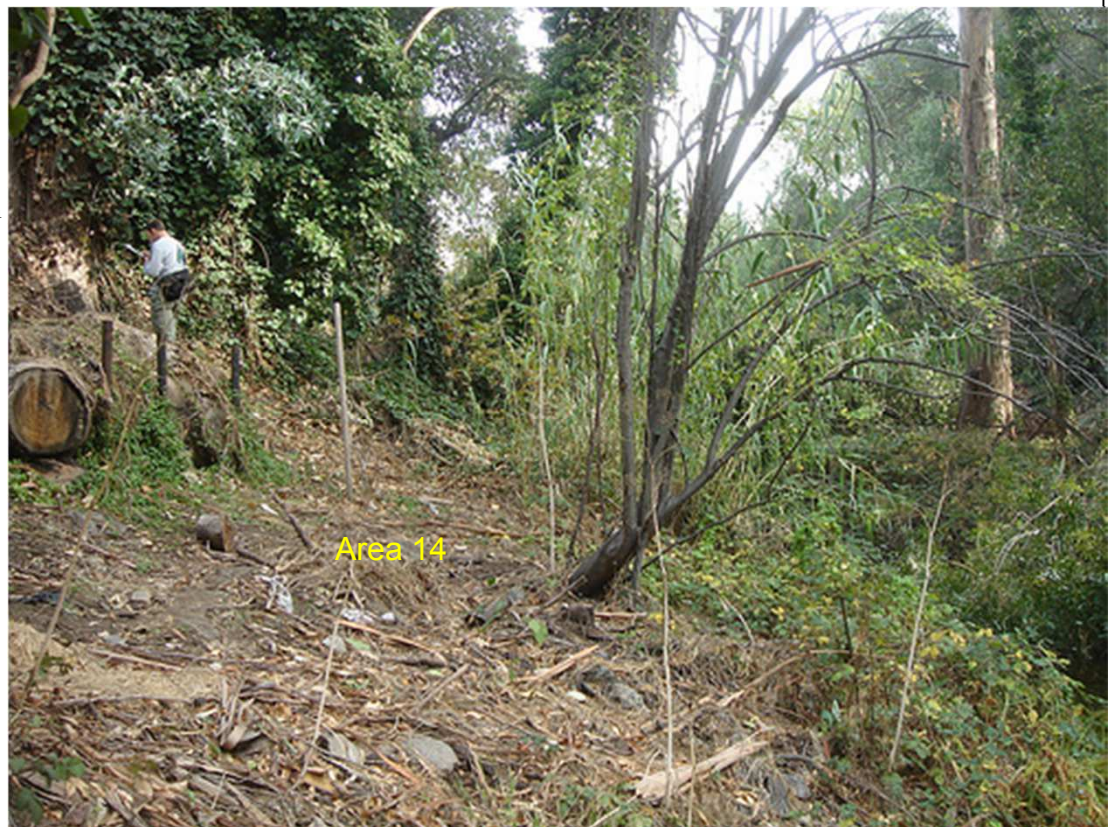
**Photo 20.**

Potential  
staging/landing area  
14. Looking east from  
tree #318 on map  
Sheet 10.
