ARROYO LAGO
PLEASANTON, CALIFORNIA

PRELIMINARY GEOTECHNICAL REPORT

PREPARED BY
ENGEO Incorporated

May 18, 2023

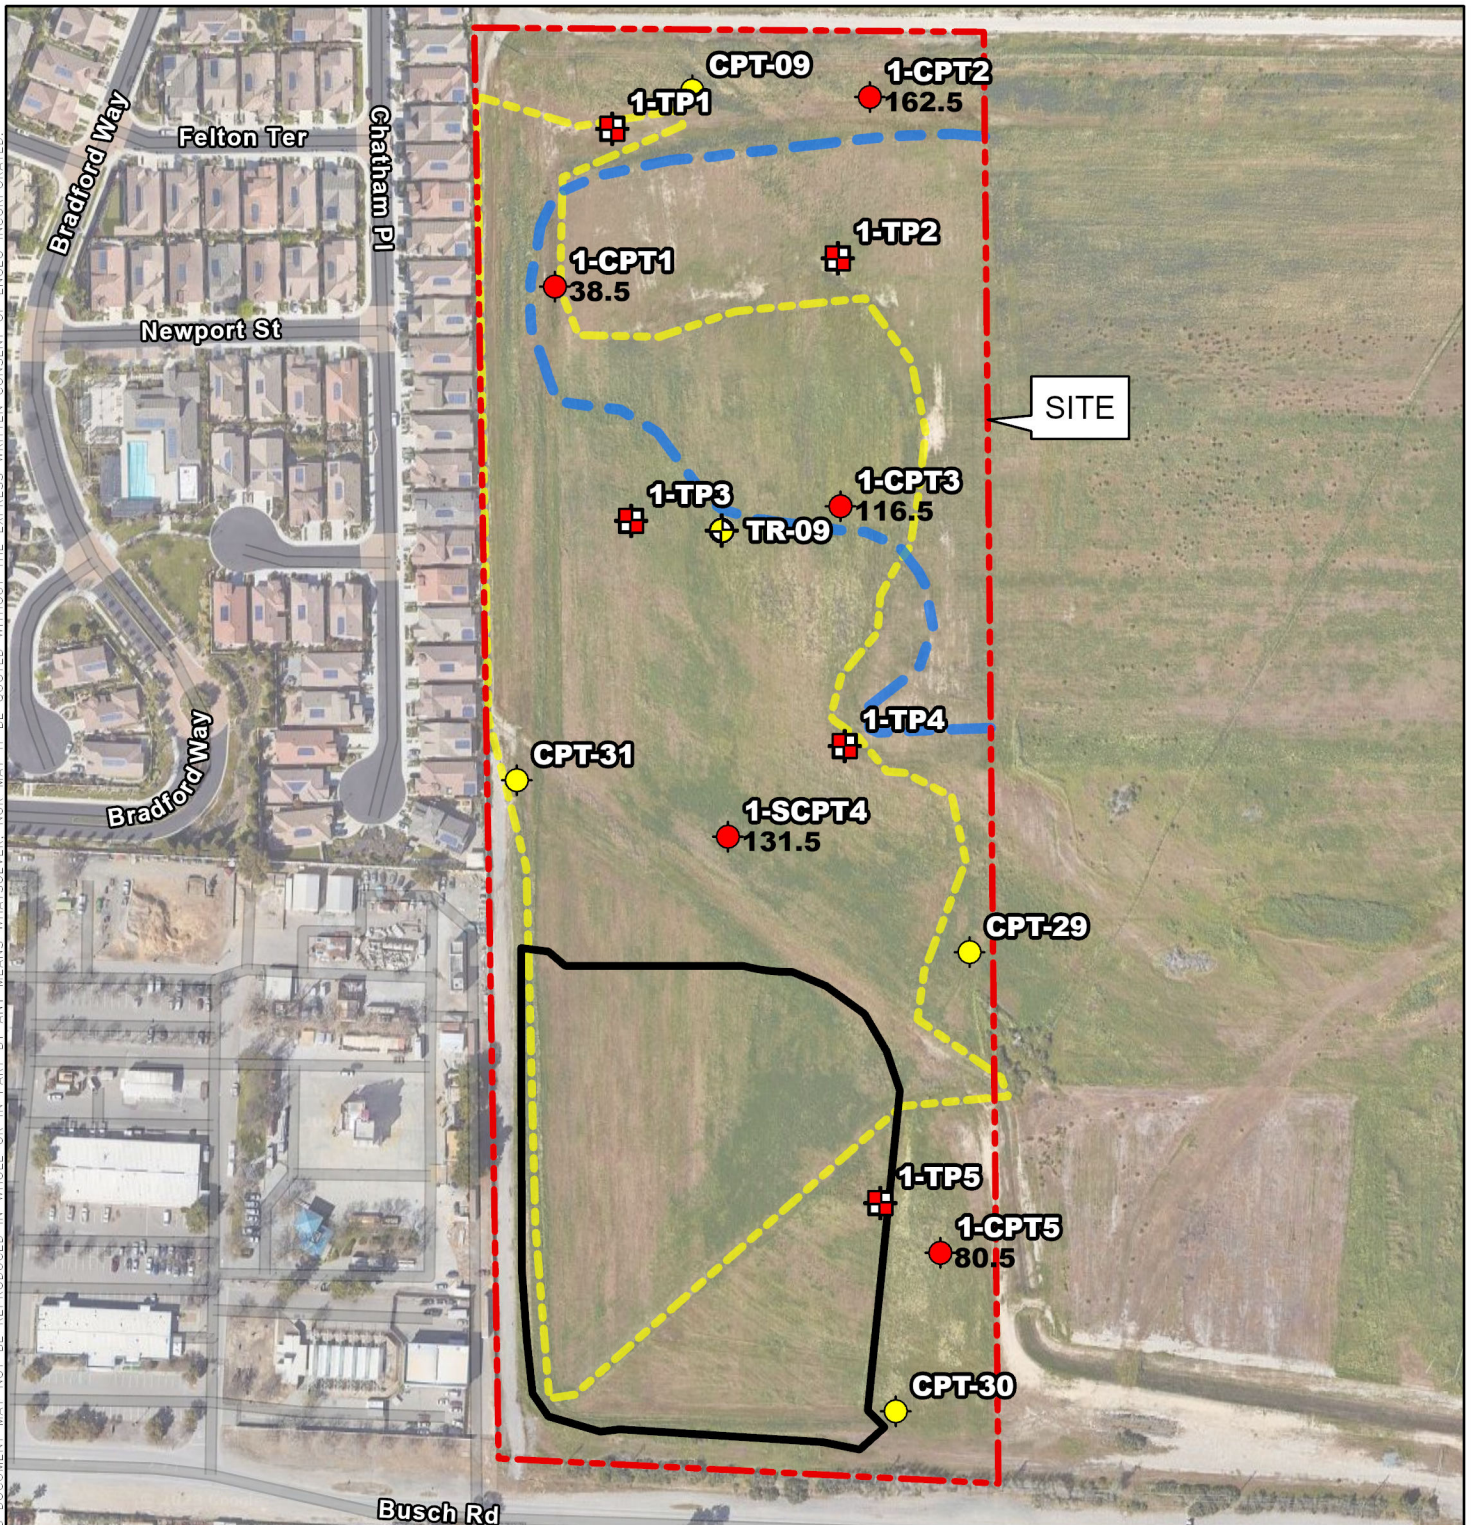
2A

ALL LOCATIONS ARE APPROXIMATE

We observed excavation of five test pits as shown on the Site Plan (Figure 2A). A representative of our firm observed the test pit excavation and logged the subsurface conditions at each location. We retained the services of a subcontractor operating a backhoe to excavate the test pits using an approximately 2-foot-wide bucket and logged the type, location, and uniformity of the underlying soil. The depth of our test pits ranged from 10 to 10½ feet below the existing ground surface. Once completed, the test pits were backfilled following field exploration activities using nominal compactive effort by the bucket.
